greater WELLINGTON
REGIONAL COUNCIL

Wairarapa Peer Review

2004/05

Inspection date: 14 July 2005

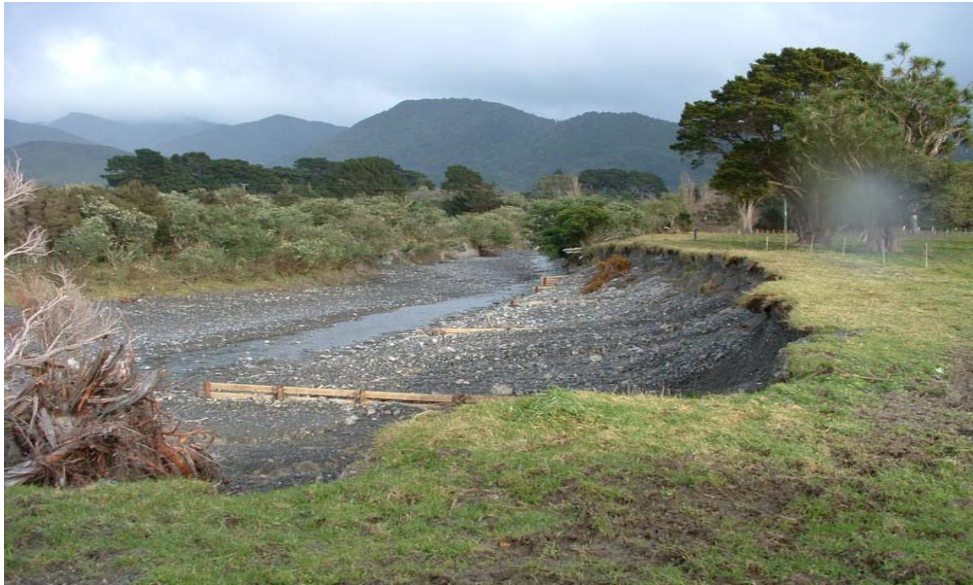
To protect the road and maintain the river in an ideal alignment a series of retards (driven railway iron and timber wale construction) were constructed both upstream and downstream of the road bridge. On one of the more critical bends, approximately 500 tonne of rock was placed to prevent the stream changing course and outflanking the road bridge. A major willow planting programme will be completed this planting season.

Picture 1: Retards on the Wairongomai Stream

The reviewers consider the works appropriate for the situation, and endorse the planting of the site with willows this planting season. An ongoing maintenance programme will need to be developed to ensure that the retards and proposed planting are kept in a good condition.

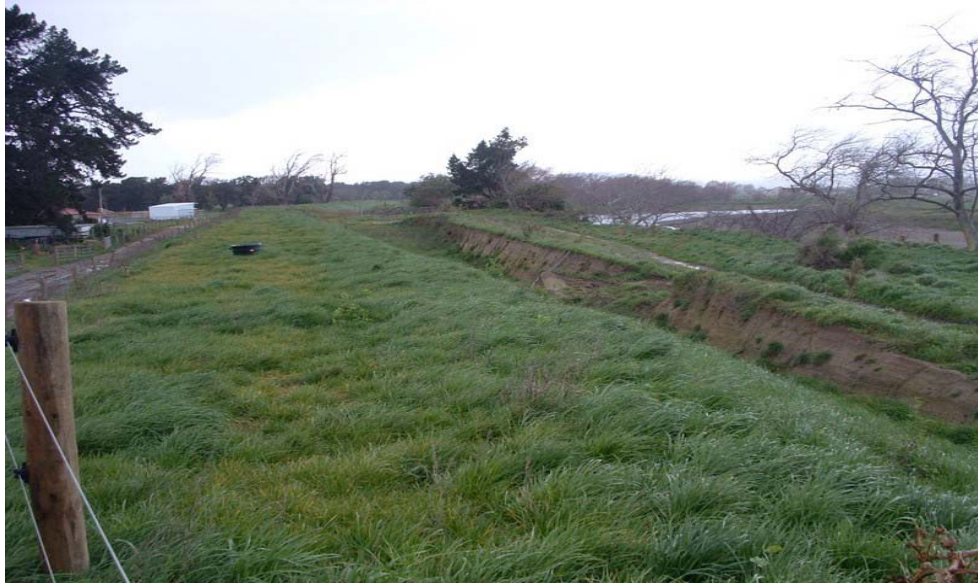
Due to delays in the resource consent process, the stopbank and concrete wall continued to deteriorate. The August 2004 flood event created an emergency situation, and a decision was made in September 2004 to construct the new stopbank under the emergency provisions of the RMA. A resource consent was granted to do the remaining work, including the removal of the old stopbank and concrete wall, however this has been appealed. This work will be completed when resource consent is granted by the Environment Court.

Picture 2: Scadden stopbank

The condition of the new stopbank was good, with adequate grass cover and no evidence of overgrazing.

The reviewers agreed with the urgent need to relocate and replace the existing stopbank and concrete wall structure with the new stopbank (see picture 2). The remaining works should be constructed as soon as resource consent is granted to ensure the area on the river side of the stopbank is suitably protected.

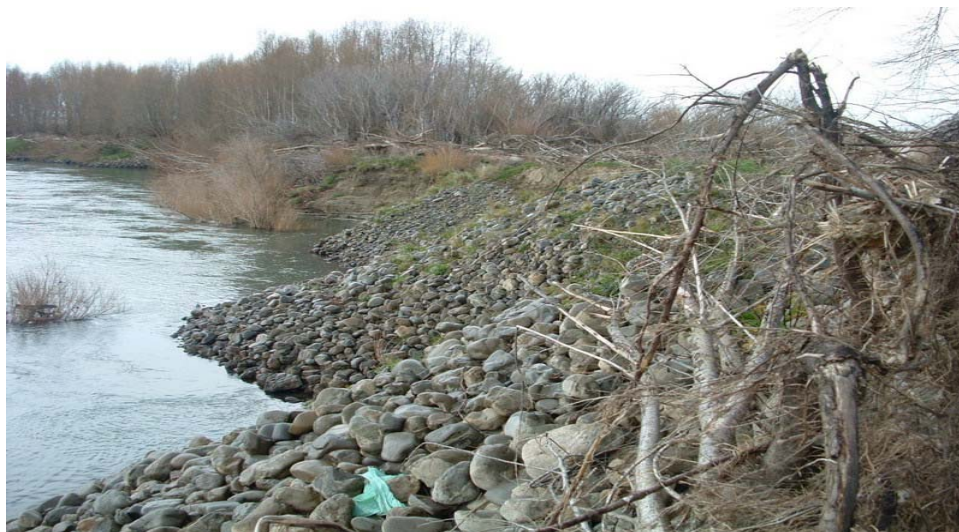
Picture 3: boulder groynes

The reviewers were impressed with the application of a fairly standard method of edge protection to this unusual situation. The boulder groynes are cost effective, and are working extremely well.

The groynes were in good condition with a suitable batter slope and no evidence of slumping. The reviewers recommend the planting and ongoing establishment of willows to enhance the stability of this site.

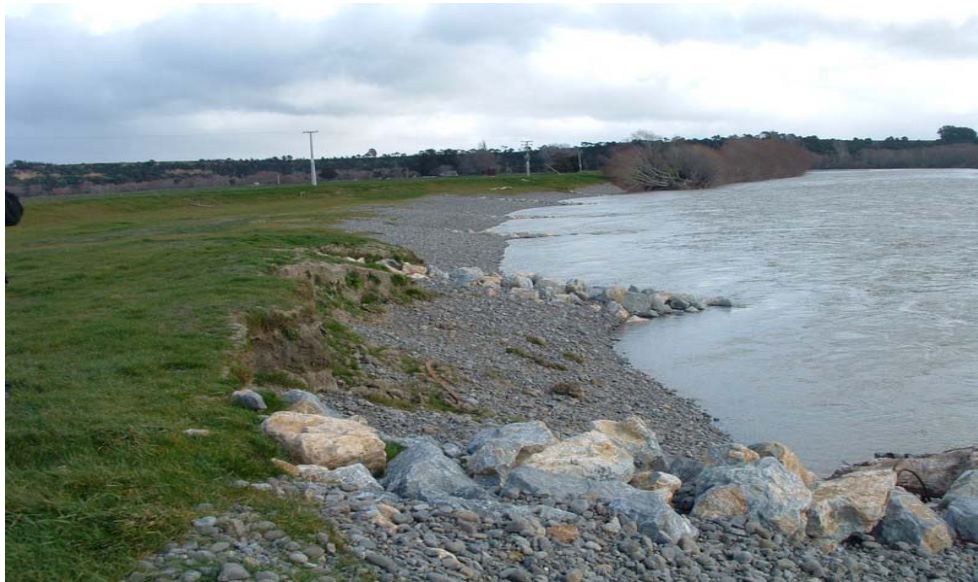
To repair the lateral erosion and maintain the design channel alignment through the Guscott's property, the left berm on the outside of the bend was rebuilt with gravels from the right bank. Then approximately 1,200 tonne of rock was delivered to site and used to construct six small evenly spaced rock groynes; if required a seventh downstream groyne may be constructed in the future.

Picture 4: Series of rock groynes on the Guscott's property

The reviewers consider the approach and solution taken appropriate for both situations, especially given the extremely difficult access to both sites. It is important that the river, through these two properties, is maintained in a suitable channel alignment to

The reviewers believe the alignment of the rock groynes appropriate, and note that as well as mass planting the newly constructed works with willows during this planting season that the existing willow stand upstream of these works is also reinforced. The gravel beach on the right bank should also be monitored to ensure that the new works are not put under additional pressure.

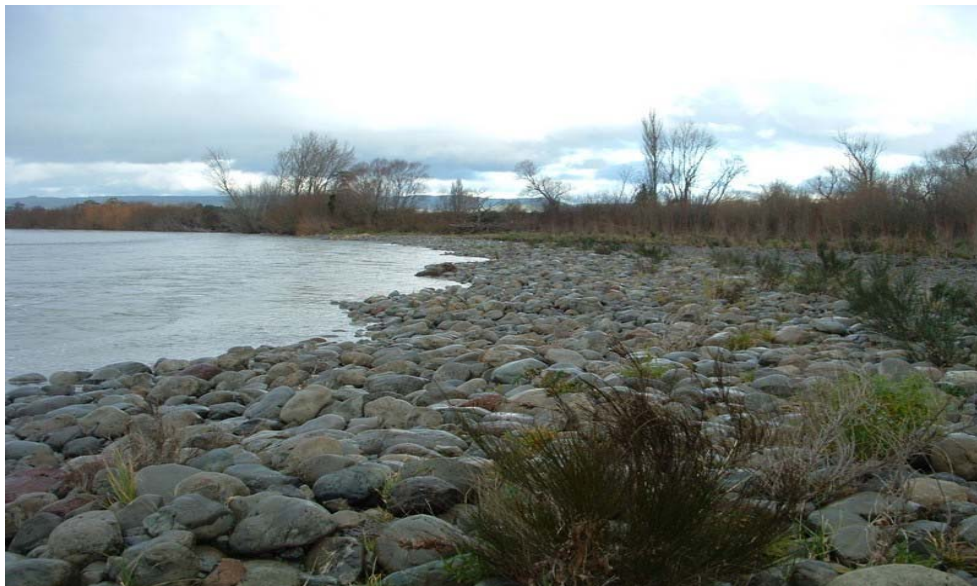
The reviewers also visited this site two years ago. The condition of the armouring layer over the intervening two years is comparable; however the reviewers note the following concerns:

- *The scour occurring at the backside of the armouring, which was noted during the last inspection is still continuing and should be monitored to ensure that it does not jeopardise the integrity of the work.*
- *There are some depressions in the toe of the armouring layer; this may indicate potential failure spots and should be monitored closely.*
- *The left bank gravel beach requires monitoring to ensure the works are not placed under additional pressure.*

Picture 5: Boulder armouring layer.

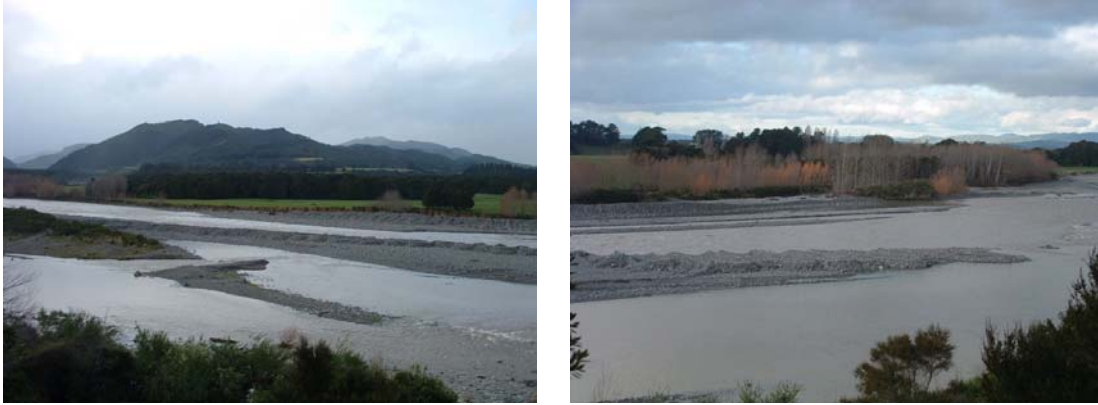
Woodside is situated in the upper reaches of the Waiohine River near the water intake for Greytown and Featherston. The reviewers were shown how certain reaches of this river are managed almost entirely by working towards the design channel alignment through willow plantings, and in channel gravel management; specifically the use of pilot cuts and crossblading.

By providing the Waiohine River with a consistent width, removing constrictions, building berm areas up through planting, and taking the pressure off vulnerable bank edges, the river is staying within the confines of its design alignment.

Picture 6: Looking upstream and downstream of a pilot cut on the Waiohine River
