# **Wellington Peer Review of Assets Maintenance Standards**

**2006/07**

**Waikanae & Otaki Rivers**

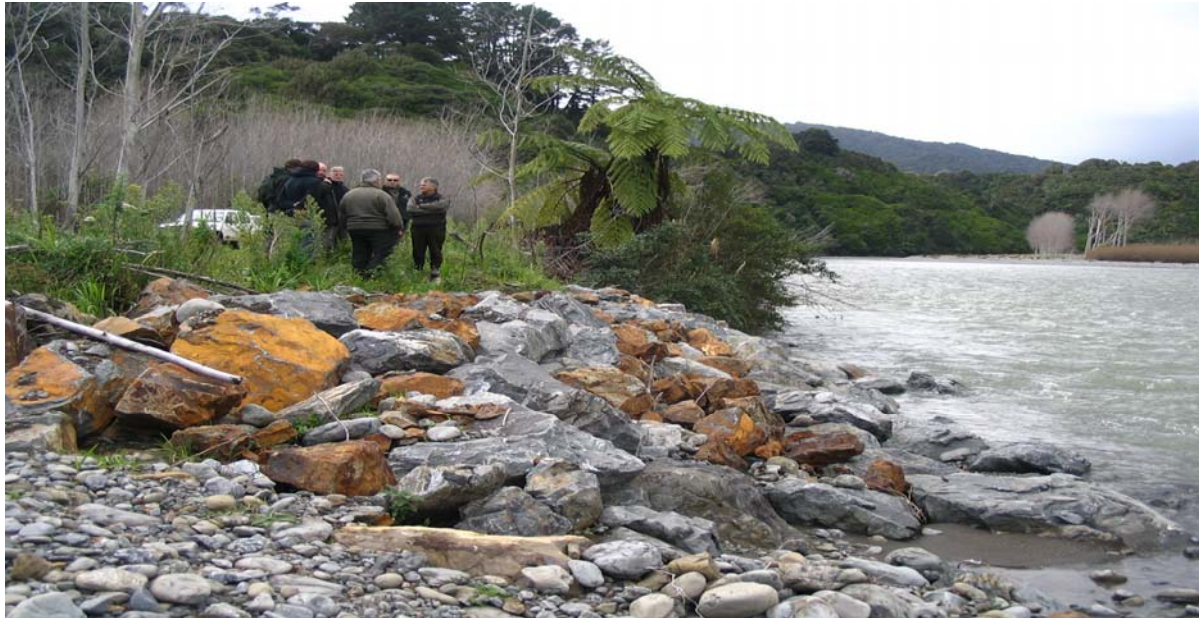
- Maintenance of the right bank rockline. Linton rock has been used which is priced competitively at \$50/tonne delivered. This rock line requires "top up" following periods of high flows, and was extended during the 2007/07 financial year. Future works include extending this rock line into the existing downstream rock groyne works.
- Debris fences and tree buffer on the right bank. Maintenance of these structures may include topping up of the groynes, re-driving of irons, (if the fences were undermined), and interplanting

**Figure 1 - Upper Taylor’s rockline extension (upstream right bank)**

- *The reviewers agree with the approach taken to maintain the alignment and has resulted in a well developed and stable river edge. Access road and adjacent metalled pad area improves the accessibility for long term maintenance work. The change to using a tractor and boom to spray vegetation spraying has improved the efficiency of the operation from the previous hand spraying.*

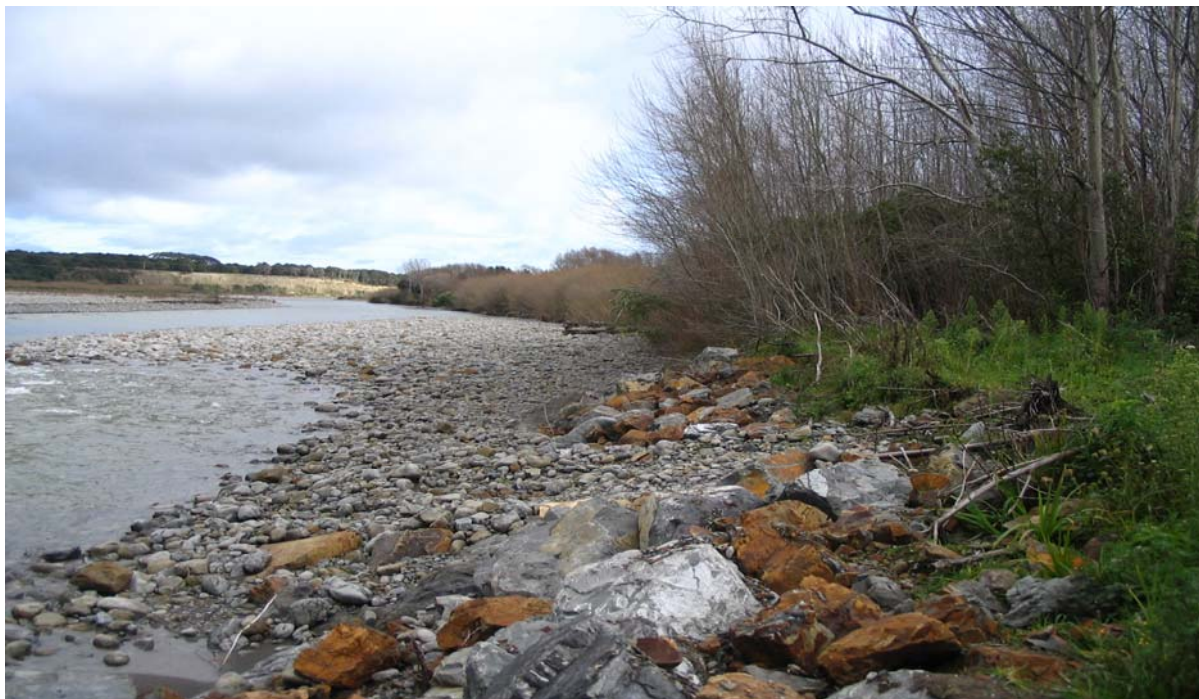
**Figure 2 - Upper Taylor’s rockline extension (downstream right bank)**

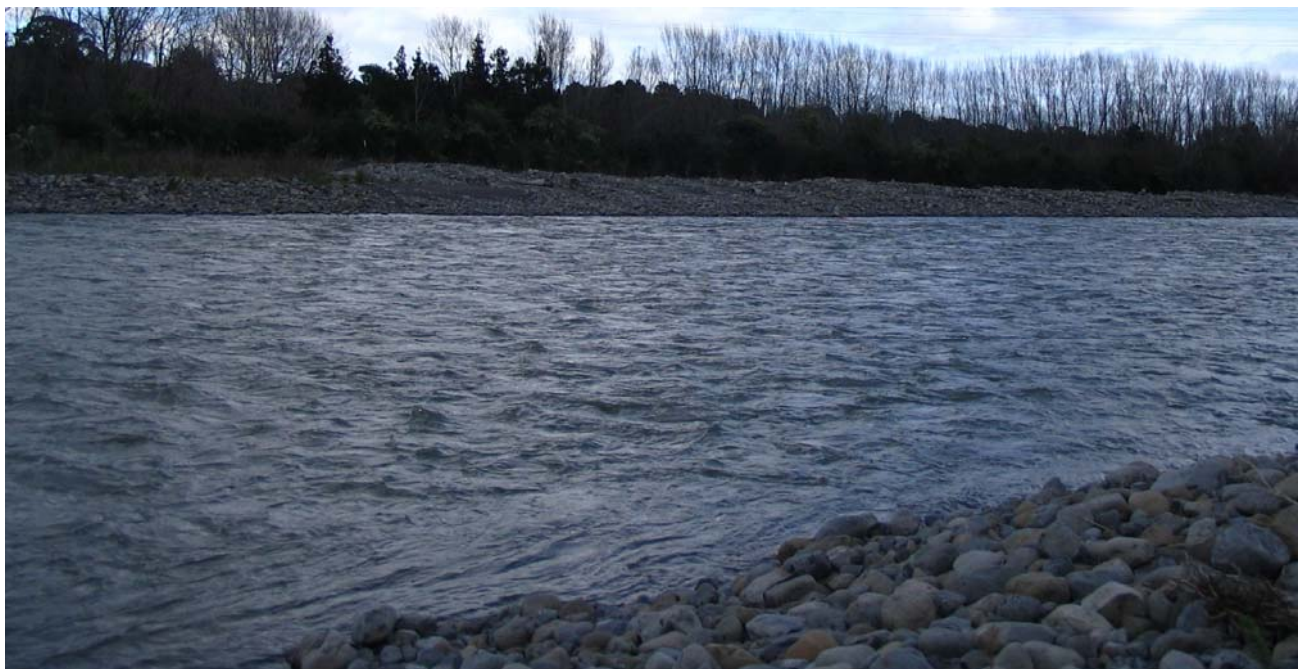
The cliffs area has been prone to erosion on the left bank with the adjacent cliff face being particularly vulnerable. Previous work has included substantial planting of approximately 14,000 willows. On the Wallace / Lutz area, the ongoing maintenance utilising dozer machinery was required to open the channel up, providing a cut through and cross blading work over a 2 week period in the last 12 months. This work was required to maintain the channel width of 255m specified for the Chrystalls to Otaki Gorge reach and to maintain the design alignment

**Figure 3 - Wallace / Lutz left bank**

*The reviewers endorse this approach for routine maintenance and recommend this practice is continued with ongoing development of the buffer tree zone.*

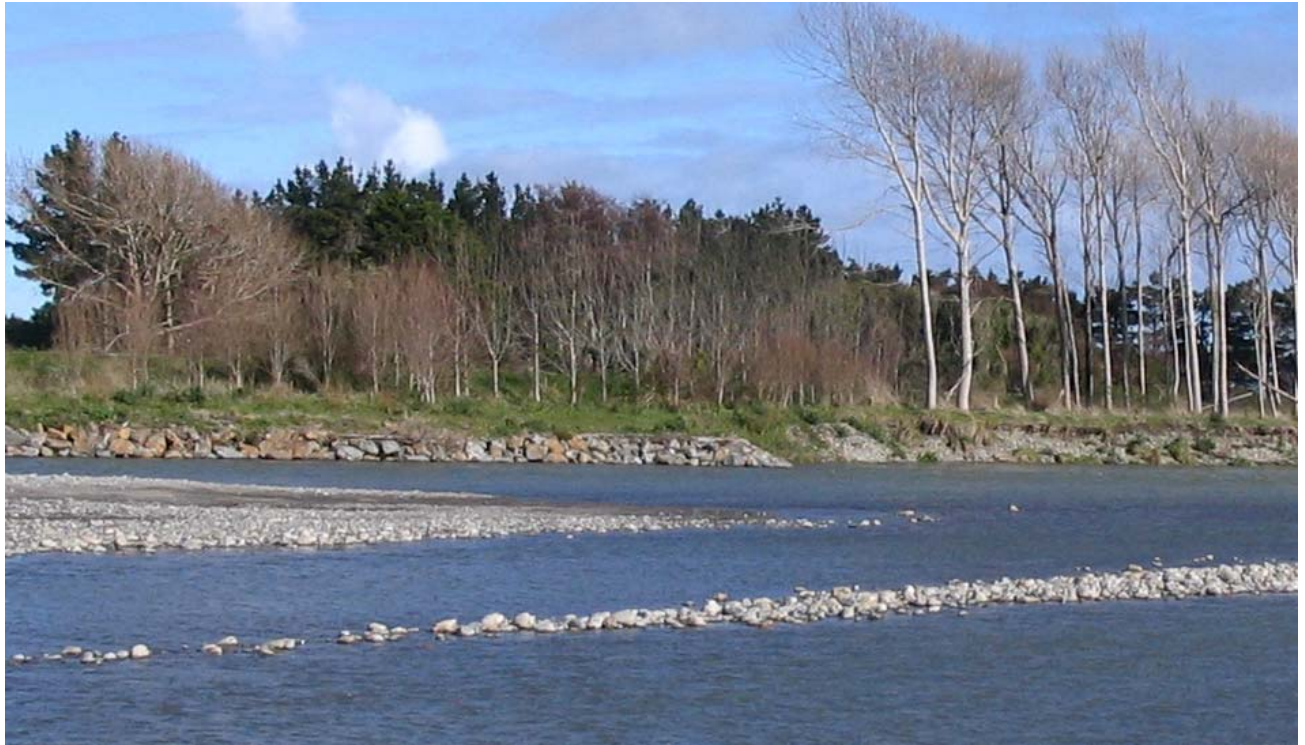
The rockline has been developed over the last 10 years to stabilise the left bank. The rockline has been a successful structure but has suffered from erosion at the down stream end. To mitigate this problem a small groyne was constructed at the downstream end of the rockline. The groyne has been successful in changing the flow pattern and diverting the velocity away from the bank edge. There has also been gravel abstraction in the reach to maintain bed levels.

**Figure 4 - Leithbridge rockline, left bank. Use of the end groyne to assist in the transition from the rock lining to the unlined bank**

*The reviewers note the practice of the end groyne is robust methodology to ensure the integrity of rockline and that the asset is providing the required erosion protection on the left bank. The left bank downstream of the rockline shows similar erosion problems and as there is limited protection from the existing vegetated buffer zone, the area will benefit from the additional groynes that are planned to be constructed. This will need to be monitored as further protection may be required.*

Future work includes 2 additional groynes on the down stream of the rockline on the left bank.

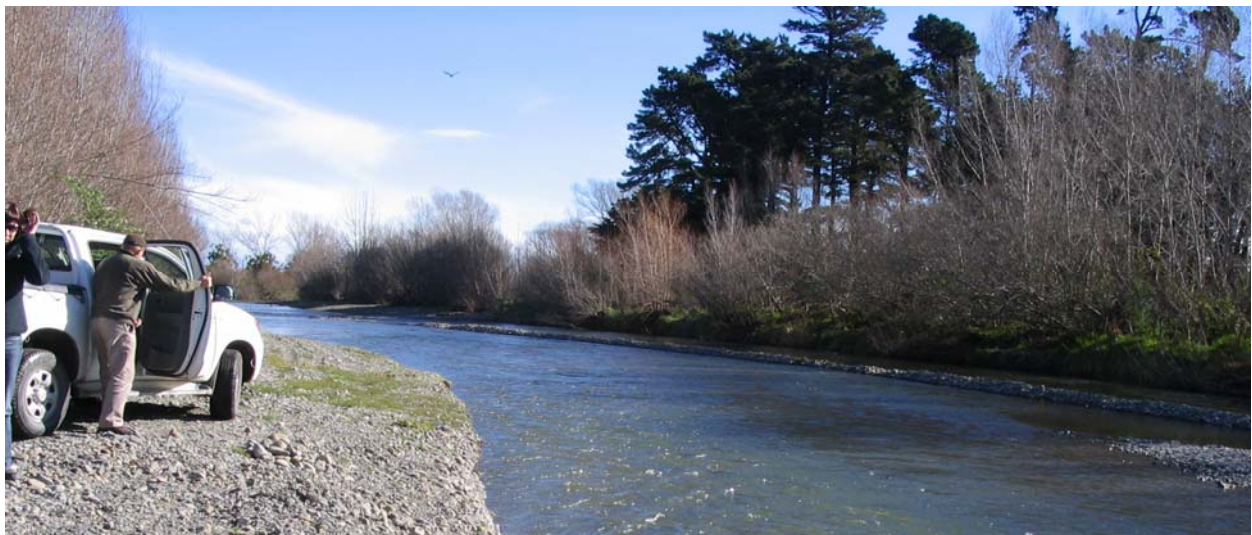
Figure 5 - Wet gravel extractions

The current wet extraction consent expires in September 2007 and equates to an annual volume of 5000m<sup>3</sup>/year. The consent is structured to cater for protection of the environment and the sensitivity of the location to a scientific reserve. The remaining extraction is carried out using the standard methodology and does not require any bunding and equates to an annual volume of 9,000m<sup>3</sup>/year. The wet extraction has a number of conditions that includes the formation of a bund to contain any sediment caused by the extraction. The construction of the bund must allow for areas of no extraction both upstream and downstream of the specific area of extraction and further limits the periods in which the extraction can occur. The area observed on the site visit demonstrated the bund area that had been constructed, with the remnants of the bund wall still remaining.

*The reviewers note that the consent conditions are restrictive in what should be a simple extraction process and the operators are monitored and have been competent in complying with the consent conditions. The reviewers conclude that the conditions on the consent are operationally restrictive and a costly process for extraction and note that the loss in the volume of gravel from this consent is unlikely to have a detrimental impact on the river management. However, routine monitoring of cross section data will provide the appropriate information over the following years.*

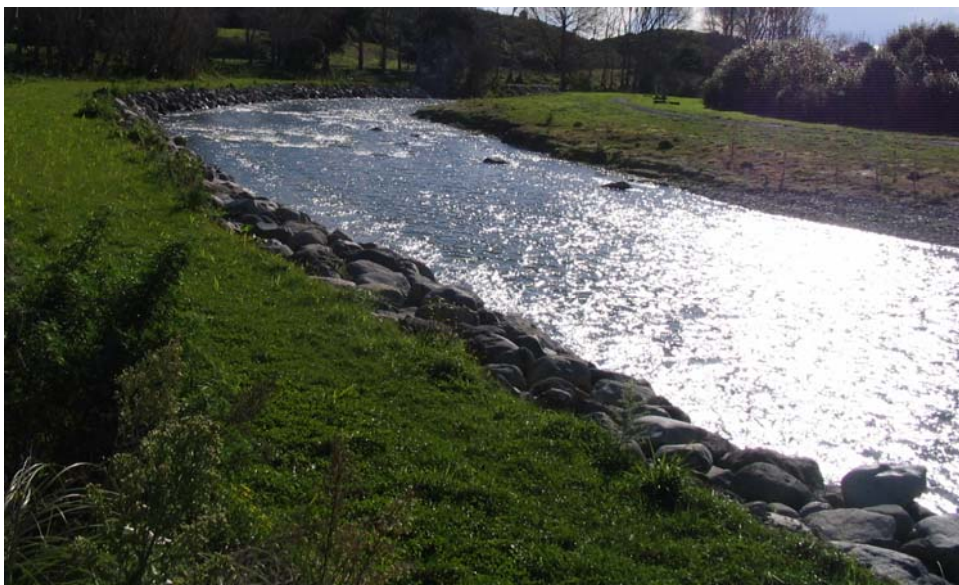
**Figure 7 - Jim Cooke Capital Work**

The rock line work at Jim Cooke Park was completed in 2006 at a cost of \$1,000,000. Prior to the construction erosion occurred as the meander created targets points on opposite sides of the channel bank.

*The reviewers were impressed with the standard of the asset and it appears to be well constructed. The overall improvement to the area will significantly contribute to establishing the preferred design alignment.*

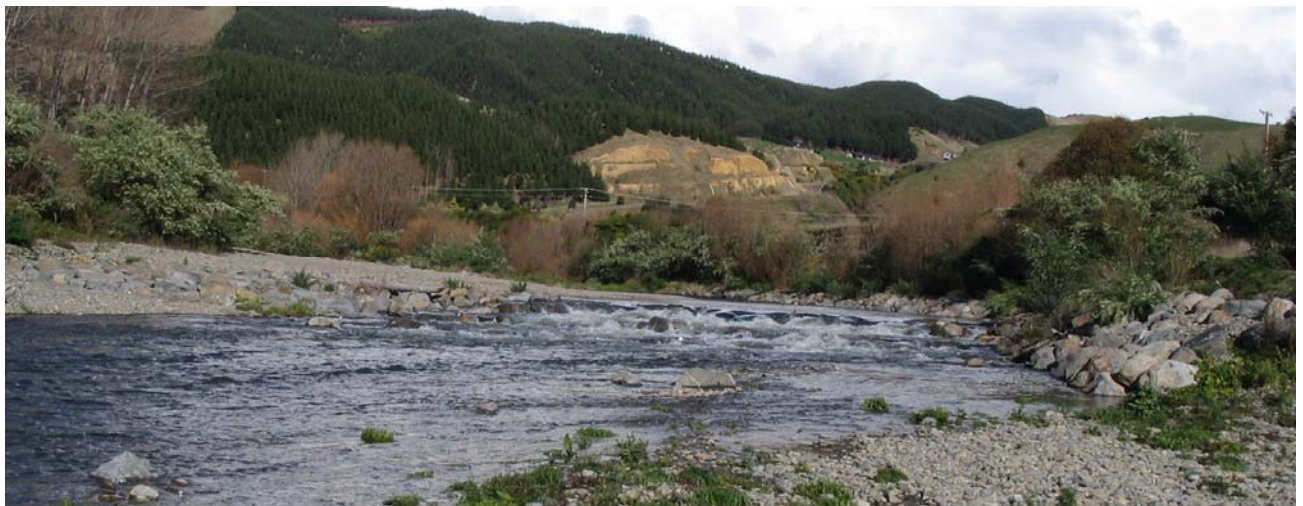
Figure 8 - Kebbels Corner

The works at Kebbels include 2 rock groynes and rocklining on the left bank. The rocklining leads into Kebbels weir at the downstream end of these works. The rock weir was constructed to mitigate the degradation upstream of the corner and reduce the rock lining being undermined.

Downstream of the weir, four rock groynes (known as Maple Lane groynes) have been constructed following the 1998 flood events. An erosion embayment had formed between the second and third groynes, as part of the routine annual maintenance programme, a lead in rockline (or rock return) was constructed upstream of the groyne. The existing weir structure is planned this year to have maintenance work with replacement of rock.

*The asset appears to be performing well and providing a robust erosion protection to the corner. However, a review of the weir should be considered and the original design concept evaluated against the current configuration.*
