Shelly Bay Development

Preliminary Geotechnical Assessment Report

Client: The Wellington Company

19-Jan-2016

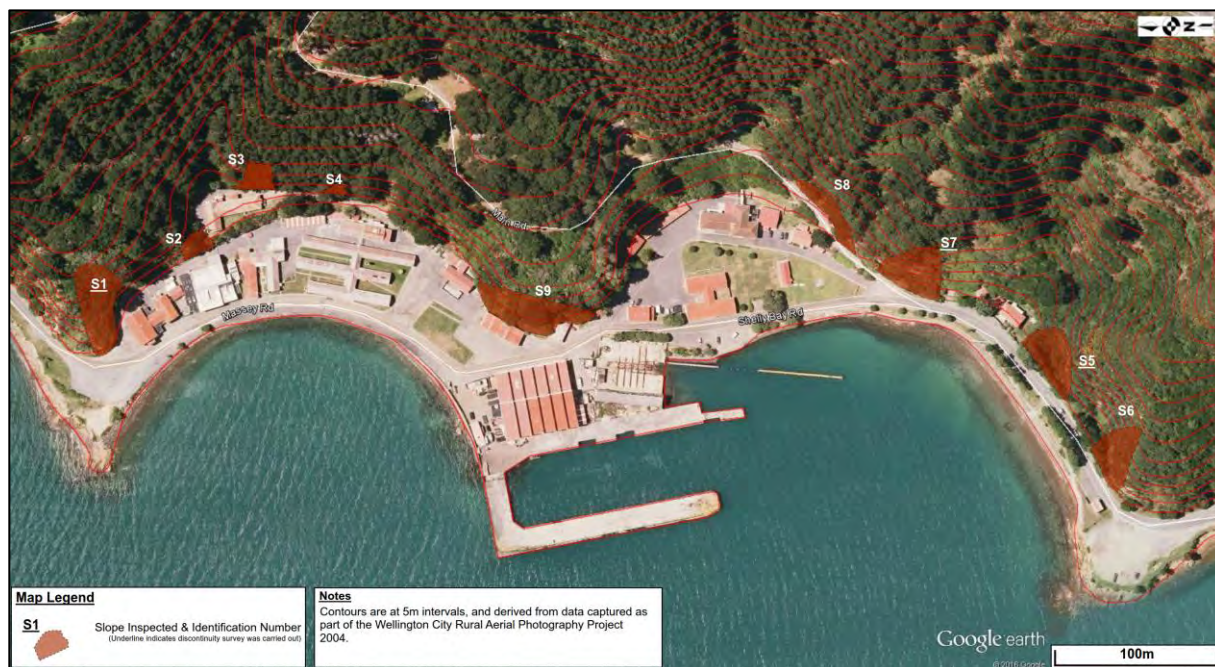
3 sites in total (Slopes 1, 5 & 7) were also subject to detailed discontinuity mapping, either as a result of visibly unfavourable discontinuities 'daylighting' across the outcrop, visual evidence of large or recent debris falls, and where access to the feature on foot was possible. A detailed site walkover and observations matrix has been compiled for each slope and is included in Appendix B. General observations from the inspection are discussed and analysed in the following sections.

Figure 5 Location of Slope Inspections at Shelly Bay

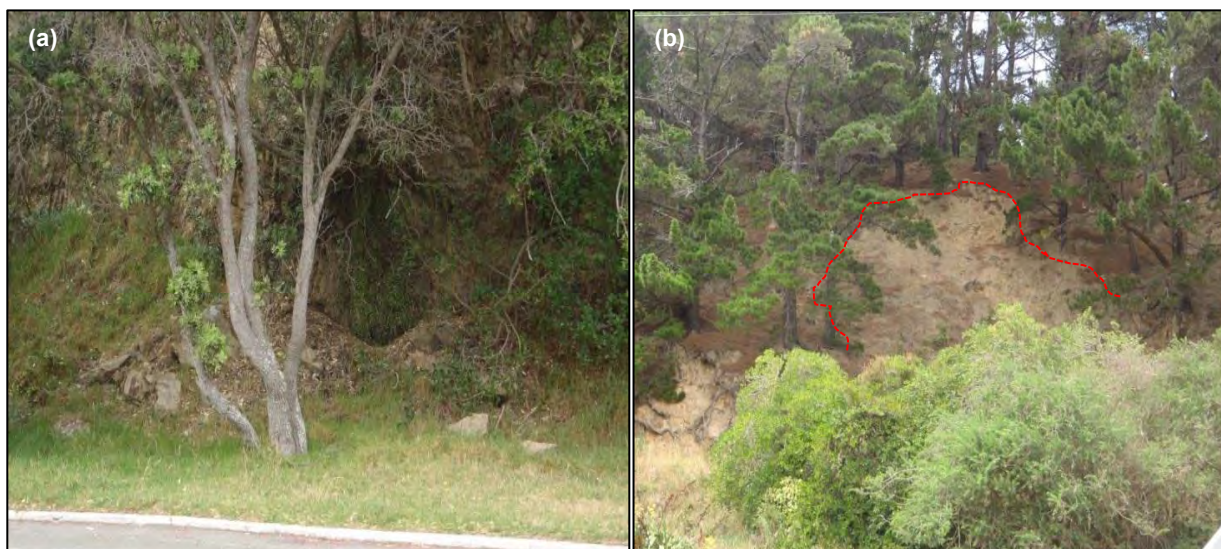
At the majority of slopes, debris volumes were substantially less than 0.5m^3 , with only a few discrete blocks of very weak to moderately strong greywacke up to 400mm across present in the resulting slides, and only at some sites. However, at slope 5, a much larger, albeit older debris flow, potentially up to 10m^3 in volume was observed, with intact boulders of moderately strong to strong greywacke rock up to 900mm across present in the debris pile. This is shown below in Figure 6(a).

Limited shallow translational failures in the superficial cover of soil overlying the greywacke rock were observed during the walkover and survey. However, the dense cover of vegetation and generally difficult access to the higher areas of Mount Crawford means that the possibility of such slope failures elsewhere cannot be discounted. It is likely that the dense vegetation covering much of the hillside has acted in part to stabilise this shallow surface layer, however such failures are very common in slopes of similar geology and topography in the Greater Wellington region, and are often triggered by periods of intense rainfall or seismic activity. Consideration should be given to the potential for such failures during detailed design, if significant removal of vegetation from slopes is required. One such failure, at Slope 8, is illustrated below in Figure 6(b).

Figure 6 (a) Rock fall debris at toe of Slope 5; (b) Extent of shallow surface failure above greywacke outcrop at Slope 8

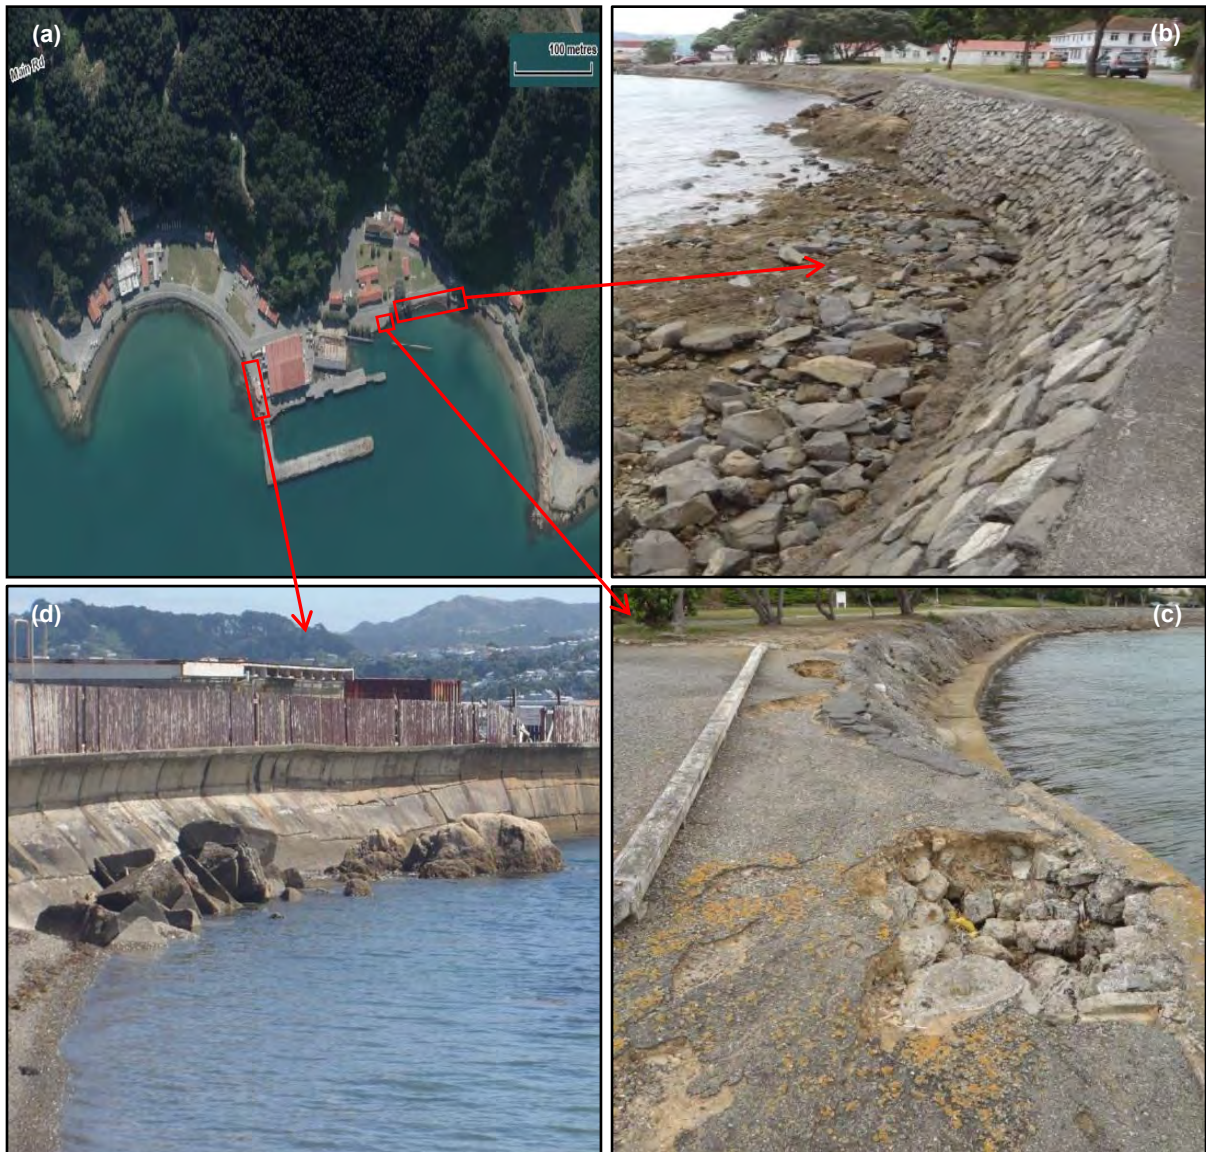
Whilst some of the existing sea walls appear in good condition, others are not and some have even undergone partial collapse. In general, the seawalls are not considered to offer significant resilience to lateral spread, and may have been founded directly upon liquefiable sediment. These features may require retrofit or complete replacement.

Figure 8 General impression of existing seawalls around the site: (a) Location Plan; (b) Concrete/greywacke boulder facing founded directly onto bedrock; (c) damage to existing seawall in southern bay; (d) collapse of seawall in vicinity of Shed 8.

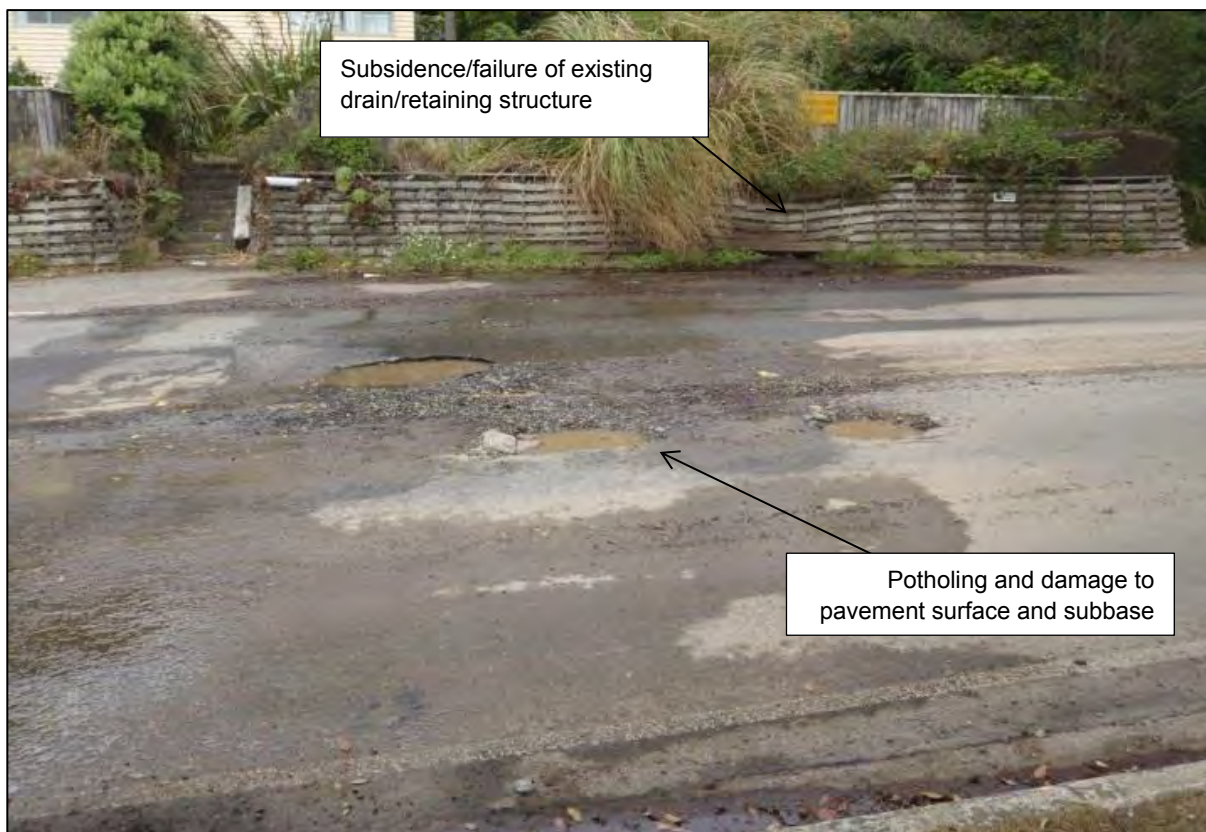
Figure 10 Road damage due to surface water from gully runoff

Consideration should be given to rerouting the stream, which currently drains from the gully in the southeast of the site (shown on the geological interpretive map in Appendix A), into a culvert below the existing road level. The existing drain beneath the structure in this location is in a state of considerable disrepair, and the constant flow of surface water across the road has caused substantial localised damage to the pavement, as per Figure 10 below.
