# Hutt Estuary

## Intertidal Sediment Monitoring 2012/13

Prepared  
for  
**Greater  
Wellington  
Regional  
Council**  
March  
2013

# HUTT ESTUARY: SEDIMENTATION RATE MONITORING SUMMARY

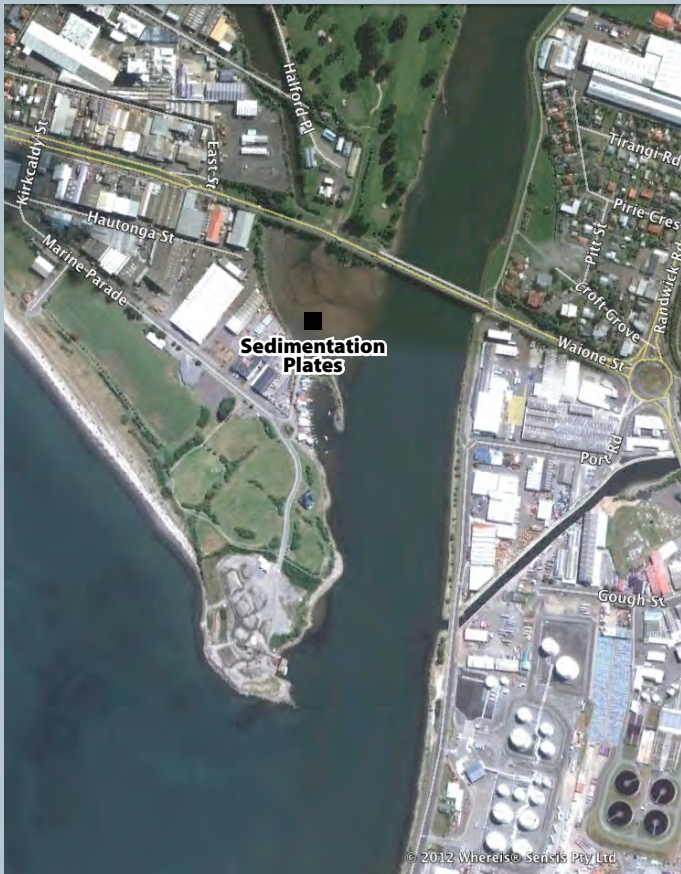
Figure 1. Location of intertidal sediment rate monitoring plates in the lower Hutt Estuary (see also Table 2).

To monitor ongoing sedimentation rates, four concrete plates were buried in intertidal flats of the Hutt Estuary in 2010 (Figure 1 - see Stevens and Robertson 2011 for further details) and have been monitored annually since that time.

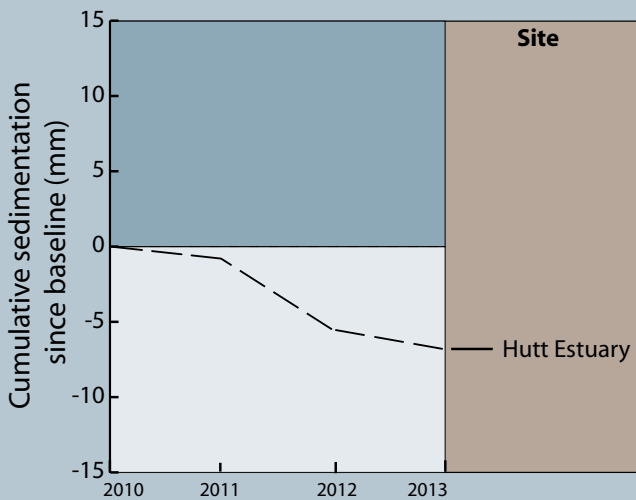
Figure 2. Cumulative change in mean sediment level over buried plates in Hutt Estuary, 2010 to 2013.

Table 1 presents the 2010-2013 sedimentation rate results for the four plates buried in Hutt Estuary, with summary data presented in Figures 2 and 3. To account for spatial and temporal variation in sedimentation rates from natural processes such as wind generated waves, tidal flows, and river inputs, site averages are used to estimate a mean annual sedimentation rate for the lower estuary. Mean sedimentation rates for the site range from -9 to +2mm/yr (Table 1), with the overall site mean of -3.75mm/yr, falling within the "very low" category (see condition rating on the following page).

A likely reason for the low mean annual deposition rate measured over the past three years is regular dredging of sediments from the channel in the lower estuary.

As such, ongoing monitoring is recommended to measure sediment deposition and temporal change on the only significant remaining intertidal flat within the estuary.

Continue to measure sediment plate depths annually.

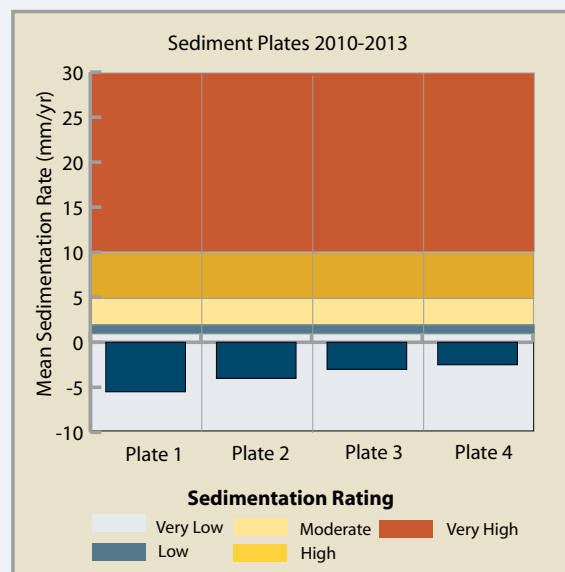
Figure 3. Mean annual change over individual plates in Hutt Estuary, 2010 to 2013.

Figure 3 shows the smallest sediment losses at plate 4, trending to the largest at plate 1. As plate 1 is located closest to the main river channel, this trend may reflect greater flood and tidal scouring of the tidal flats adjacent to the main channel. However, given the short period of monitoring to date, these initial values may reflect localised variance rather than longer-term sedimentation trends within the estuary.
