ADDENDUM TO

Archaeological values of freshwater
historic heritage of the Wellington Region
(Cochran, Murray and Kelley, 2012)

SUBSURFACE LIMITED
Archaeological Services

May 2015

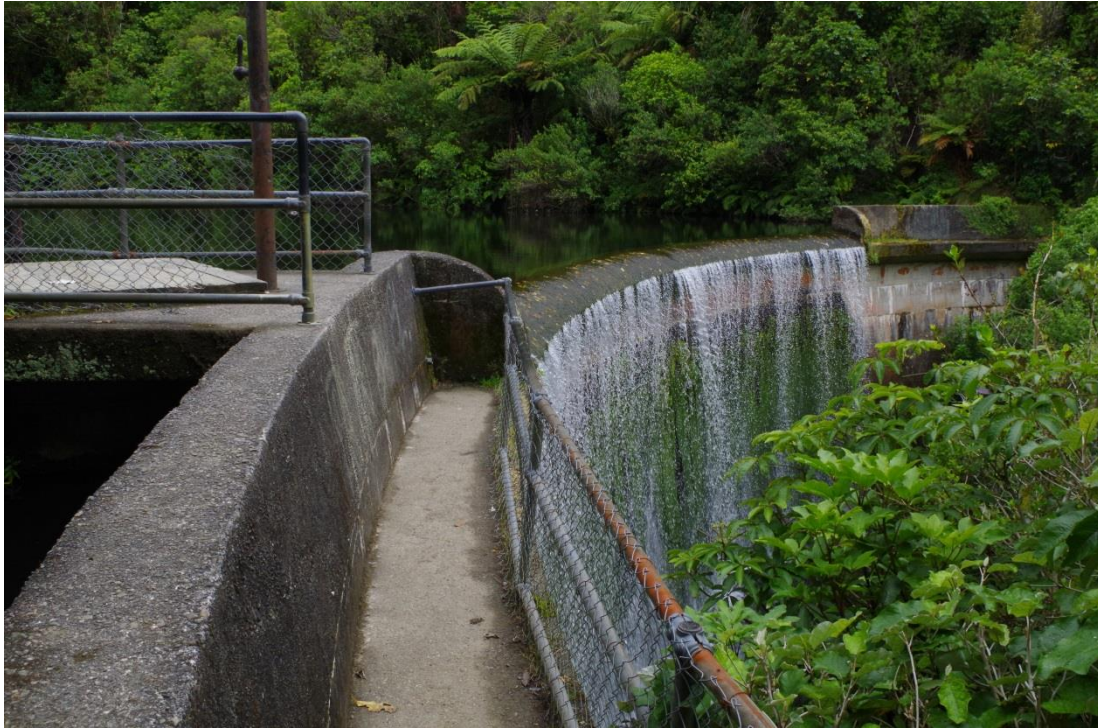
Main dam, looking across crest of dam past intake valves towards spillway (Dodd, 2015)

The Birchville dam is a 46 metre long unreinforced concrete arch dam which supplied water to the Upper Hutt area between 1931 and 1954.¹ There are several pieces of disconnected pipe in the stream bed down-stream of the main dam, as well as concrete tanks set in the bank between the stream and the walking track.

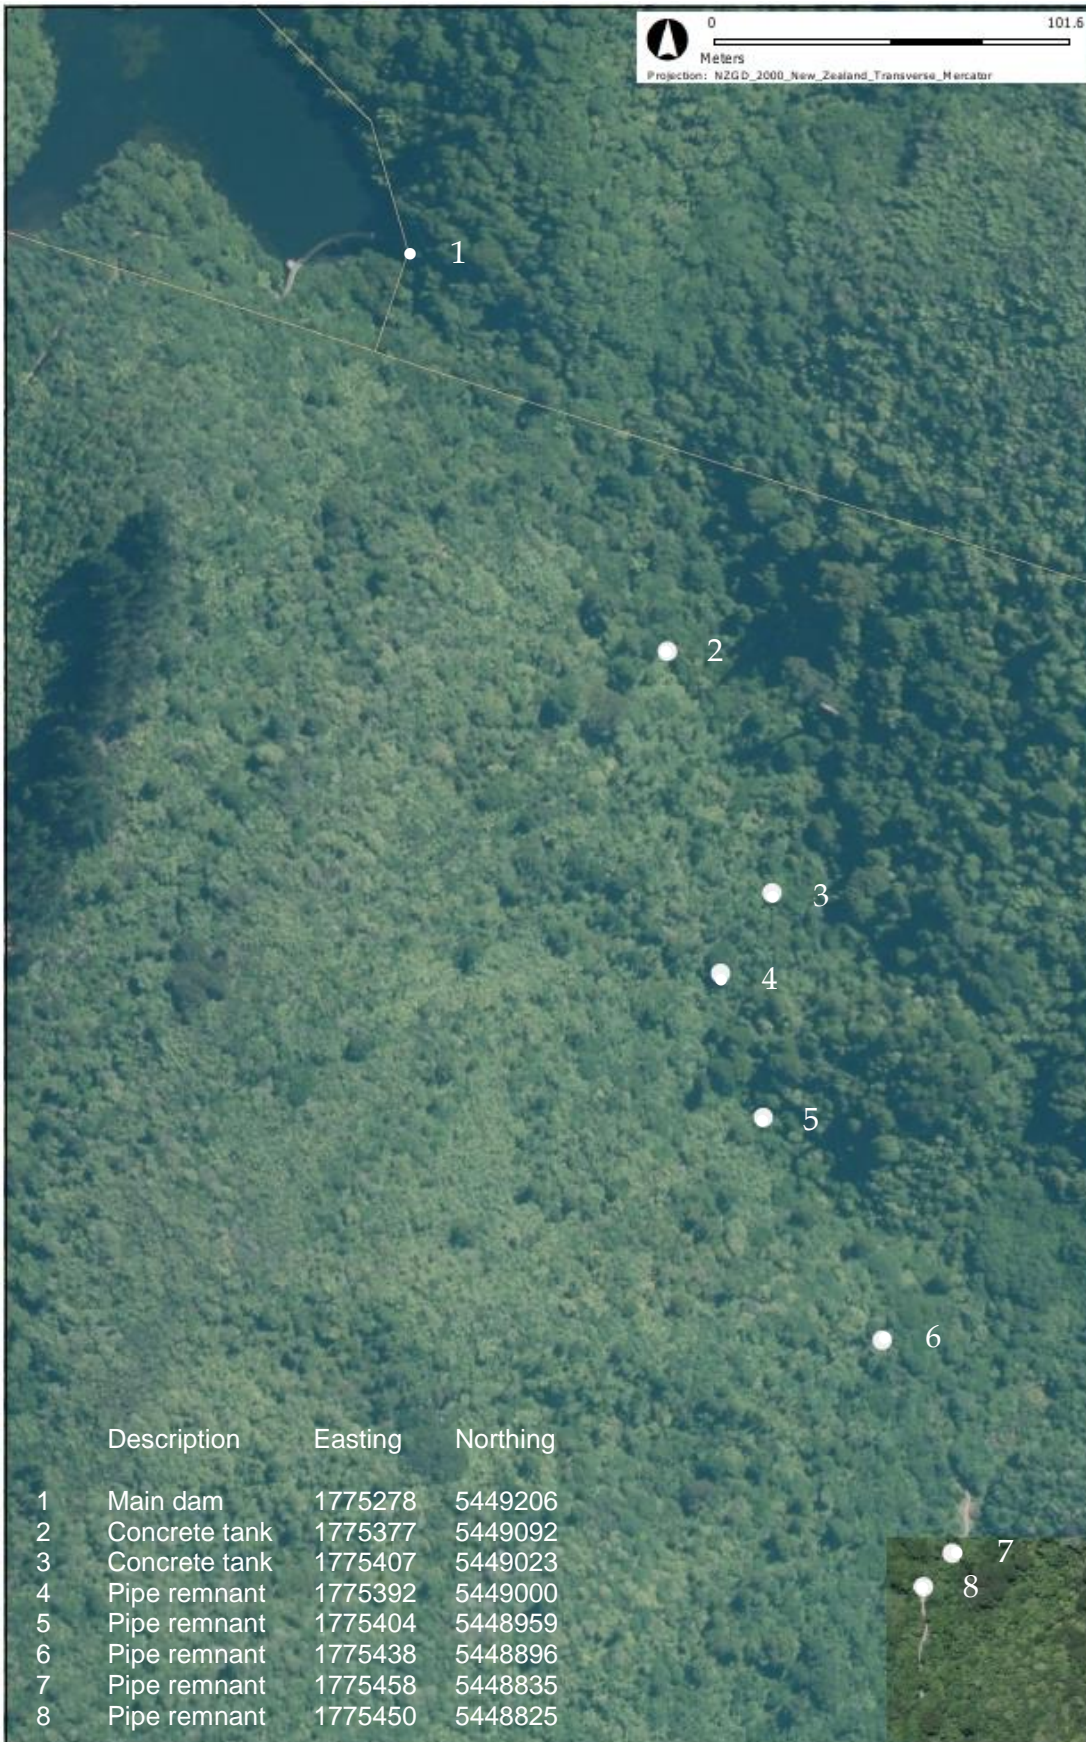
Aerial photography showing the location of the various features associated with the Birchville dam and water supply (Source Upper Hutt City Council on-line GIS, 2015)

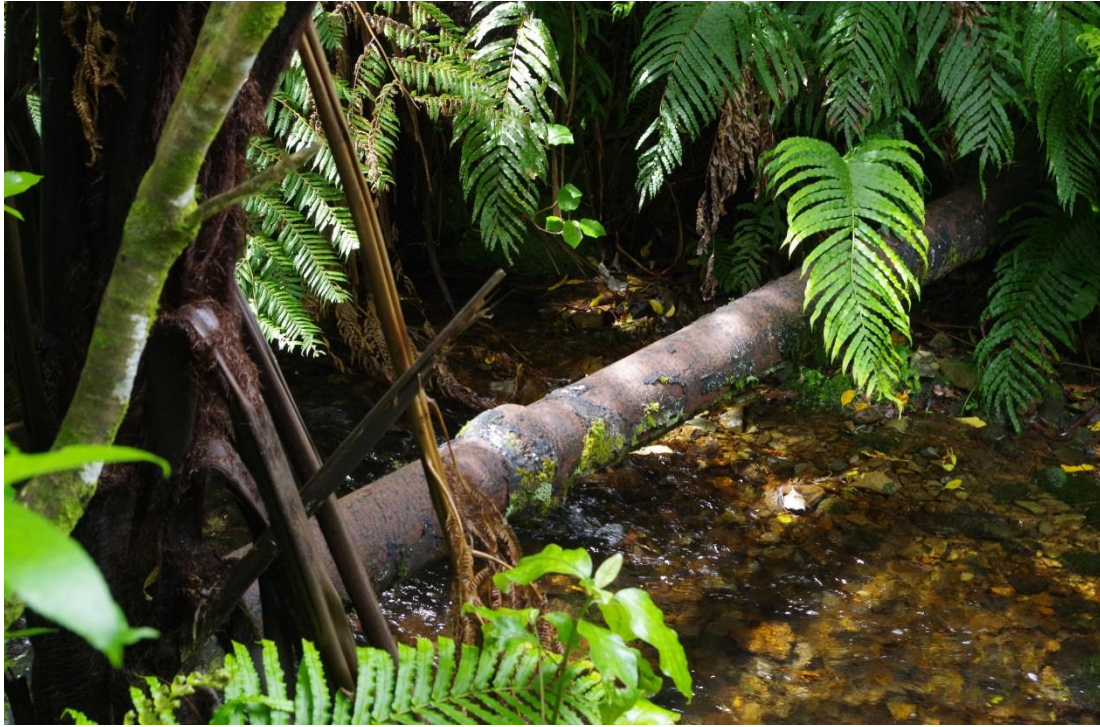
Disconnected sections of water supply pipe in stream south of dam (Dodd, 2015)

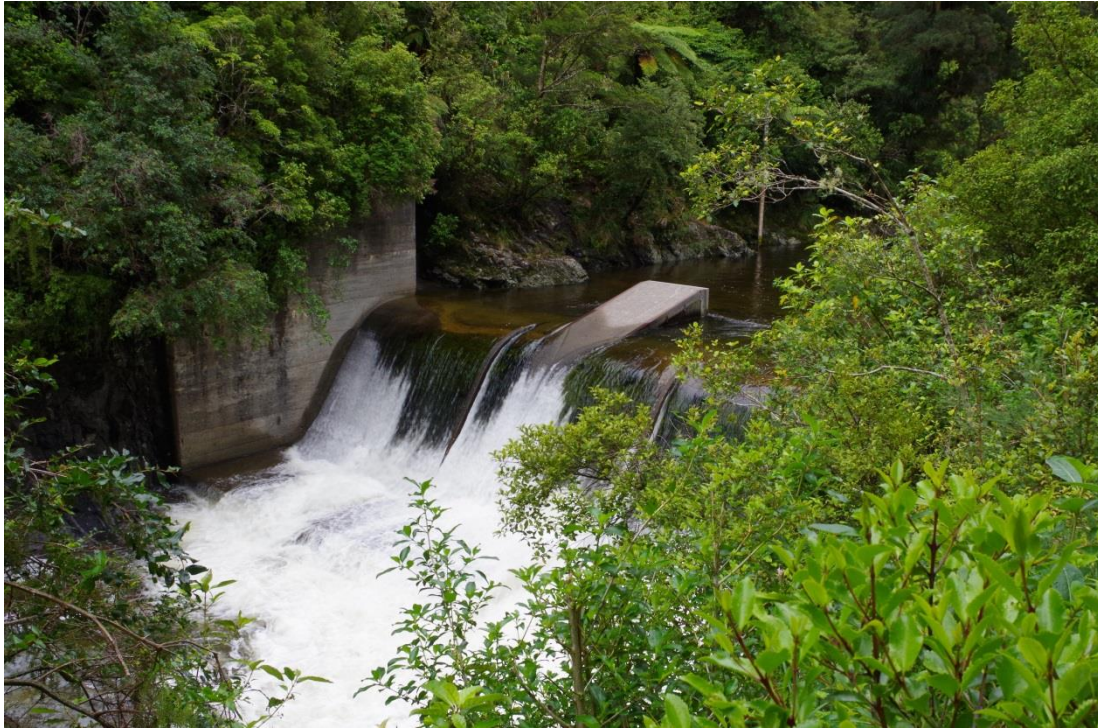
Weir and intake (S26/4) viewed from track to southeast, the true right abutment contains the entrance to the pipeline tunnel

The weir is part of a water supply system that was constructed between 1946 and 1957.¹ It is of concrete construction with dimensions approximately 38 metres in width and 8 metres high above the stream bed on the downstream side. The intake is located centrally towards the true right side, with the overflow on either side, and this leads to a chamber contained within the construction of the weir. The weir house which incorporates access to the chamber is on the true left abutment, and the true right abutment contains the entrance to the pipeline. From the intake the water travels through a 700-metre long tunnel, and across a pipe bridge (S26/5) to a sand trap and strainer house before being piped to the Te Marua facilities. Below the treatment facilities, on the true right (northwest) side of the river, there is an outflow from a scour pipe and an overflow. Concrete abutments supporting a timber platform on welded steel girders are located at the base of the overflow and waste pipe and are set in the river bank. The supports for the pipe bridge are clear of the river bed on rocky outcrops.

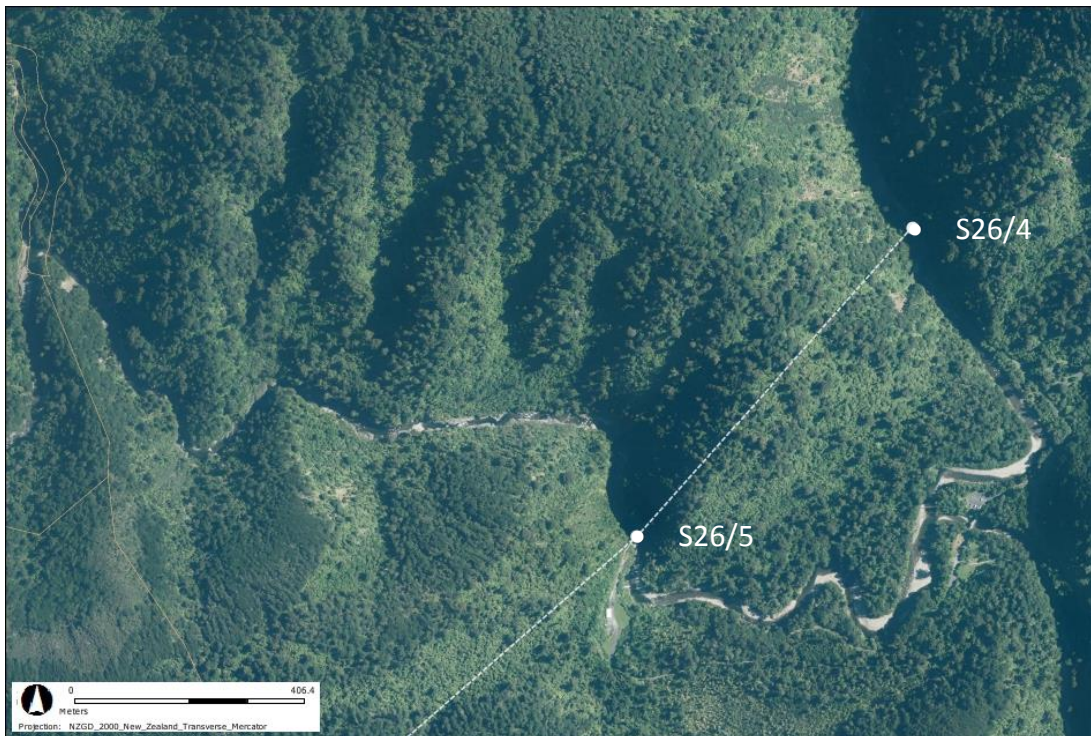
Aerial photography showing the location of the intake (S26/4) and pipe bridge (S26/5) associated with the Kaitoke water supply. Direction of pipeline shown as dotted line (Source Upper Hutt City Council on-line GIS, 2015)

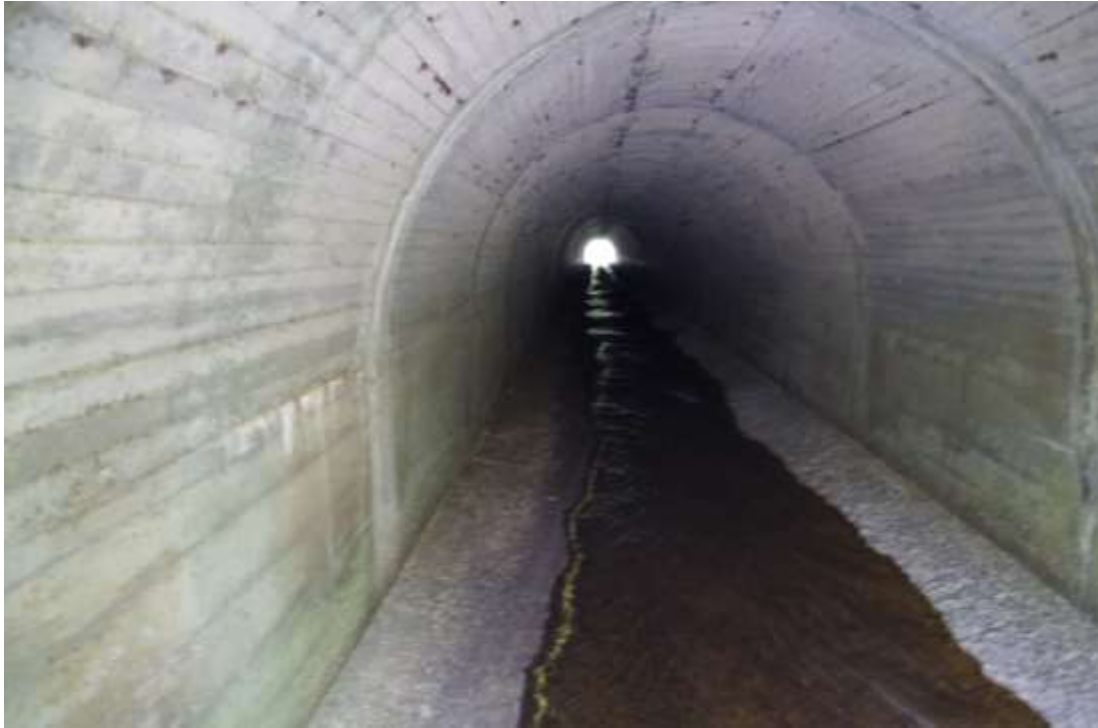
Inside of the stream diversion tunnel, looking southeast from northwestern end (Dodd, 2015).

The diversion tunnel is a concrete-lined arched tunnel approximately 100 metres long. There is an open square-sided concrete lined lead in to the tunnel approximately 4 metres wide and 2.5 metres deep. The tunnel was constructed as an air raid shelter in 1944, and the concrete lined channel allowed for the diversion of the Kaiwharawhara stream through the tunnel after the war.

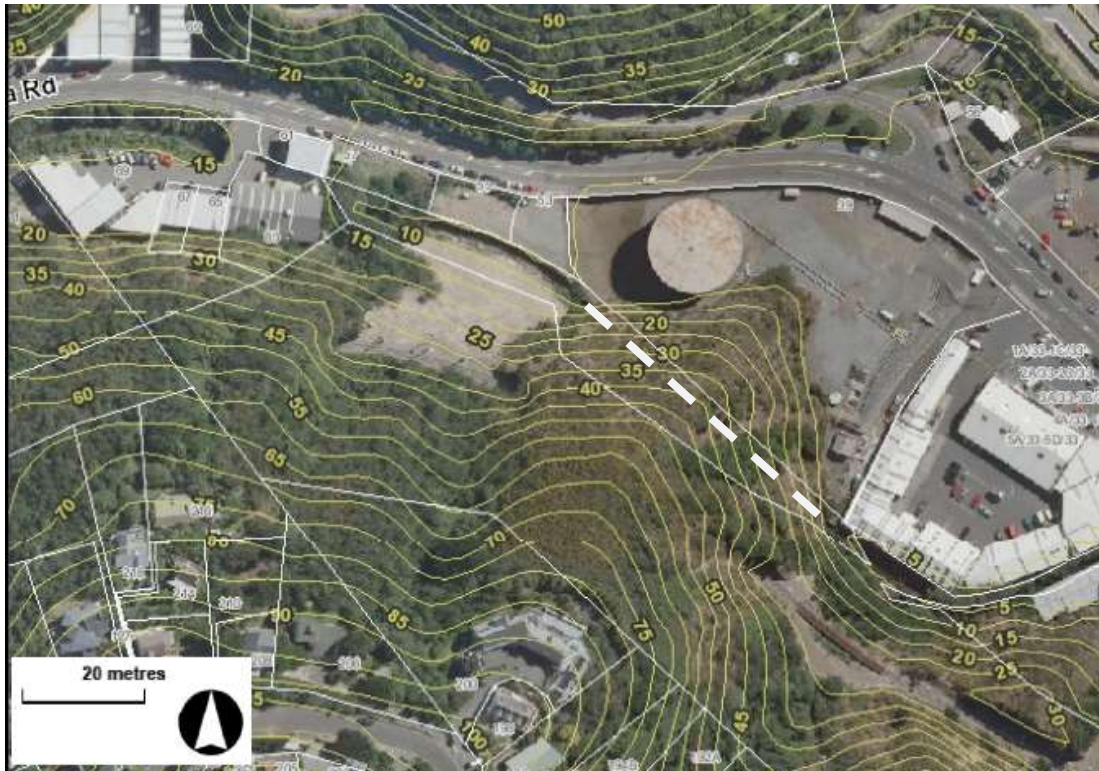
Aerial photography with 5-metre contours showing the location of the Kaiwharawhara stream diversion tunnel. (Source Wellington City Council on-line GIS, 2015)

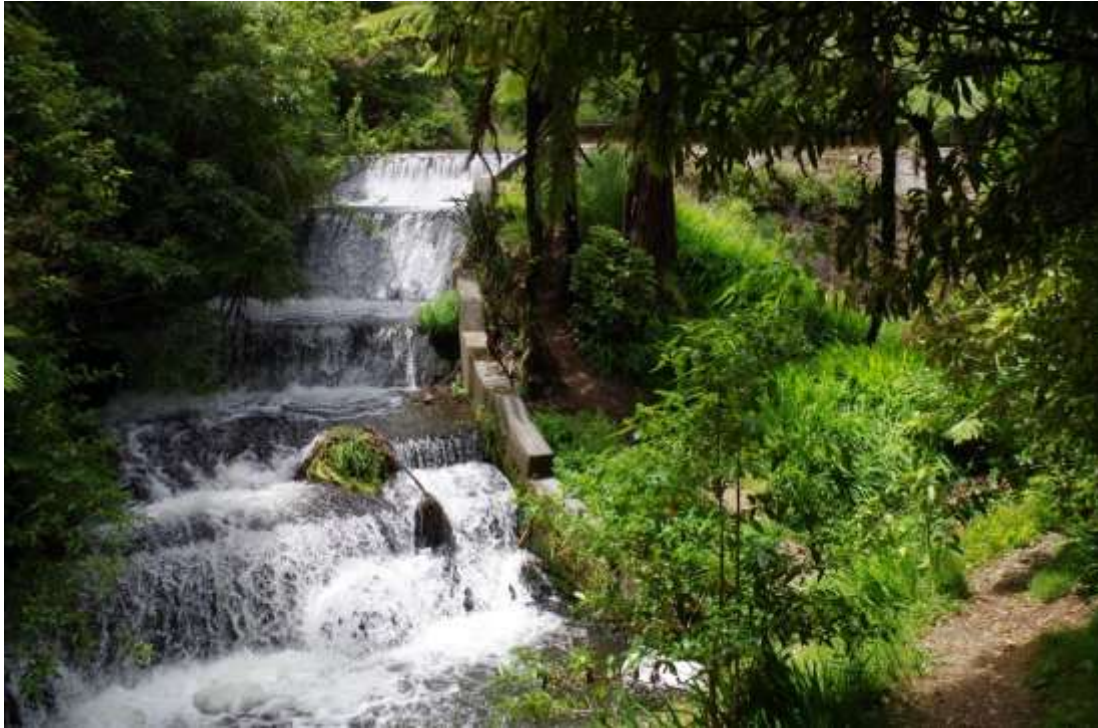
Looking east from the bottom of the Korokoro dam spillway (Dodd, 2015).

The Korokoro dam is a concrete gravity dam, and possibly the earliest surviving example of its type in New Zealand.¹ Visible elements of the Korokoro dam include the dam itself, with a stepped spillway and incised foundation stone on the northern side. There is a timber viewing platform on top of the dam. Downstream there are numerous pieces of decommissioned water supply pipe both in the stream bed and set in the banks. There are also pieces of the tramway rails in the stream. Pieces of water supply pipe, and concrete supports are visible in the stream bed intermittently for much of the length of the stream until it reaches Petone.

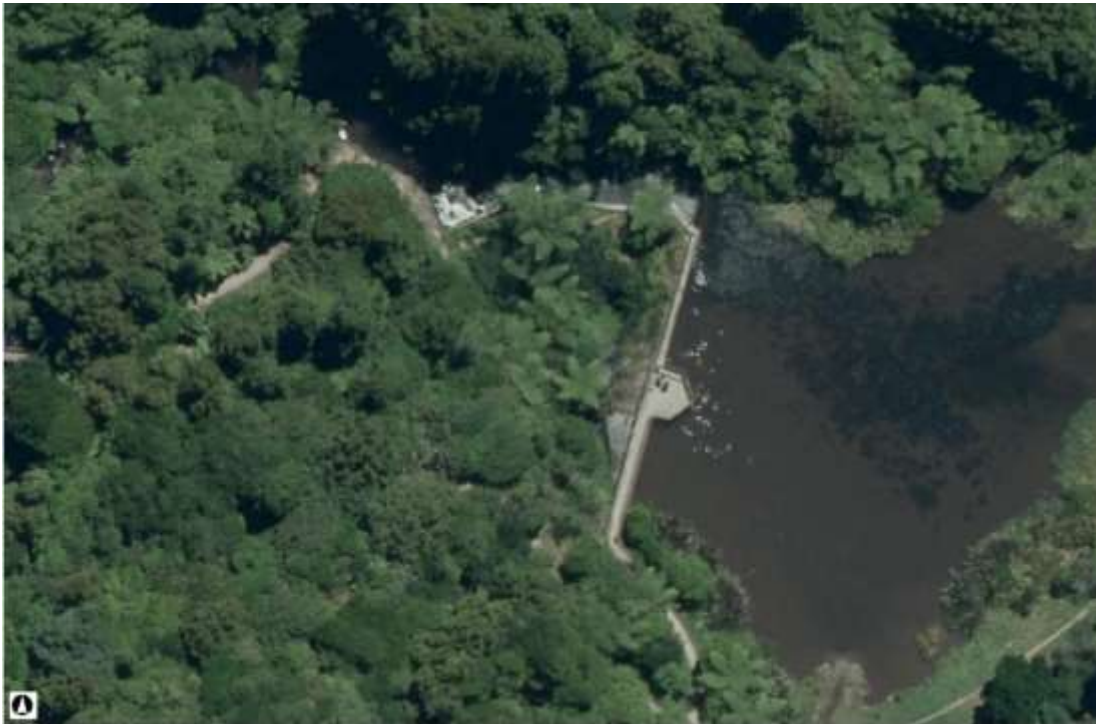
Aerial photography showing Korokoro dam and spillway (Source Hutt City Council on-line GIS, 2015)

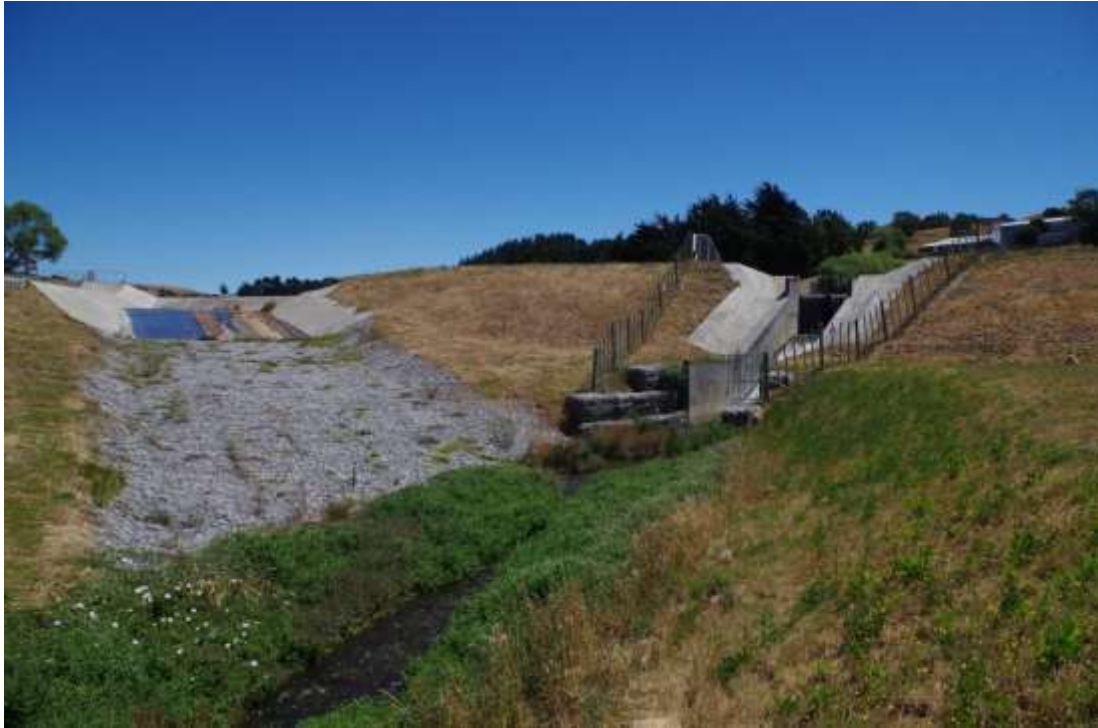
Upper reservoir dam and spillways (Dodd, 2015)

The Kourarau Hydroelectric Power Scheme incorporates a number of features including two reservoirs, dams, spillways, pipelines, surge towers and powerhouses.¹ It extends over 3.5 kilometres of the Kourarau stream valley. The upper reservoir is contained by a concrete reinforced earth dam with concrete lined spillway. The smaller lower reservoir at the confluence of the Kourarau stream and Sailormans Creek is also contained by an earth dam with an intake tower set in the reservoir, and a scour chamber below the dam.² The lower dam also has a concrete lined spillway leading to a concrete weir. The two surge towers incorporated into the pipeline are not within the stream bed itself, but are visually prominent features in the landscape.

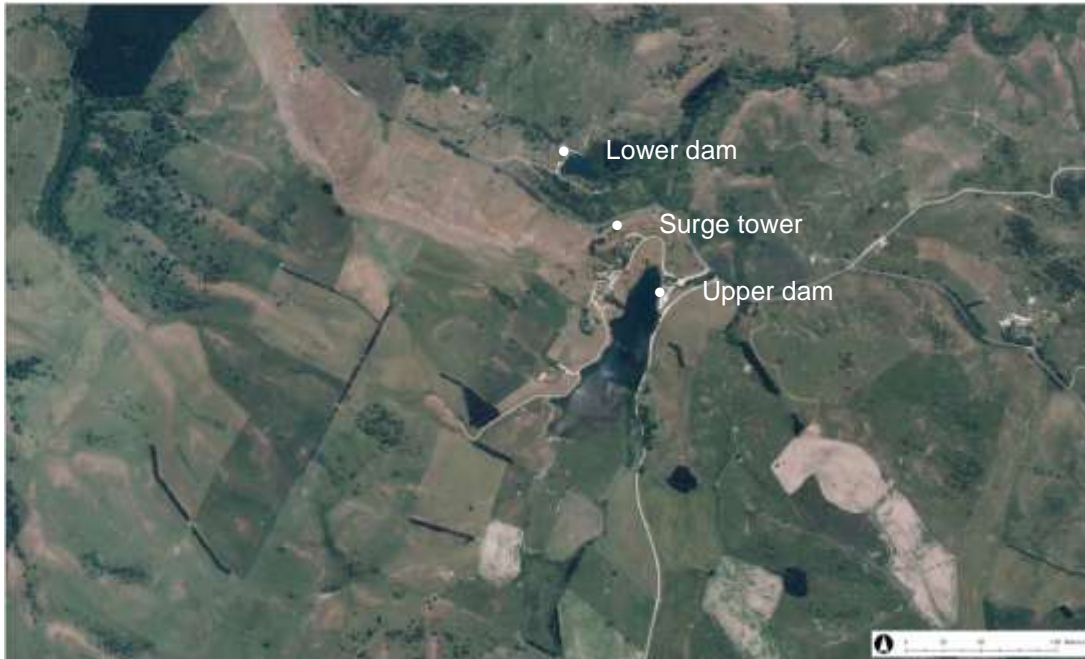
Aerial photography showing the location of the Kourarau reservoirs (Source Combined Wairarapa Councils on-line GIS, 2015)

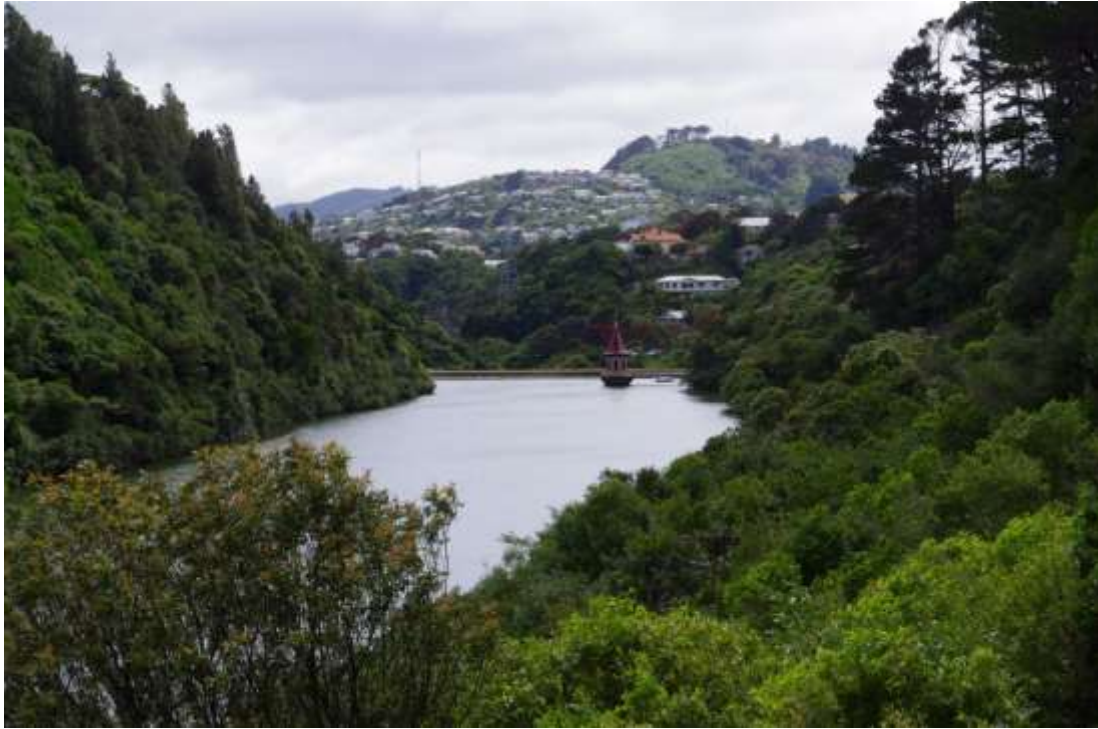
Lower Karori Dam and reservoir viewed from the south (Dodd, 2015)

The Lower Karori Dam comprises an earth dam of puddled clay, valve tower set into the dam and connected with a steel walkway, concrete spillway on the western side of the dam, and underground pipe network.¹ It also includes a second by-way on the eastern side which incorporates a concrete weir, concrete lined channels and culverts and a wooden flume. The lower Karori dam differs from earlier puddle earth dams in New Zealand in that it includes concrete facing on the upstream side for wave protection.² The construction of the dam also necessitated smaller temporary works to contain the water during works³, and these are likely to be preserved underwater.

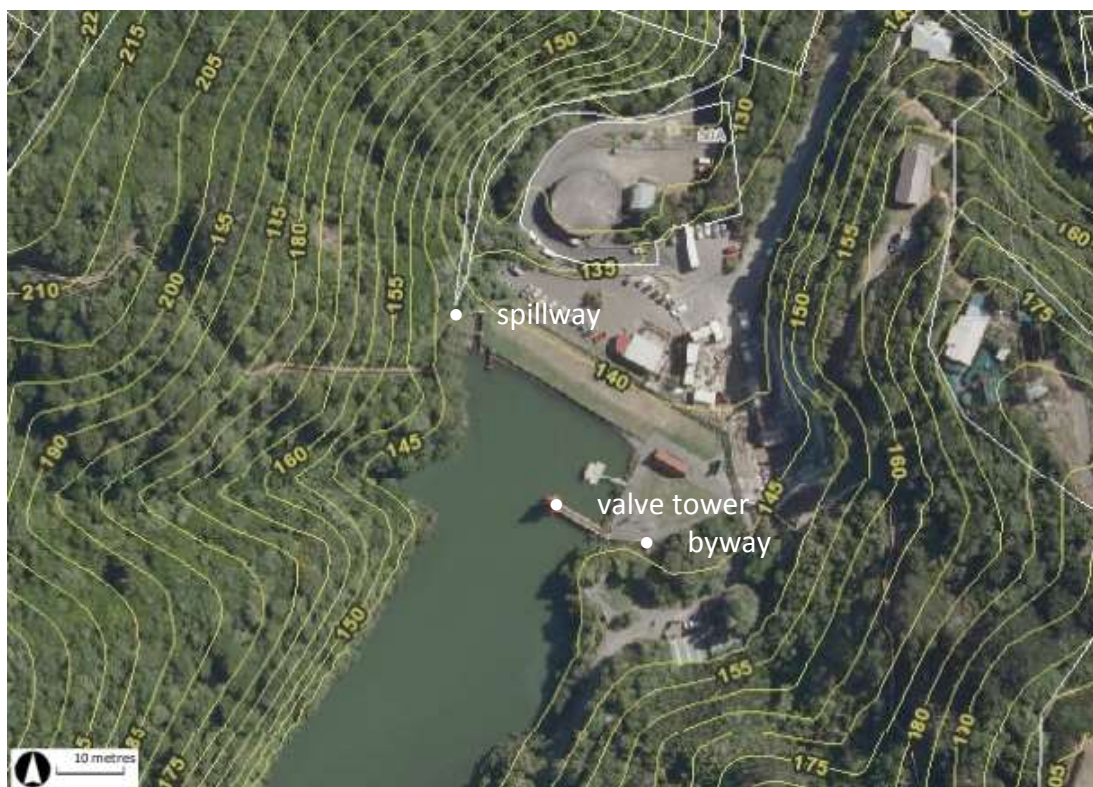
Aerial photography with 5-metre contours showing location of dam, western spillway, valve tower and start of eastern byway (Source Wellington City Council, on-line GIS, 2015)

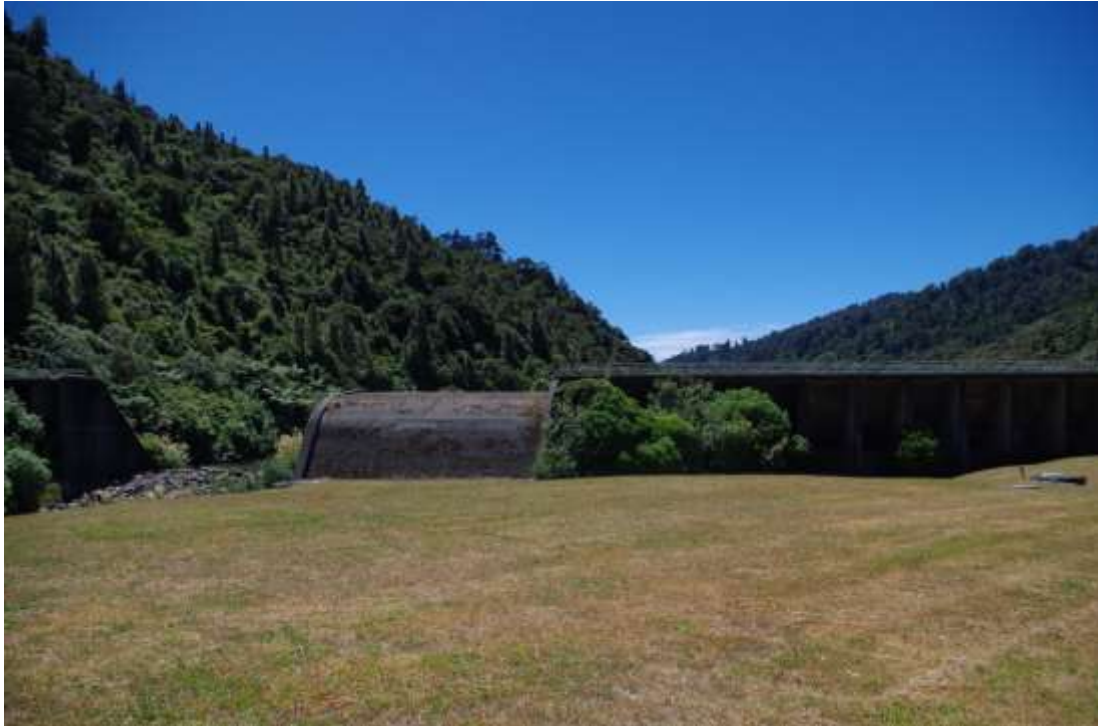
Morton Dam viewed from western downstream side. Demolished section and spillway visible in the left of frame (Dodd, 2015)

The Morton dam (1911-1988) is a butress dam formed by sloping concrete slabs supported by concrete pillars at regular intervals. Dimensions are 128 metres in length and 17 metres high. The stream currently passes through a 24.5 metre wide demolished section of the dam immediately north of the spillway. Features presently within the stream bed include concrete weirs and stone rubble.

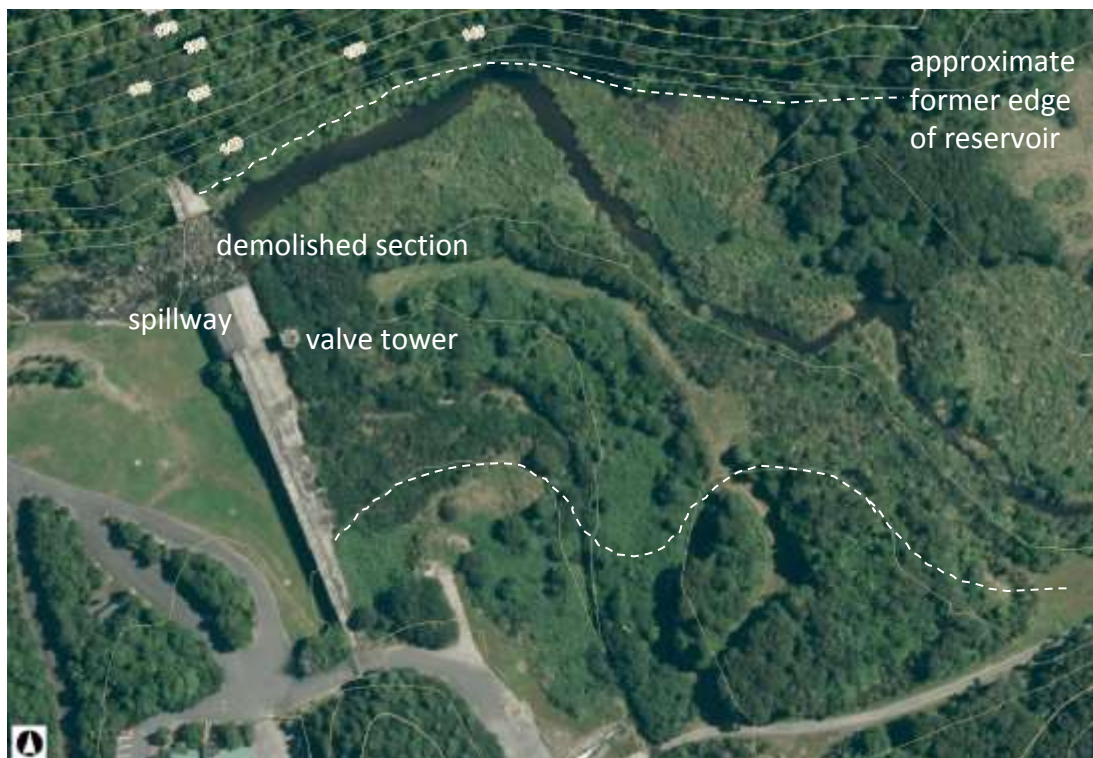
Aerial photography with contours showing location of Morton dam, approximate former edge of the reservoir, spillway, valve tower and demolished section of dam in stream bed (Source Hutt City Council, on-line GIS, 2015)

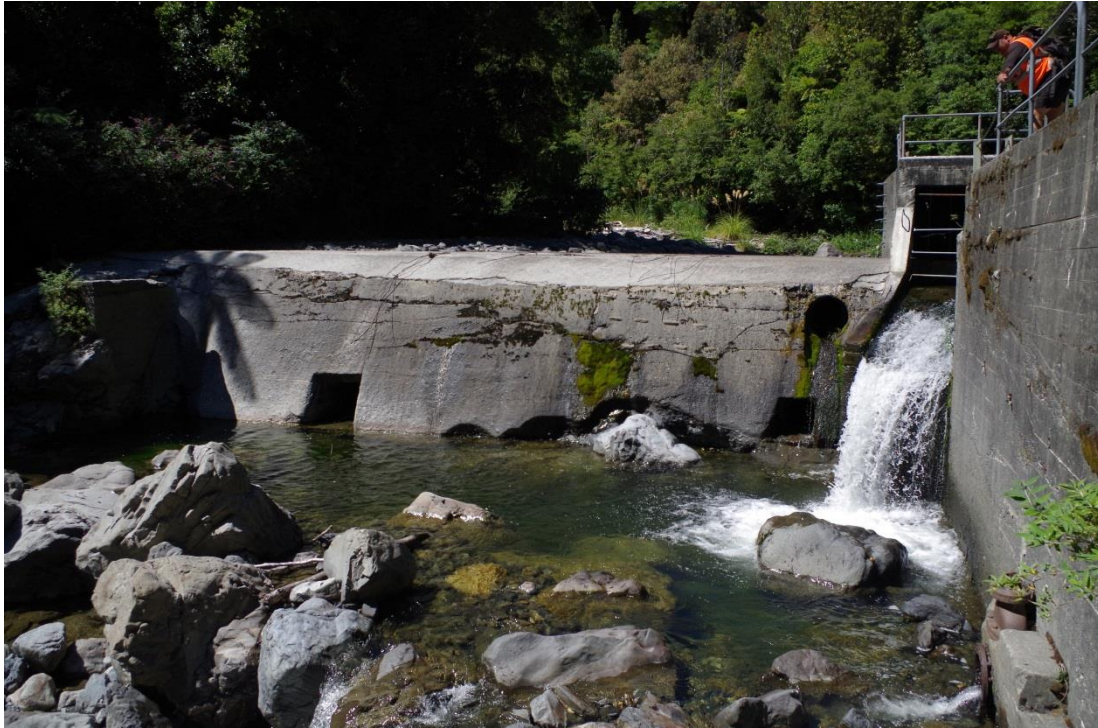
Orongorongo water supply main weir viewed from downstream to the northwest (Dodd, 2015)

The main weir is a concrete structure 3.7 metres high on the downstream side, and about 16 metres in length. It incorporates the intake and small spillway on the true left side of the stream. The water is fed into a 525 mm diameter pipe and travels along the south side of the stream to the first tunnel (R27/534). The intake and connection to the water pipeline are in two level-roofed steel reinforced structures on the south side of the weir, with steps leading to the top of the structure which has pipe handrails around the perimeter.

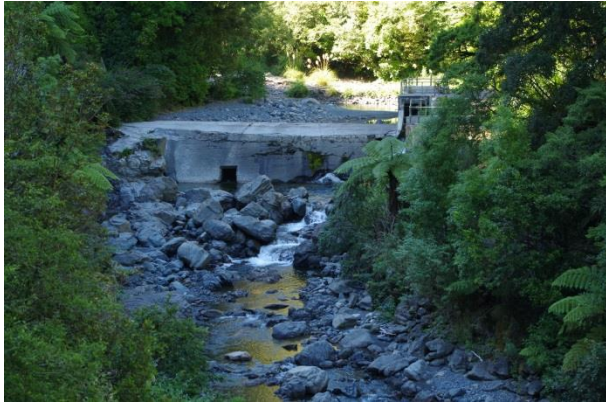
Main weir viewed from downstream side to NNW

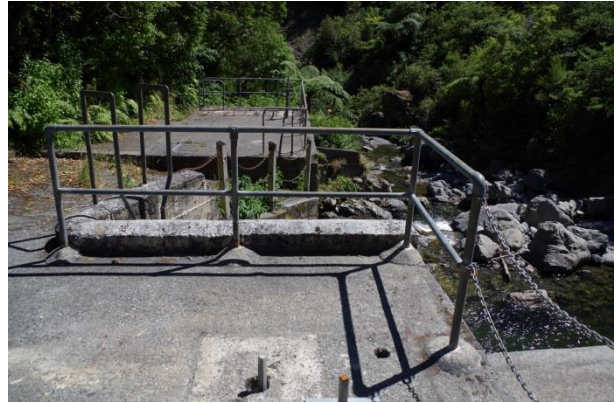
Main weir looking SE across the top of the intake structures on the true left

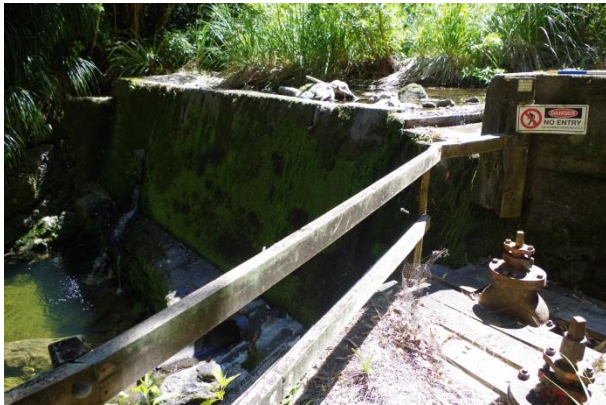
Big Huia intake viewed from the track adjacent to the intake structure

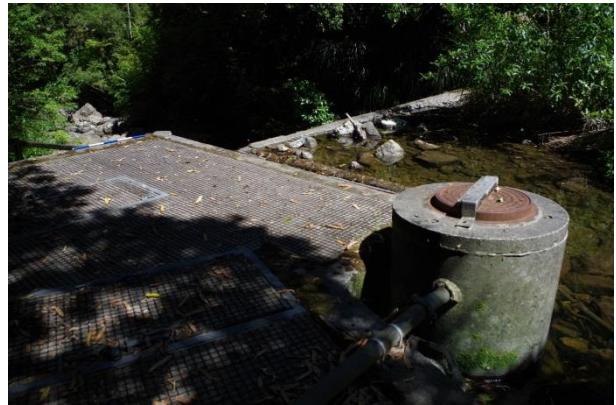
Big Huia intake looking across the top of the intake structure

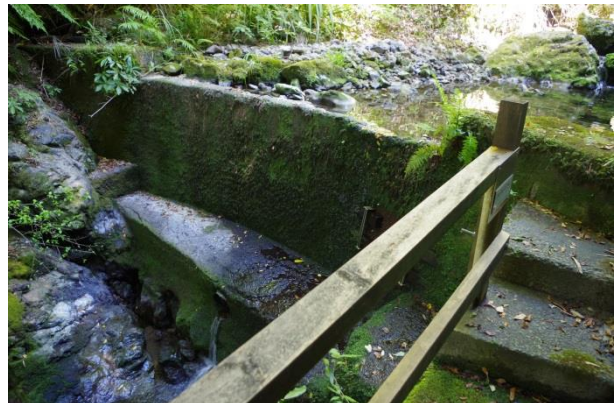
Little Huia intake viewed from the track adjacent to the intake structure

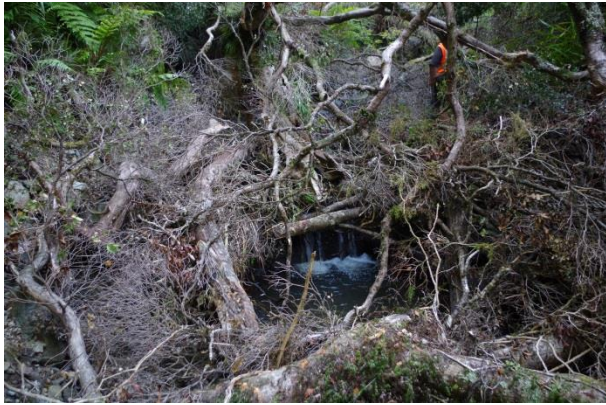
The Telephone creek intake is no longer in service. It comprises a small concrete weir in the stream bed approximately 175 metres upstream of the confluence. The weir has an intake pipe on the true left side, and about 20 metres downstream of there are concrete supports in the stream bed. Strwn pipe remains are visible along the stream bed with one 20 metre long section still insitu on its supports.

Telephone creek weir and intake viewed from the south. Obscured by fallen trees

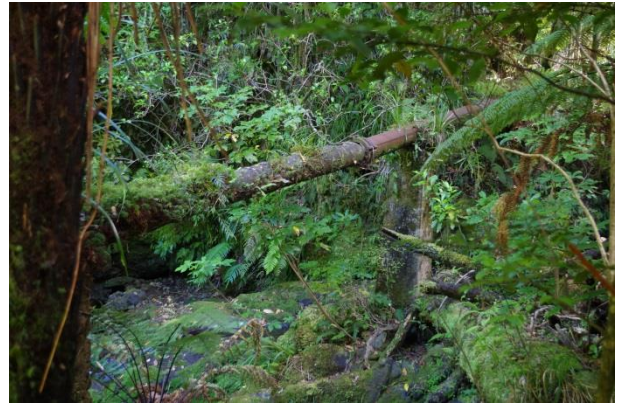
Telephone creek water supply pipe on concrete supports in the stream bed to the south of the weir and intake

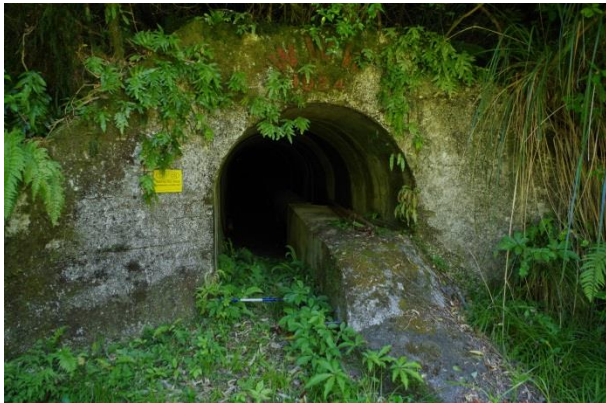
The shorter of the two, this tunnel alleviates the need for the water pipeline to negotiate a tight bend in the river to the north. The tunnel is 103 metres in length, as has the letters W W W and the date of construction, 1924 fixed to the concrete above either portal. The tram rails have been removed from the tunnel floor, and the entrance has been boarded off at one end.

Short tunnel, eastern portal, with water supply pipe leading into concrete abutment on the right hand side

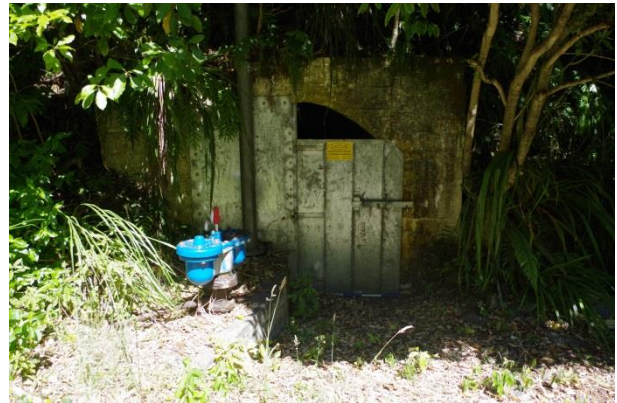
Short tunnel, western portal

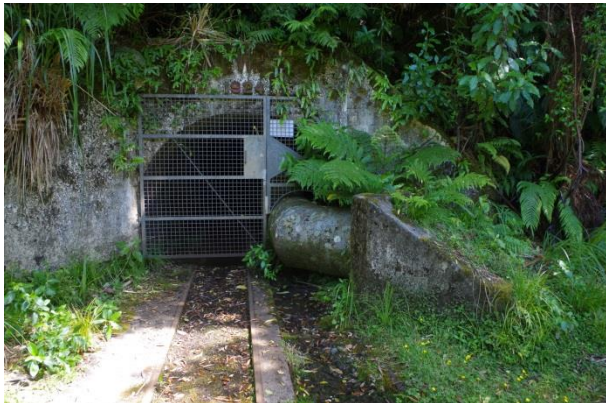
The main tunnel linking the water catchment at Orongorongo with the Wainuiomata dams is 3.2 kilometres long. Cross section dimensions are 2.1 metres wide, by 2 metres high. As with the shorter tunnel, the letters W W W and the date of construction, 1924 are fixed to the concrete above the portal. At the Orongorongo end there is a tramway turntable which allowed the trolleys to be redirected either to a tip head 8-10 metres above the river immediately opposite the tunnel entrance, or along the benched access track which incorporates the main water pipeline. The water pipe runs along the northeast side of the tunnel allowing room for the tram rails along the southwest side. From the eastern end of the tunnel the water pipe turns northeast to follow the true right bank of the river where it is buried underground for about 65 metres before surfacing again to cross the river via a pipe bridge. The tram rails has been removed from much of this section and discarded over the bank. The north-western portal for the tunnel is located at NZTM E1767828 N5428505.

Main tunnel, south-eastern portal with in situ tram rails

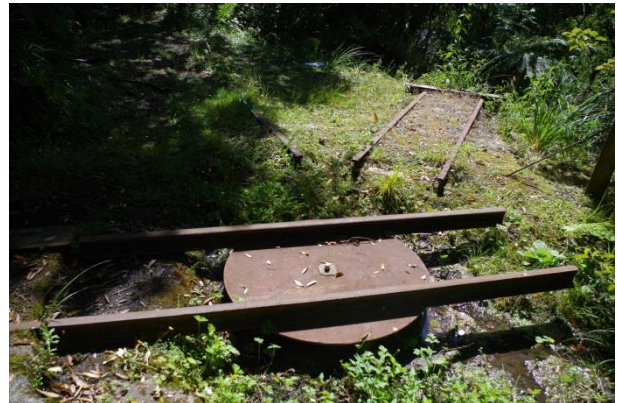
Tram way turntable in front of SE portal of main tunnel

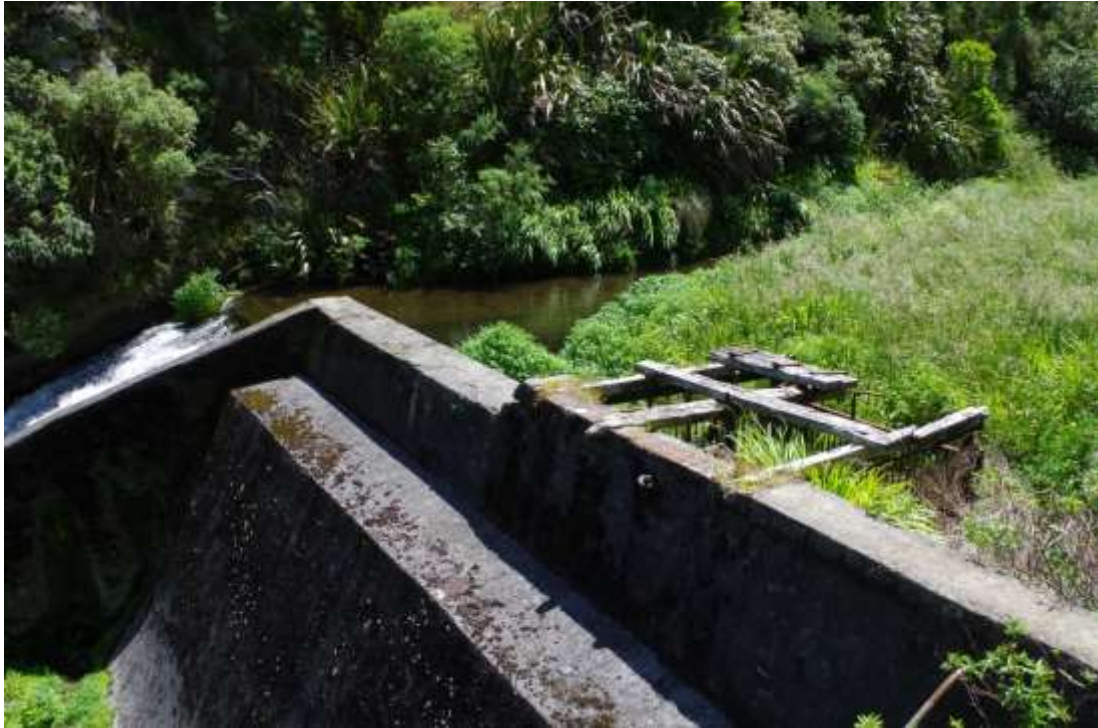
Looking southwest over the Petone Woollen Mill's weir. Intake in foreground to right of frame, spillway in background to left (Dodd, 2015)

The remains of the Petone Woollen Mills weir comprise a concrete weir with a spillway on the true left (west) side, and an intake on the true right (east). The weir itself is approximately 20 metres in length and rises 3 metres above the stream bed on the downstream side.¹ The spillway is approximately 6 metre wide, and the intake approximately 2x2 metres. The intake is a steel grill and timber structure, now largely silted up and overgrown with vegetation. A framework of railway iron 850 metres south of the Woollen Mills weir is likely to be a fence for catching debris washed downstream during periods of flooding, but the age of this structure is unknown.

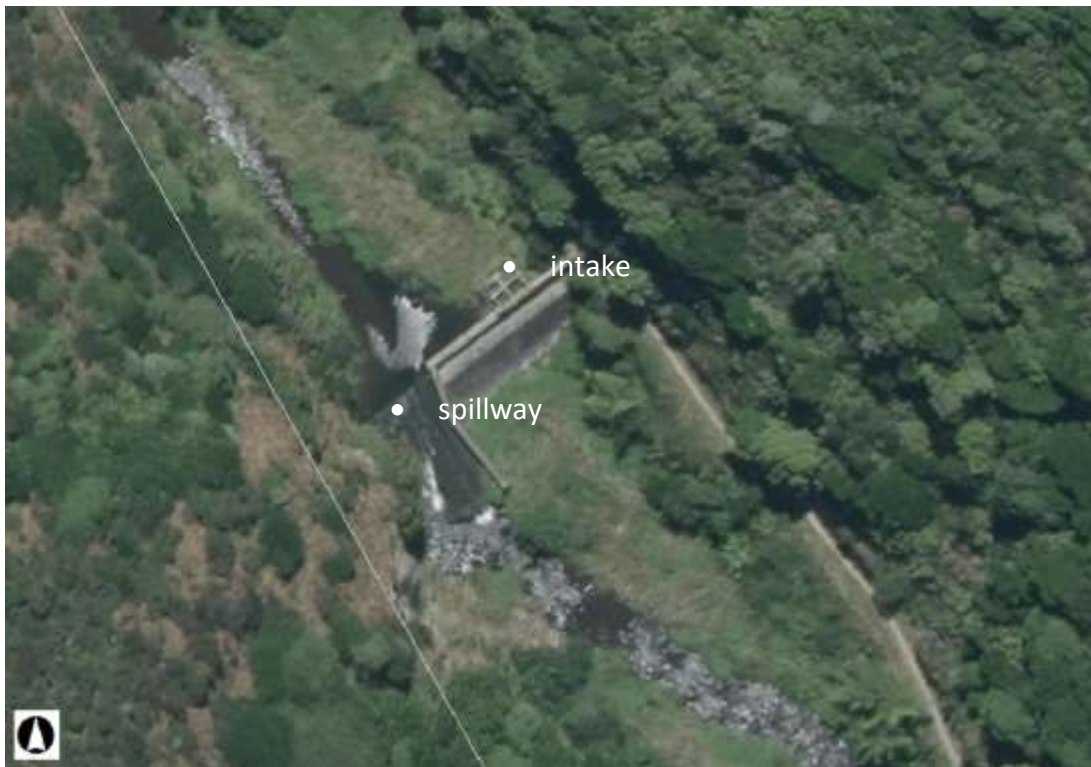
Aerial photography showing Petone Woollen Mills weir on the southwest side of the walking track (Source Hutt City Council, on-line GIS, 2015)

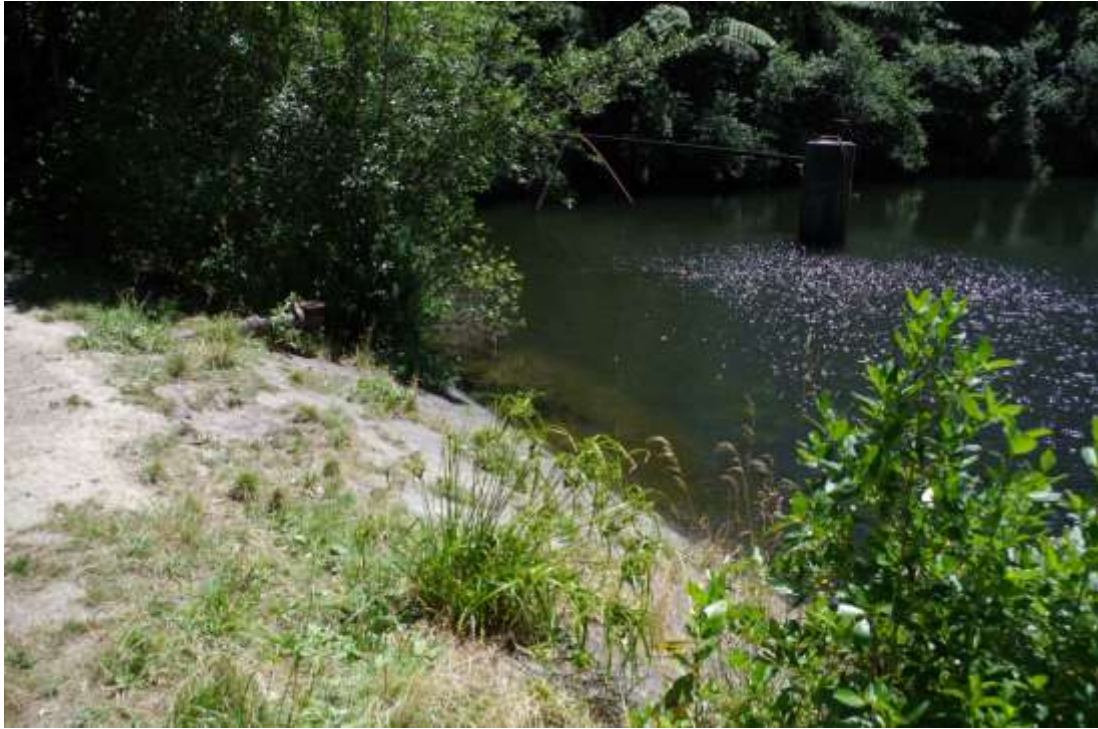
Standing on upper reservoir dam looking towards the valve tower and trolley rails (Dodd,2015)

The upper reservoir complex (1893) comprises a dam, valve tower connected with a set of trolley rails to the western edge, a concrete spillway, and a water intake and disconnected pipeway through the reserve.¹ The dam of the lower reservoir complex (1912) has been deconstructed, but concrete debris from the abutments and the spillway are still present on site, as well as the intake valve which is still visible above vegetation in the former reservoir bed and occasional sections of pipe debris in the stream bed below. Stone revetting above the track that runs alongside the western side of the reservoir is probably contemporary with the reservoir.

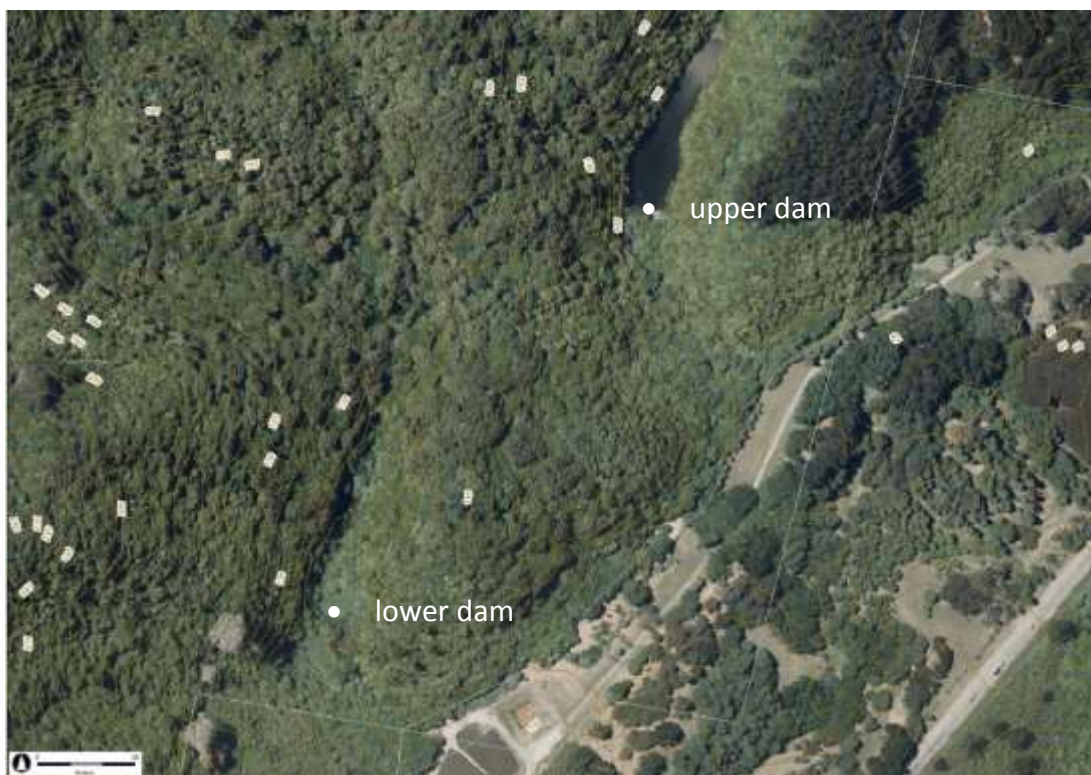
Aerial photography with contours showing the location of the upper and lower reservoir dams (Source Porirua City Council, on-line GIS, 2015)
