ADDENDUM TO

Archaeological values of freshwater
historic heritage of the Wellington Region
(Cochran, Murray and Kelley, 2012)

SUBSURFACE LIMITED
Archaeological Services

May 2015

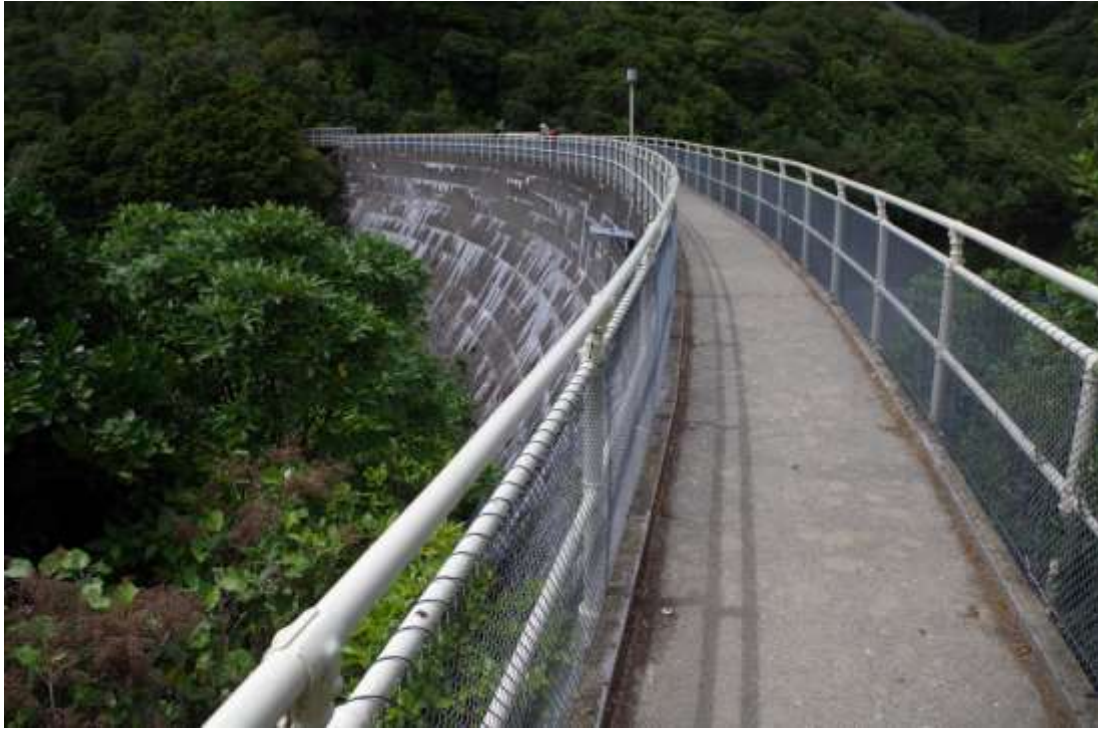
Looking east along the top of the Upper Karori dam (Dodd, 2015)

The Upper Karori dam is a monolithic concrete which spans the upper Kaiwharawhara gully in a gentle curve over a length of 111.25 metres. It has a maximum height of 24.71 metres and a 1.5 metre walkway across the top of the dam.¹ The valve tower is set into the southern side two-thirds along the length of the dam, and there is a spillway on the eastern side.

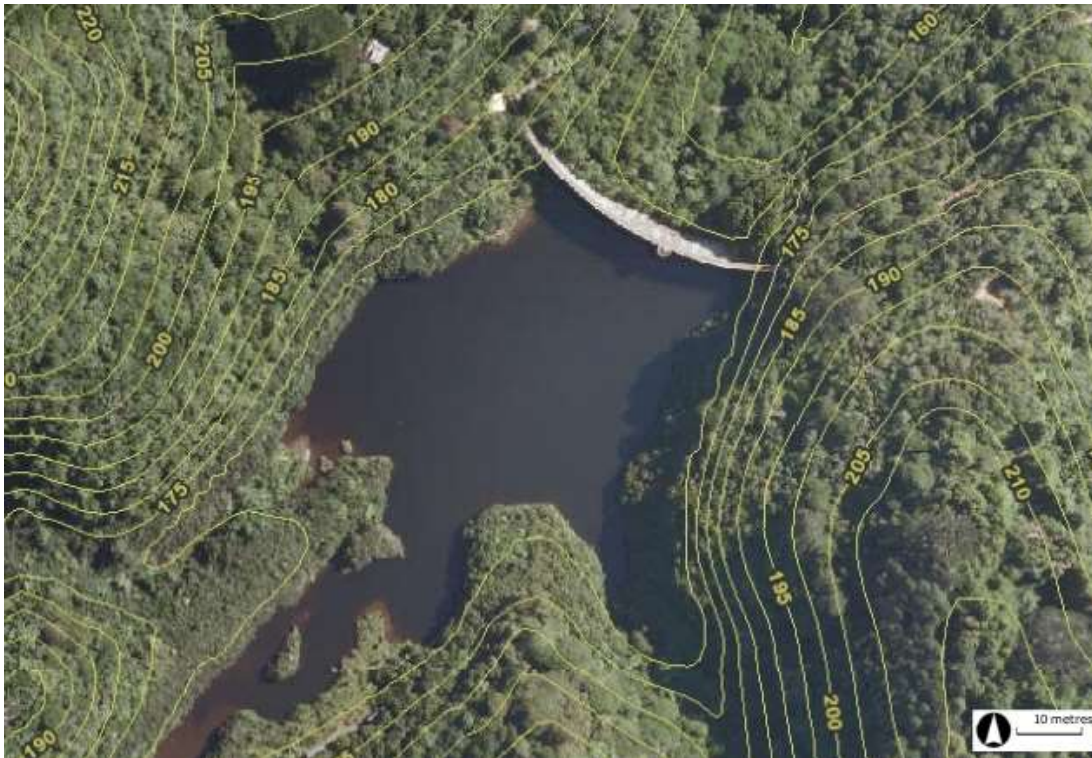
Aerial photography with 5-metre contours showing the location of the Upper Karori dam and reservoir (Source Wellington City Council on-line GIS, 2015).

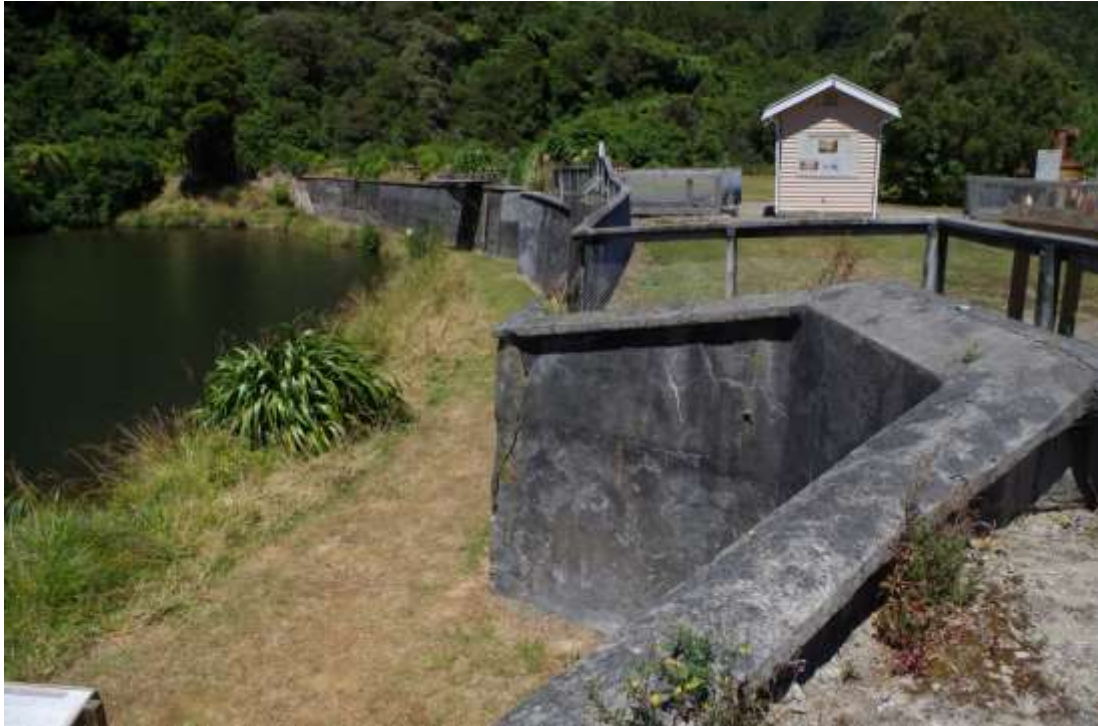
Wainuiomata water works dam, looking southeast along the face of the dam (Dodd, 2015)

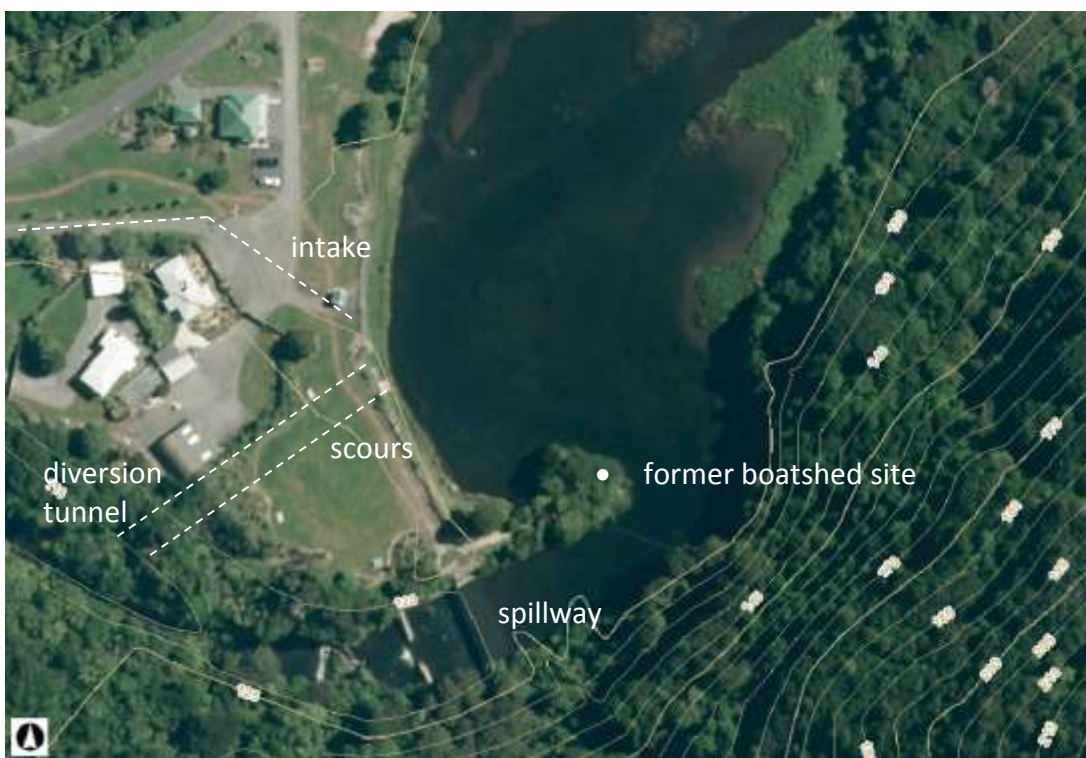
Aerial photography with contours showing the Wainuiomata waterworks dam with spillway to the south, and former location of the boatshed on the narrow headland jutting out into the reservoir. Intake, scours and diversion tunnels indicated with dotted lines (Source Hutt City Council, on-line GIS, 2015)
