Te Kauru FMP Audit Report

Client: Greater Wellington Regional Council

Report by: Matthew Gardner & Vicki Henderson

TE KAURU FLOOD PLAIN MANAGEMENT PLAN

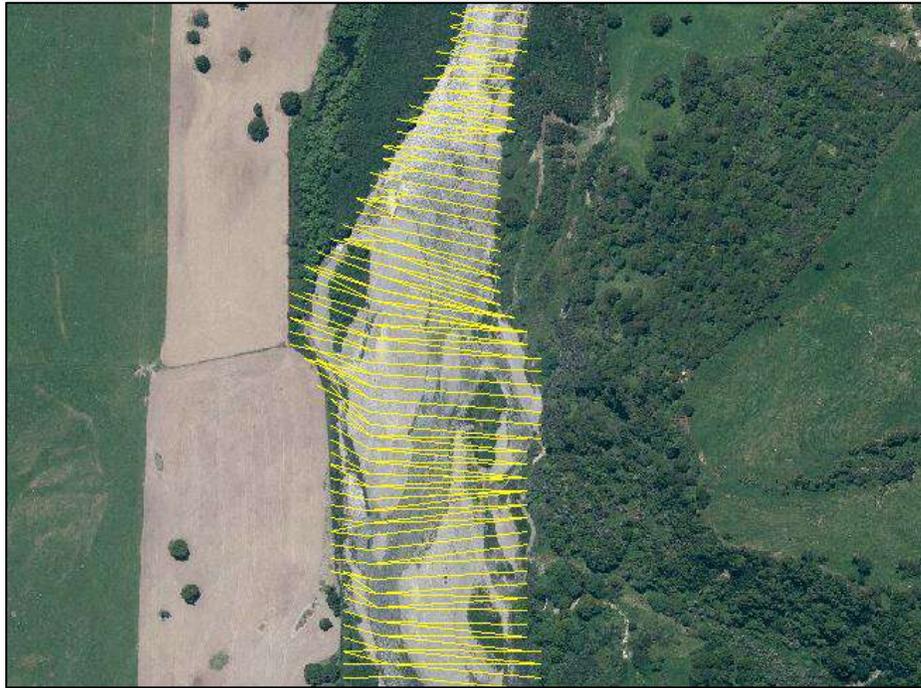
Figure 5-1 – Visualisation of Lateral Link Connections – Ruamāhanga MIKE11 Chainage - 17013 - 17446

A basic check of the setup of the lateral link connections has been carried out for the Ruamāhanga River. The lateral link connections file has been converted to a shapefile and visualised within ArcGIS. The lateral links appear to be working as anticipated for the entire length of the river. A visualisation of the lateral link connection for a section of the Ruamāhanga River branch is presented in Figure 5-1 below (The yellow lines connect the floodplain to the channel centreline, and ideally should be perpendicular to the main direction of flow as is the case in this example).

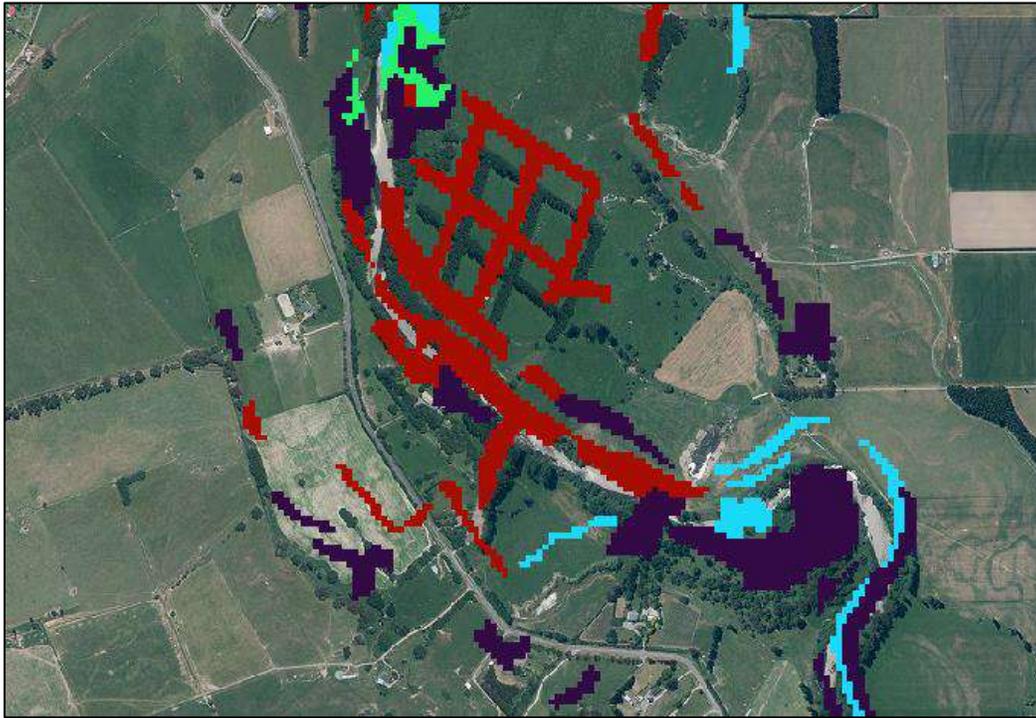
Figure 5-10 – Visualisation of shift due to possible incorrect geographic transformation

not appear to align with the underlying terrain model or imagery and are shifted north by approximately 70m.

- That the apparent horizontal shift between the applied roughness file and the terrain model is investigated and the cause for the shift is rectified. The model will likely need to be rerun as a result.

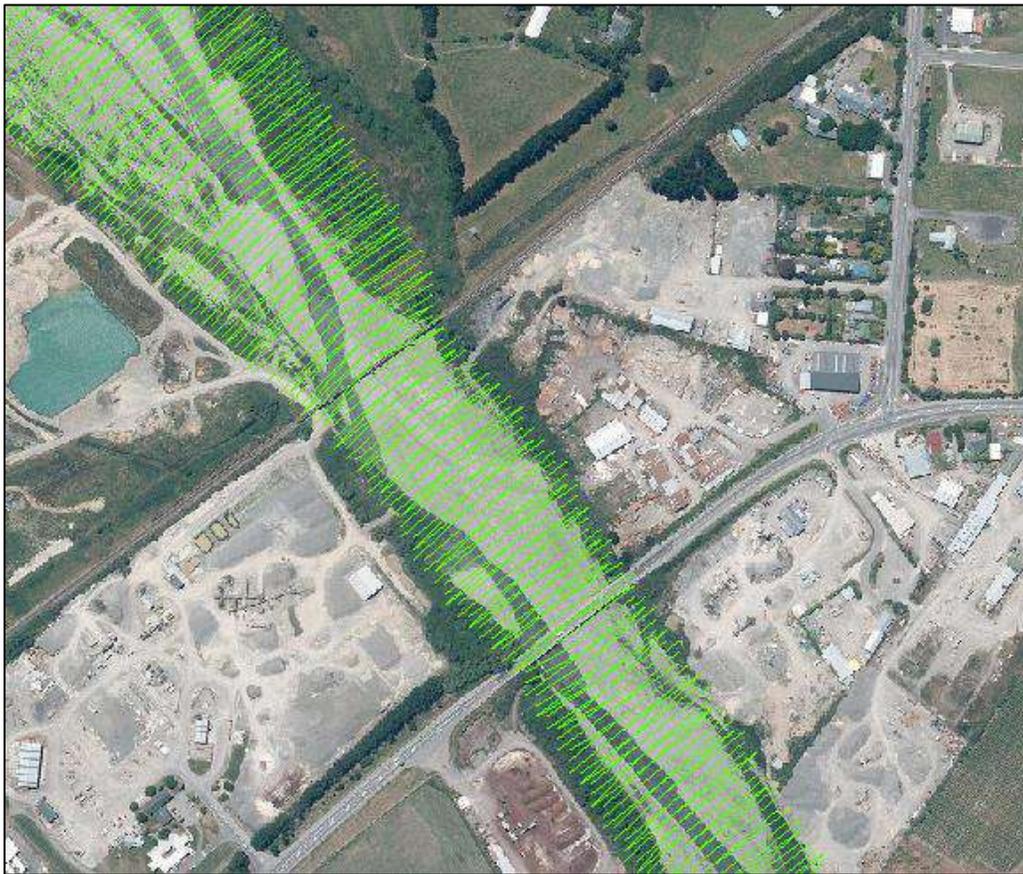
Figure 6-1 – Visualisation of Lateral Link Connections – Waingawa River (SH2 and Rail bridges)

A basic check of the setup of the lateral link connections has been carried out for the Waingawa River. The lateral link connections file has been converted to a shapefile and visualised within ArcGIS. The lateral links appear to be working as anticipated for the entire length of the river. A visualisation of the lateral link connection for a section of the Waingawa River branch is presented in Figure 5-1 below (The green lines connect the floodplain to the channel centreline, and ideally should be perpendicular to the main direction of flow as is the case in this example).

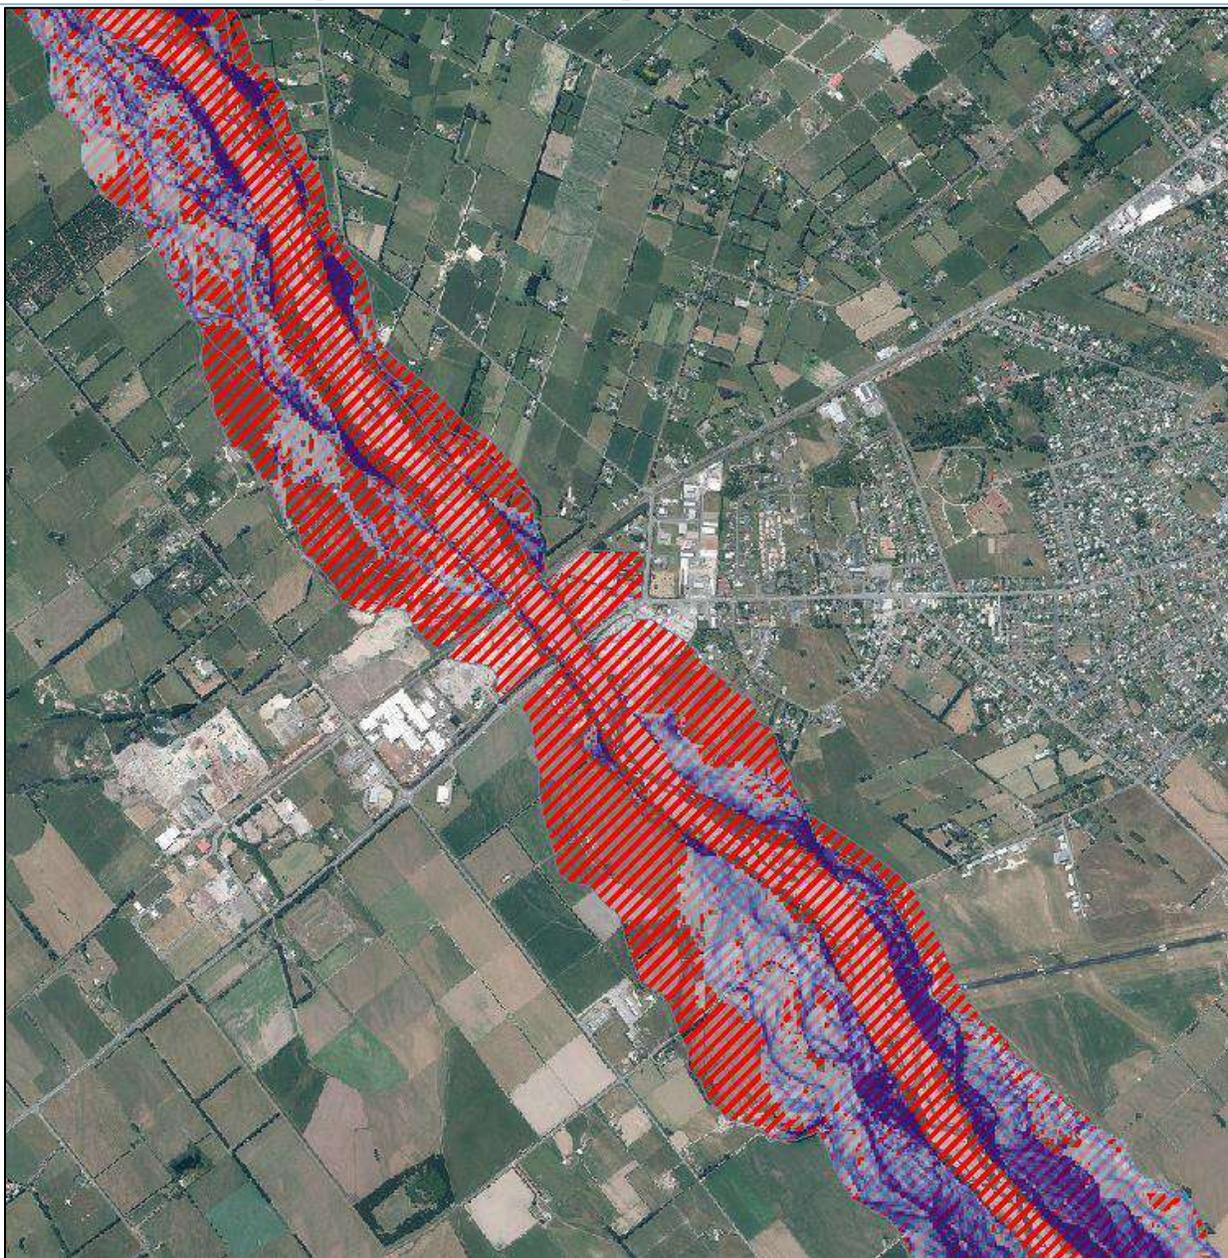
Figure 6-2 - Comparison of GWRC 50 year flood extent layer with latest 50 year model results (Waingawa River)

Comparison for a select area of the Waingawa model results is made with the GWRC 50 year flood zone layer in Figure 6-2 below. In general the modelled flood extent for the Waingawa River seems to match fairly well with the historic extents however in some areas such as in the vicinity of the bridges, the new flood extent is significantly less than the historic 50-year flood layer. This may indeed be sensible, however some commentary around the differences would be warranted.

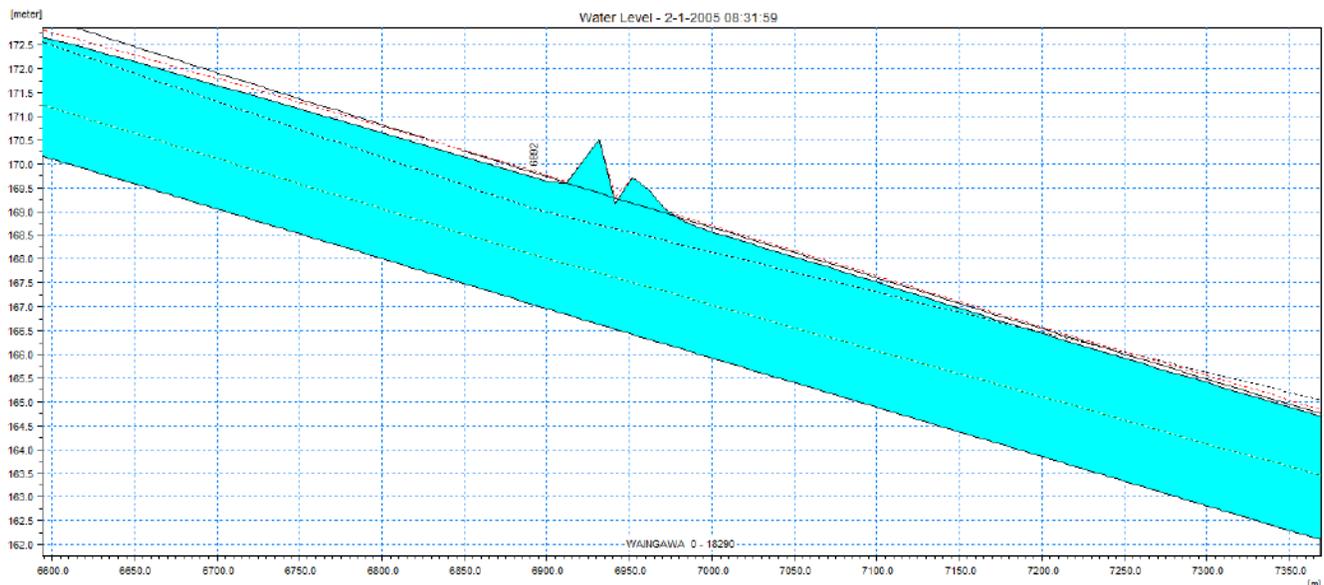
Figure 6-3 – Visualisation of MIKE11 model results in location of instability

One minor instability has been noted in the MIKE11 results at chainage 6829, this does not appear to propagate into the 2D results, however may want to be tidied up if further work is done in the model in the future.

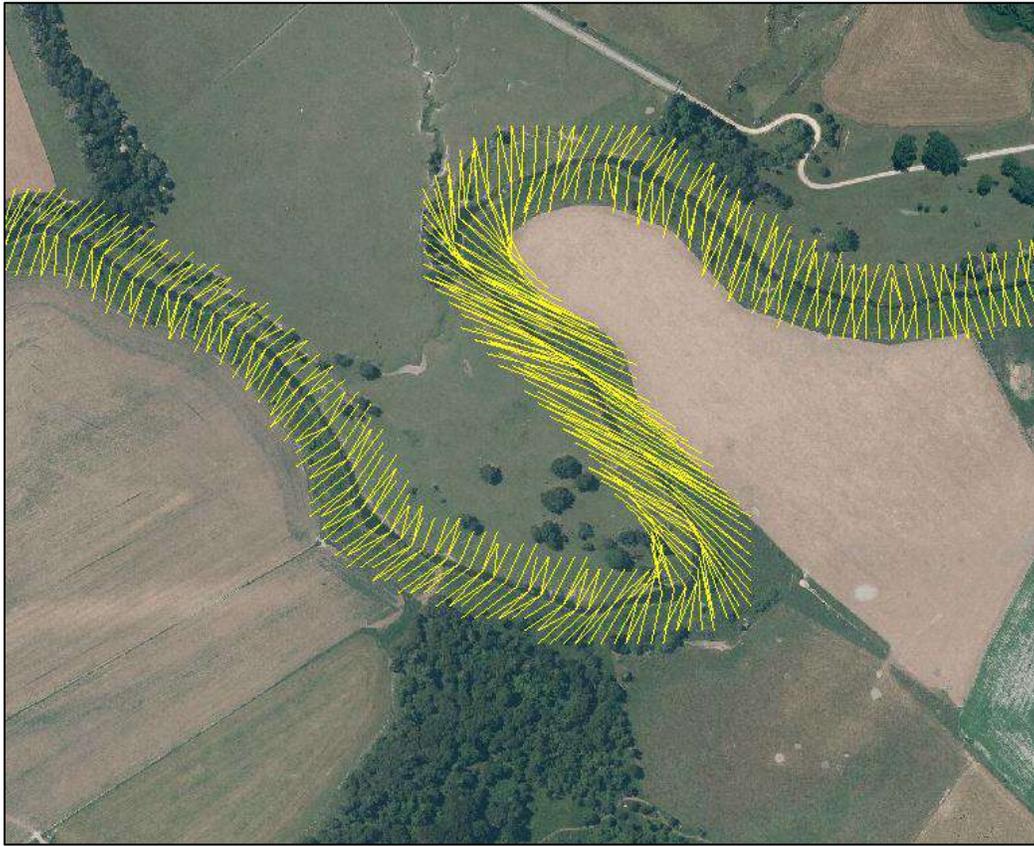
Figure 6-4 - Visualisation of Lateral Link Connections – Taueru River (M11 Chainage 1957 to 3264)

A visualisation of the lateral link connections at one particularly tight bend is presented in Figure 6-4 below.

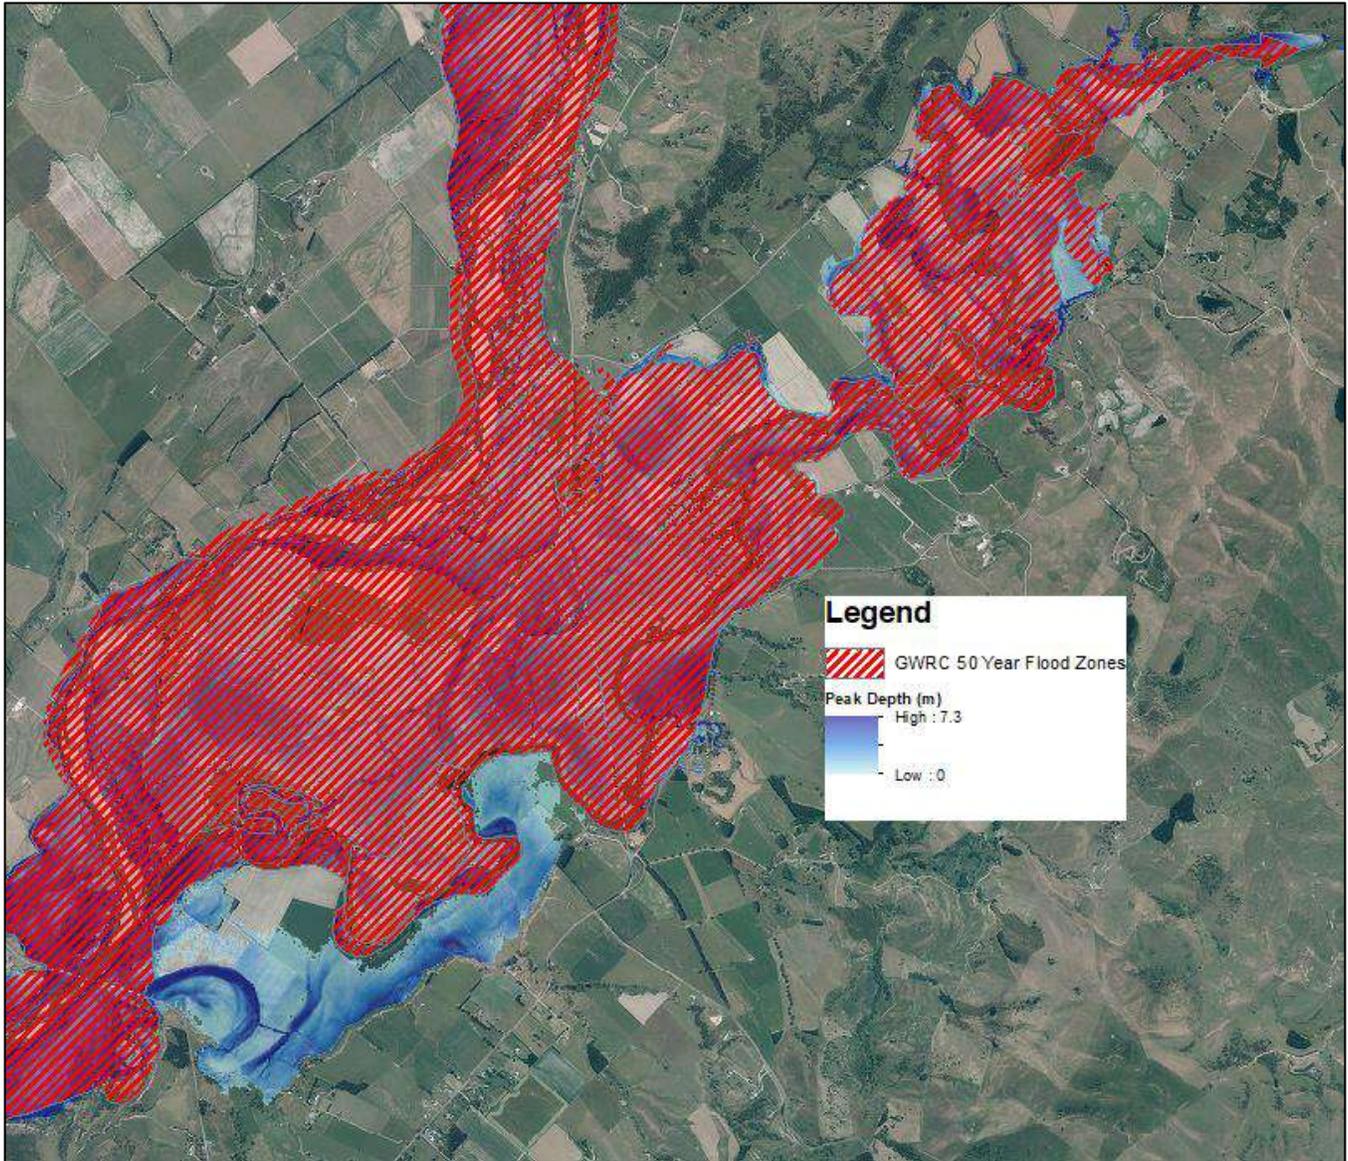
Figure 6-5 - Comparison of GWRC 50 year flood extent layer with latest 50 year model results (Taueru River)

on the true left bank in the lower reaches. These differences would warrant some further investigation to ensure the results are sensible.

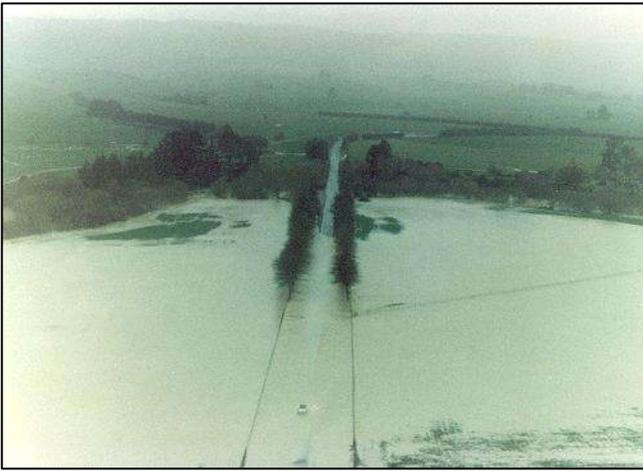
Figure 6-6 – Flood photo Te Whiti road bridge (July 1985 – 10 to 20 year return period event)

A quick comparison of flood photos shows a fairly good fit with historic flood extents. An example comparison with a historic flood photo from 1985 (between a 10 year and 20 year event) at Te Whiti road bridge is presented in Figure 6-6 and Figure 6-7 below. This photo appears to show significantly more flooding in this location than observed in the 50-year model results, however this may be due to changes in channel capacity since 1985.

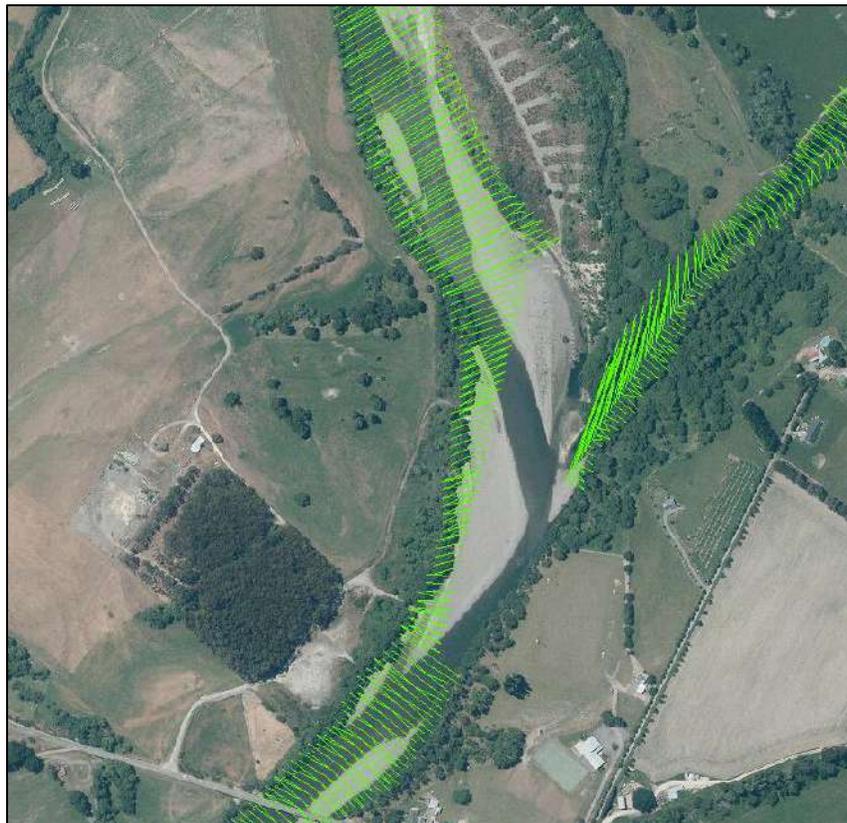
Figure 6-8 - Visualisation of Lateral Link Connections – Ruamāhanga River

A basic check of the setup of the lateral link connections has been carried out for the Ruamāhanga River. The lateral link connections file has been converted to a shapefile and visualised within ArcGIS. The lateral links appear to be working as anticipated for the entire length of the river. At the confluence of the Taueru River there appears to be a gap in links on the true left bank over a length of approximately 500m. When simulating floods which coincide with flooding on the Taueru River this will be unlikely to have any significant impact, however may impact on results which are solely focusing on flooding from the Ruamāhanga river. A visualisation of the lateral link connection for the section of the Ruamāhanga River / Taueru confluence is presented in Figure 6-8 below (The green lines connect the floodplain to the channel centreline, and ideally should be perpendicular to the main direction of flow as is the case in this example).

- The DHI peer review report recommended changing all lateral link elevation sources to use the M21 method. This has not been done in the Ruamāhanga model and should be implemented to ensure the model correctly represents the physical reality.

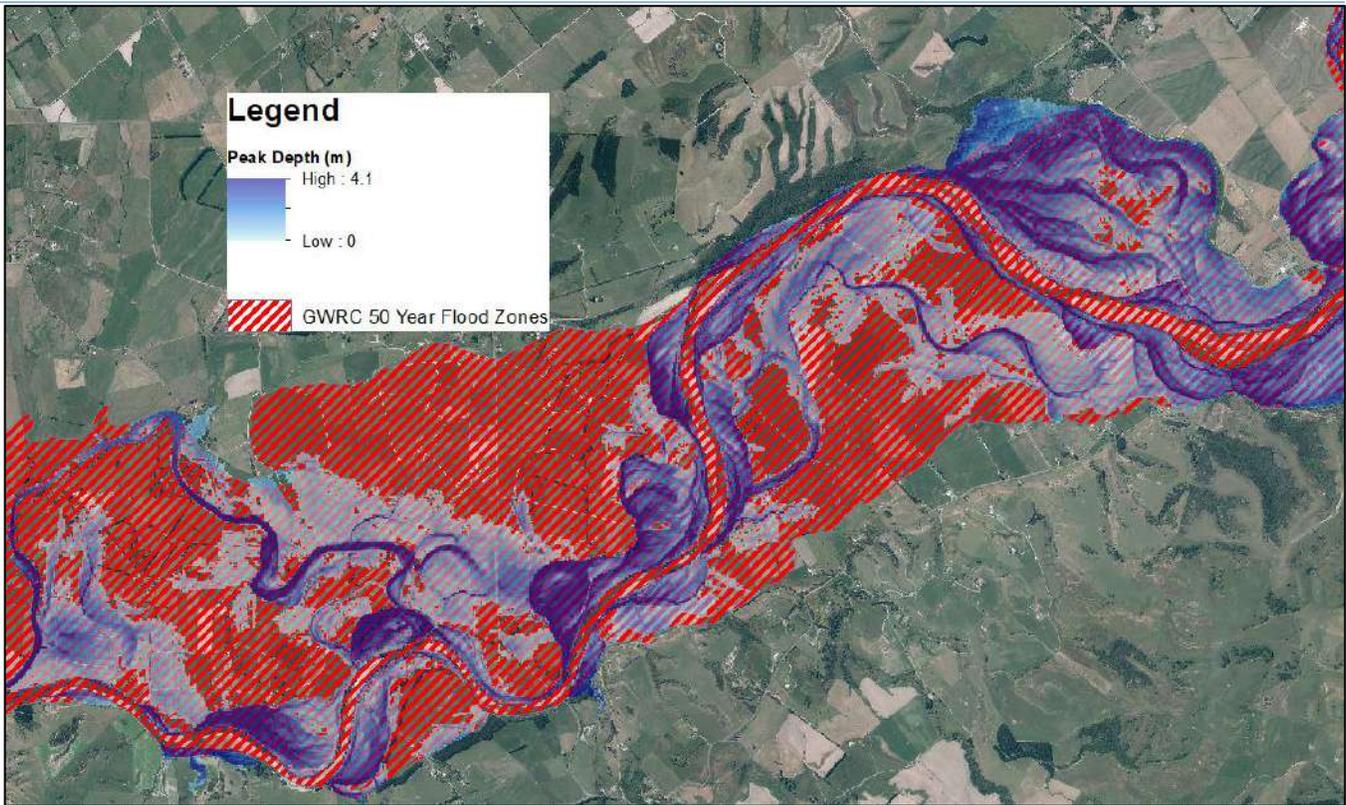
Figure 6-9 - Comparison of GWRC 50 year flood extent layer with latest 50 year model results (Ruamāhanga River)

A comparison of a select area of the Ruamāhanga model results is made with the GWRC 50 year flood zone layer in Figure 6-9 below. In this location the modelled flood extent is significantly narrower than that in the 50 year flood extent on record. The reason for the reduction in flood extent may need to be investigated. There is a possibility that changing the lateral link elevation source to M21 from HGH as recommended in section 6.2 will allow more water to spill from the river certain locations.

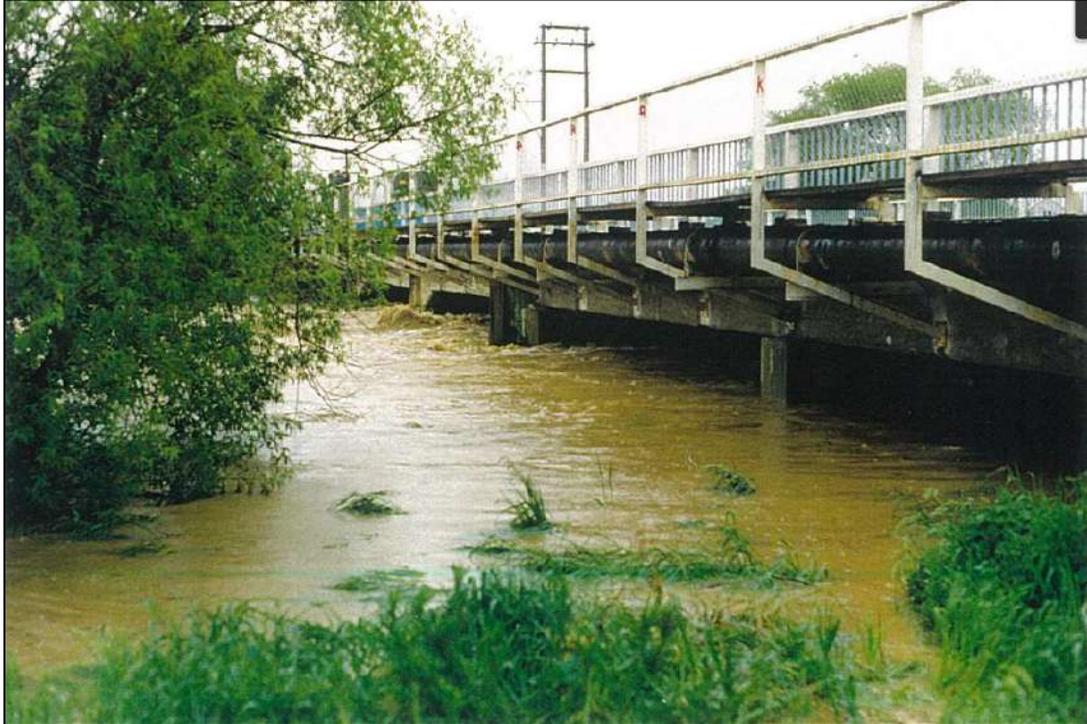
Figure 7-1 – Colombo Road Bridge – Nov 1994 Flood

location (Figure 7-1). Blockage of piers may be sufficient to cause water to back up behind the soffit.

- Including the bridge piers will allow for sensitivity to debris blockage to be tested.
- Sensitivity Results (Upper Bound Mikimiki) show that peak water levels are within 0.1 to 0.2m of the soffit at this bridge. If an increase in headloss is allowed for by adding in a bridge pier allowance, then it is possible that this structure will overtop. The impact of this on the overall floodspread should be investigated, as well as the increased hazard (ie risk to evacuation routes etc acknowledged)

In addition to including the bridge piers, due to the apparent lack of capacity available in the Colombo Road bridge, it is possible that the bridge soffit would be at risk of catching floating debris. Consideration should be given to lowering the soffit of this bridge to account for the potential of floating debris backing up behind the soffit.

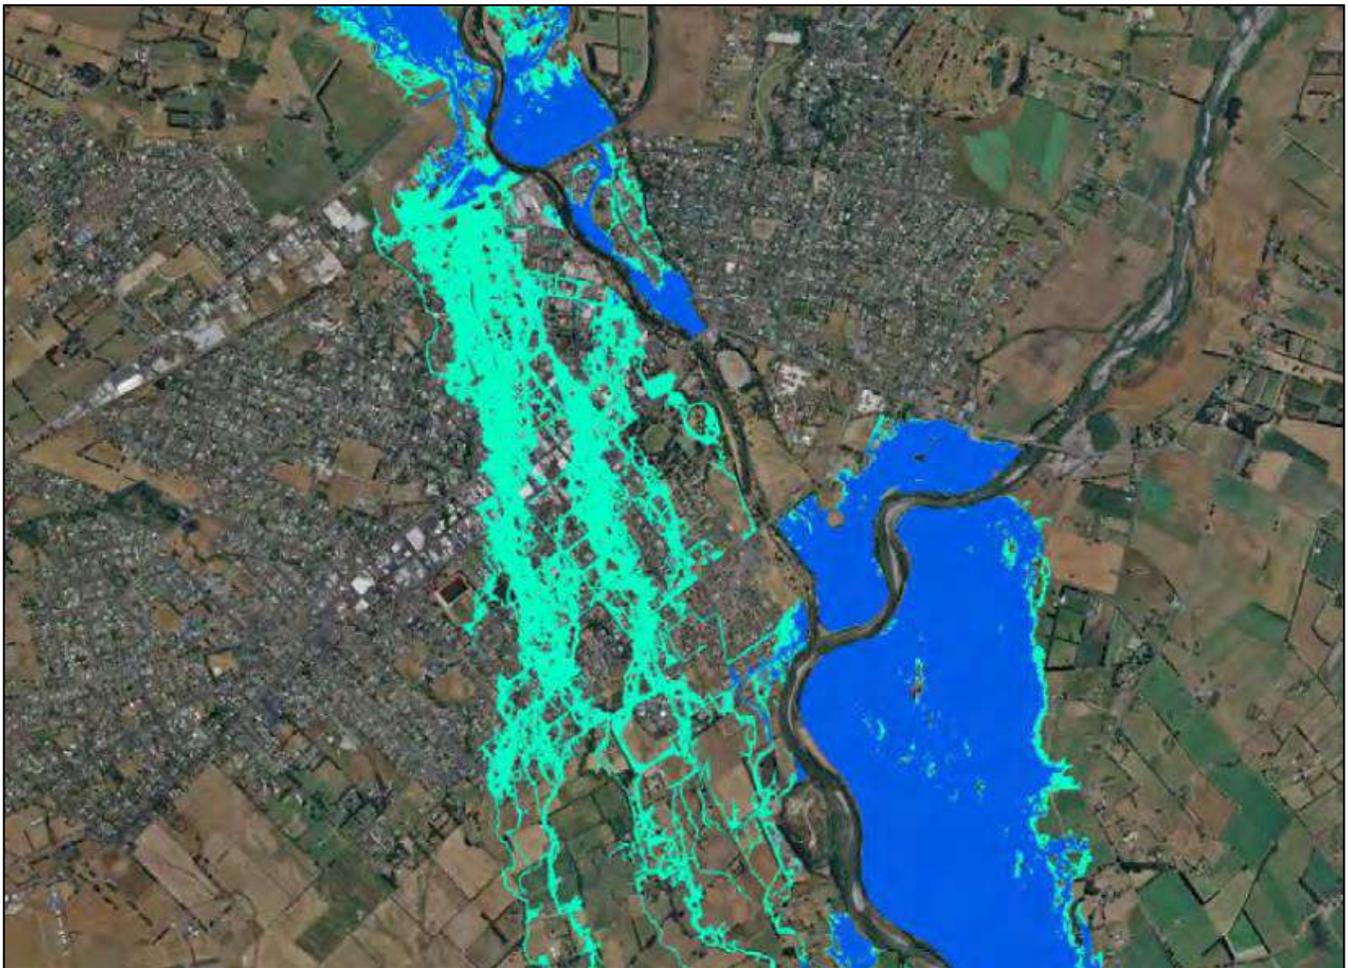
Figure 7-2 – Modelled flood extent showing flood waters overtopping the railway embankment

As a result of the railway embankment overtopping, a significant number of properties within Masterton are shown as being at risk of flooding as shown in Figure 7-2 below.

It is recommended that the setup of the bridge at the railway is reconsidered, ideally using a standard methodology such as the FHWA approach, or a standard headloss factor is applied based on hand calculations using guidelines from a reputed source such as “Open-Channel Hydraulics” (Chow, 1959). Considering the sensitivity of the model results and overall floodspread to this structure, it may be appropriate to ensure that a range of experts are consulted before an appropriate headloss through this structure is agreed upon.

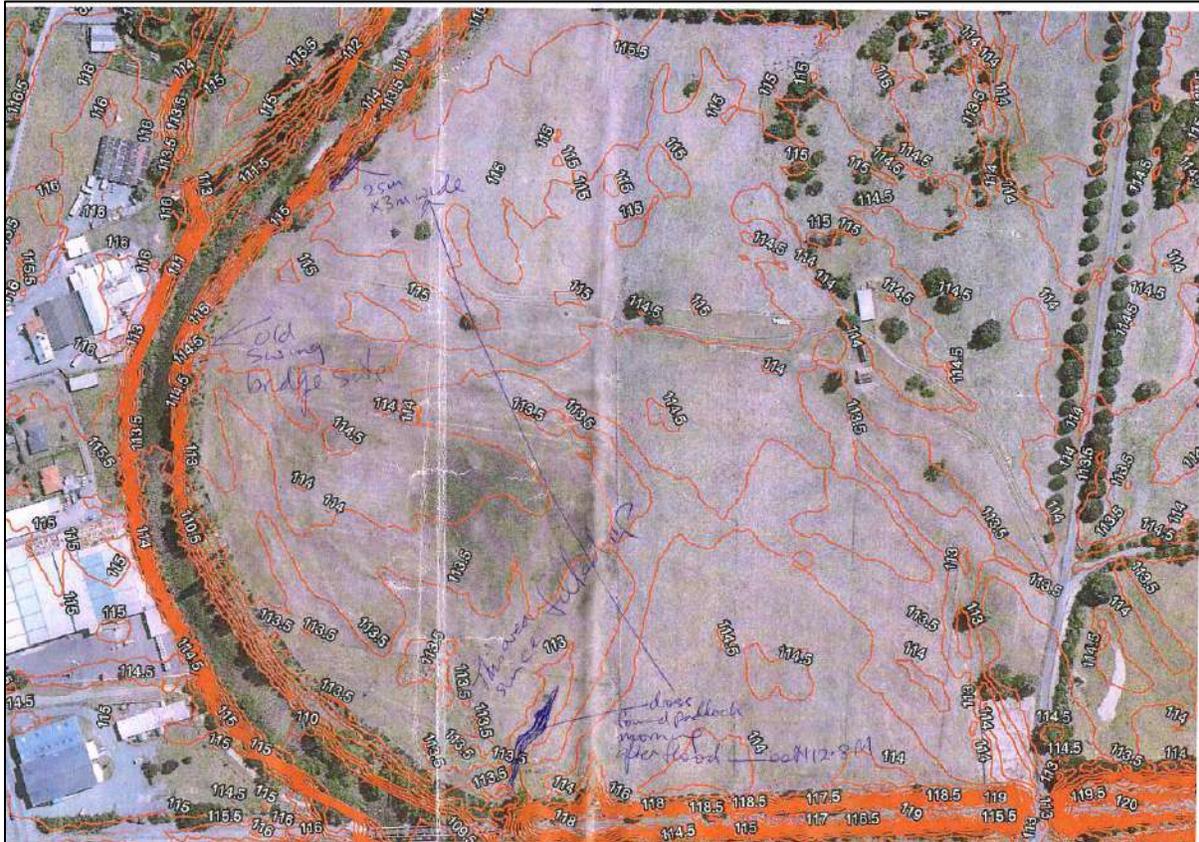
Figure 7-6 – Contour plan showing recollection of flood extent for 98 flood on Mahunga Farm (Andrew Donald)

The owner of the land (Andrew Donald, Mahunga Farm) on the true left bank at this location has reported that he walked over his land the morning after the flood event and observed that no floodwaters had inundated his farm except in two minor locations. Andrew Donald provided the following sketch indicating the extent of flooding overlaid onto a contour plan. This plan indicates that the peak flood levels immediately upstream of the bridge have an approximate level of 112.8m (Wellington MSL 1953 datum), or 122.02 m (Wairarapa Datum). This flood level is 0.85m lower than the level recorded on the true right bank by staff at GWRC. The plan is presented in Figure 7-6 below.

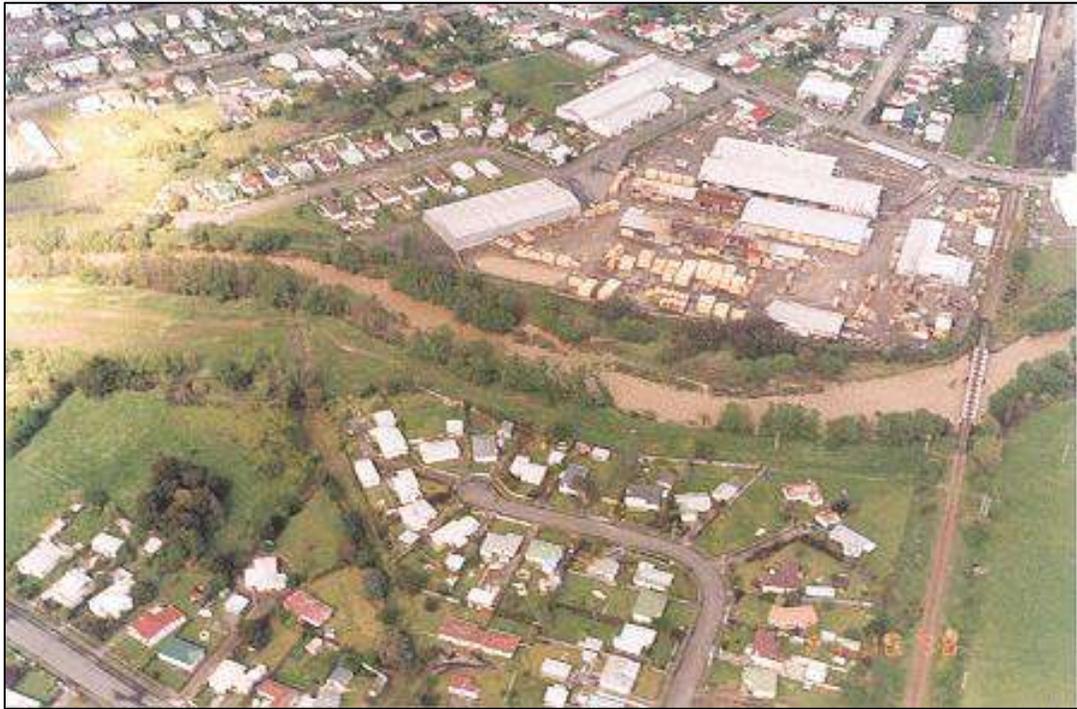
Figure 7-7 – Flood photo - showing railway bridge on the right (taken after the peak)

Inspection of the only flood photo on file which covers a small portion of the Mahunga Farm does not show any visible signs that floodwaters have risen to the level shown in the model either. Whilst these flood photos were taken after the peak, there is significant ponded water and silt visible in other photos where the water has been. A comparison of the flood photo with the model results in that area is presented in Figure 7-7 and Figure 7-8 below. Unfortunately the flood photos are taken after the peak so it is difficult to draw firm conclusions, however of note in this photo is the fact that there is visible brown silt in the left of this photo indicating that flood water has inundated the area shown as flooding in the model, however there is no obvious silt present immediately upstream of the rail bridge.

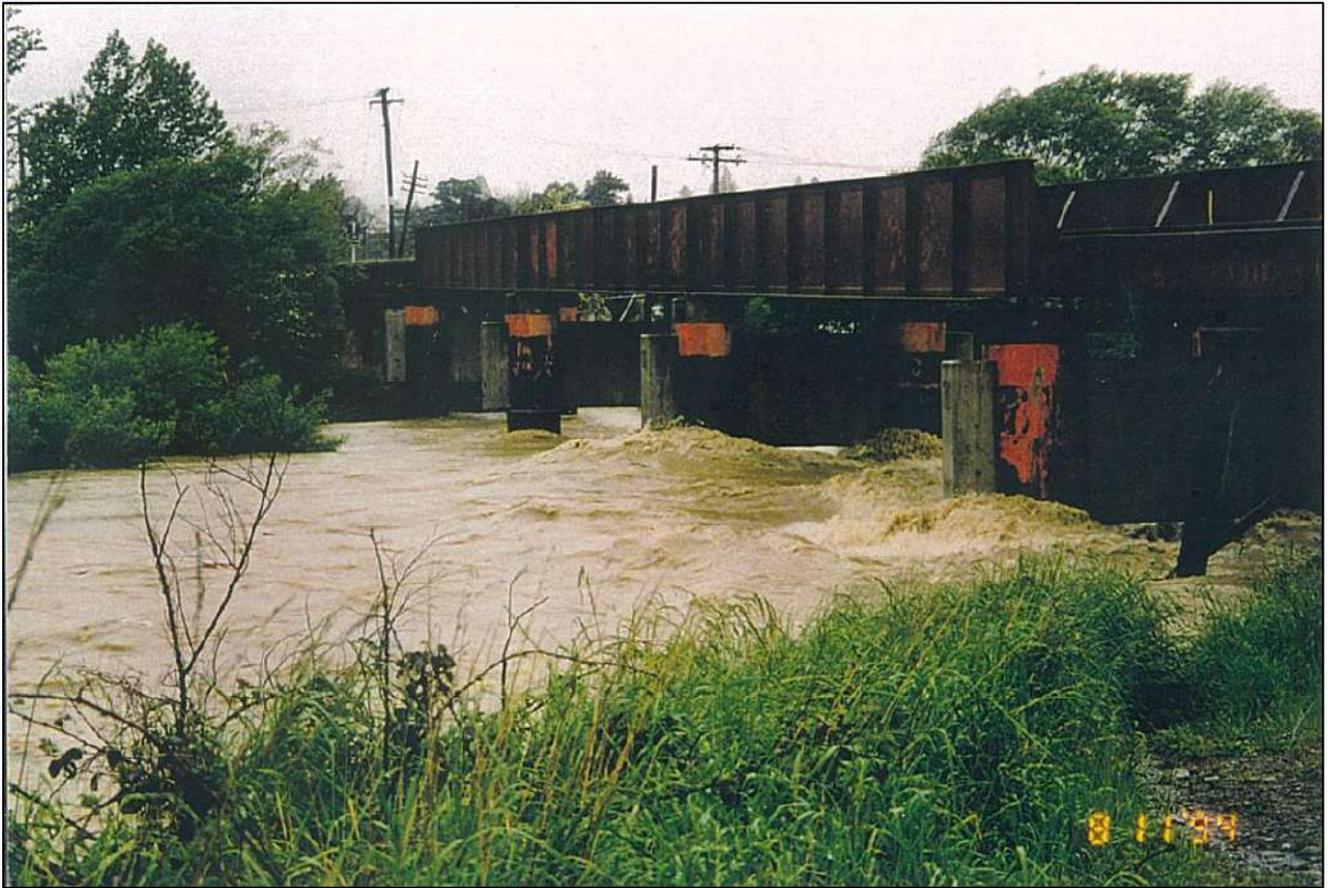
Figure 7-10 – File photo from the November 1994 flood showing elevated water levels on the true right bank

A file photo(Figure 7-10) showing water levels at the bridge during the November 1994 flood event appears to show increased water levels on the right bank due to a combination of superelevation and channel alignment. There also appears to be a fairly significant bow wave coming of the right piers which is likely to be accentuated in higher flows, particularly if blockage of the right piers is present.

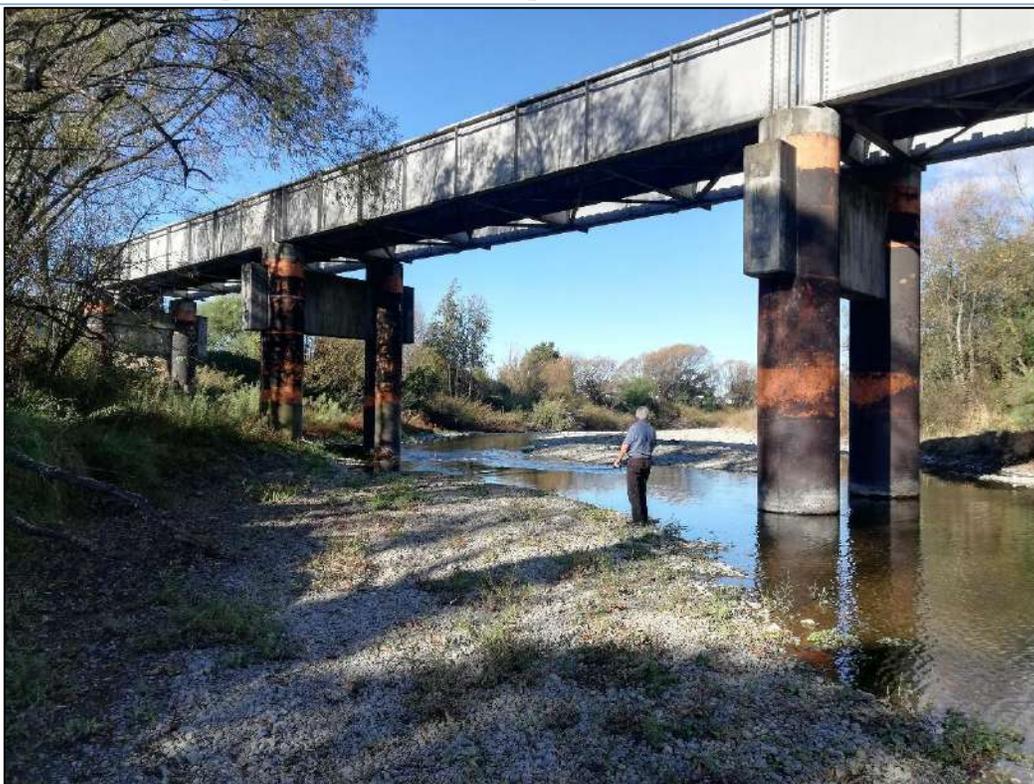
Figure 7-11 – Picture showing capacity through the bridge looking downstream

I visited the site on the 7th of May 2019 and observed that in relation to the Opaki and Colombo Road bridges, there appeared to be significant capacity available through the railway bridge. The bridge piers are skewed to the principle flow direction and there are concrete blocks at the top of the piers which are likely to slightly increase the headloss once the water reaches this level. The location of the railway groynes and vegetation protruding from the true right bank was also confirmed.

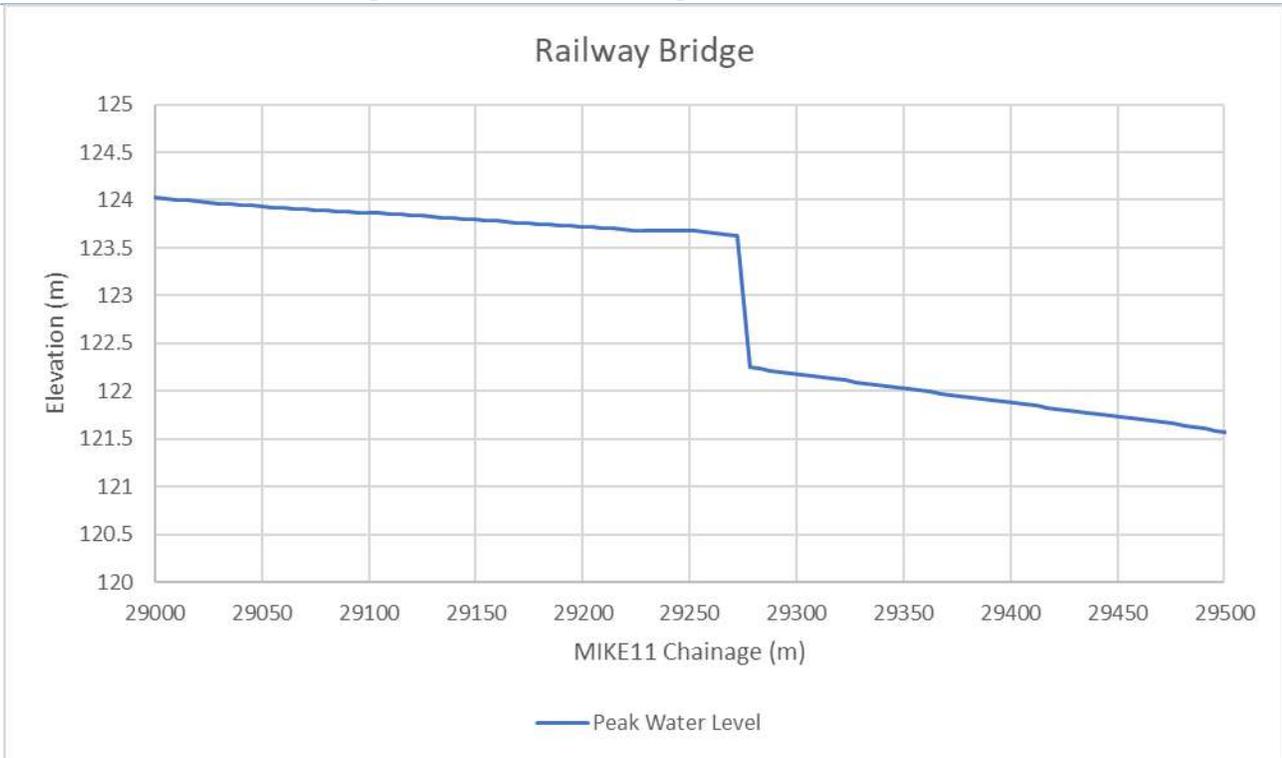
A visual representation of the head loss at each modelled bridge is presented in the following figures for the 50 year climate change run.

Figure 7-13 - Observed headloss through Colombo Rd Bridge (50 year CC)

Figure 7-14 - Observed headloss through Opaki Rd Bridge (50 year CC)

Figure 7-15 - Observed headloss through Railway Bridge (50 year CC)

Figure 7-16 - Observed headloss through Paierau Rd Bridge (50 year CC)

Figure 7-17 - Observed headloss through Lochores Rd Bridge (50 year CC)

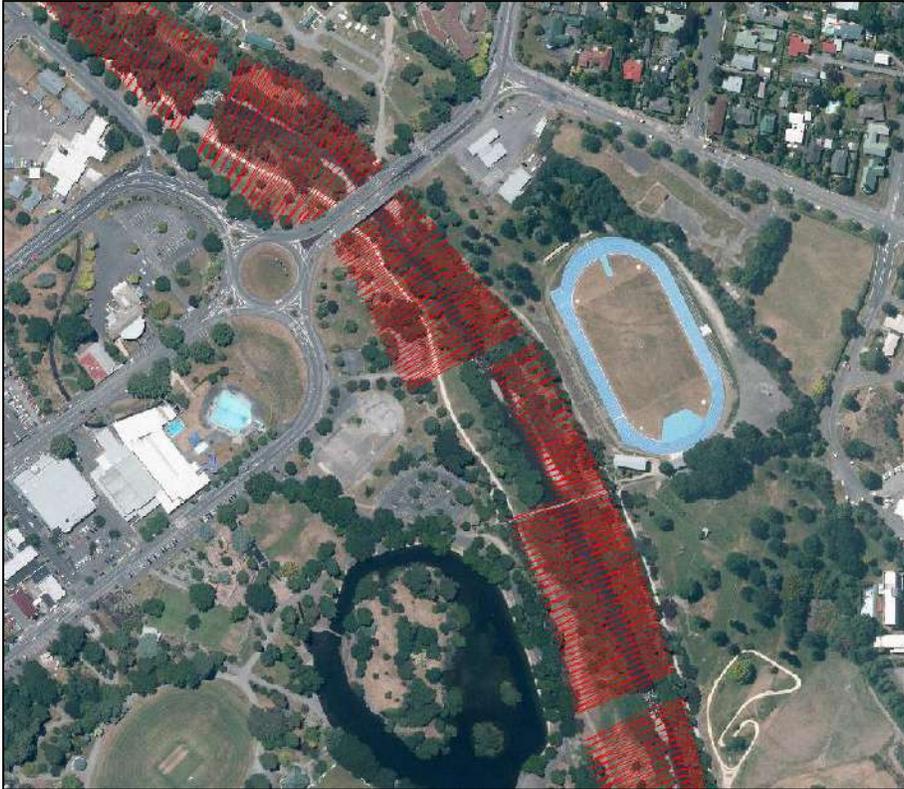
Figure 7-18 – Visualisation of lateral link connections showing gap in right bank lateral link (red lines showing link connections to centre of river)

In order to assist in visualisation of the link connections, the output from the ‘MFLateralLinkConnections.txt’ file was converted to a shapefile. Inspection of the output shows that the link connections appear to be working as expected in most locations, however it was also evident that there were several gaps in the lateral links. The most significant of these is a 130m gap in the link on the true right bank downstream from the State Highway Bridge as shown in Figure 7-18 below. Whilst the smaller gaps (~20m wide) are unlikely to make a significant difference to the results, the large gap on the true right bank will prevent water from exiting the river in this location should the bank overtop and should ideally be included in the model.

- It is recommended that the lateral link on the true right bank of the river downstream from the State Highway bridge (M11 chainage 30590 to 30720) is included in the model, or otherwise its exclusion is justified.

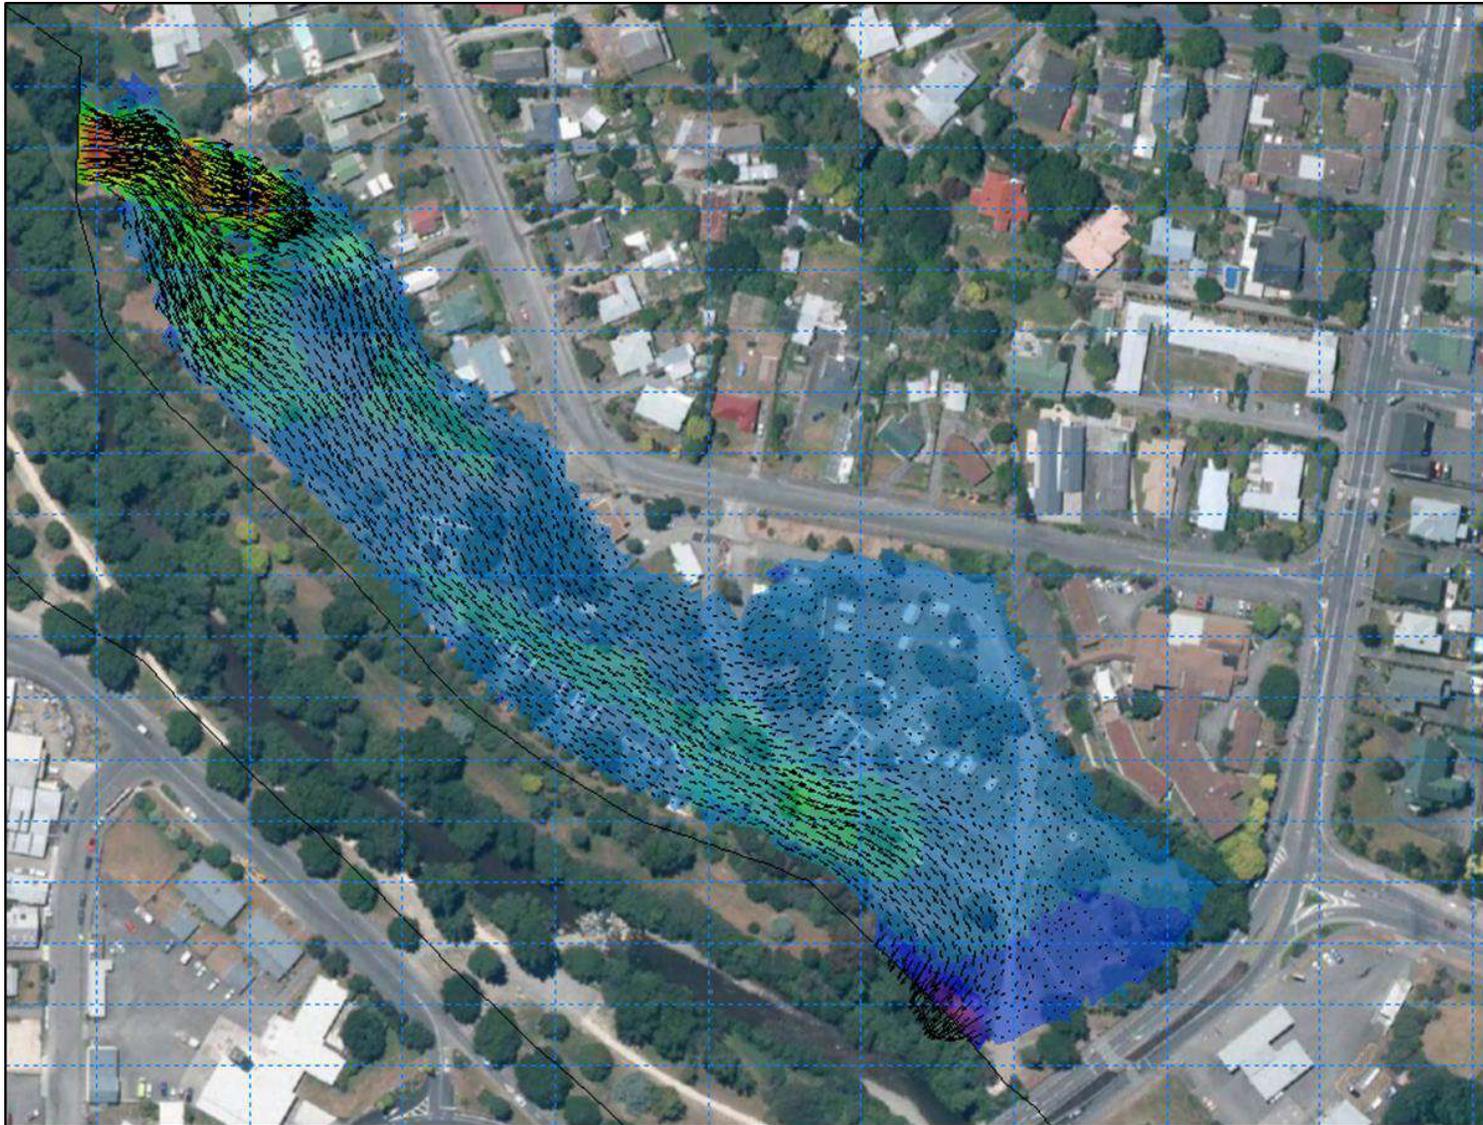
Figure 7-19 - 1998 Calibration results overlaid with vectors showing the direction of flow

Inspection of the model results show that the model is showing a significant volume of overflow on the true left bank in between sections 7 and 9. Model results show the water spilling out of the main river downstream of cross section 9 (at MIKE11 chainage 29950) and running behind the stopbank, backing up at the Opaki road bridge embankment and then spilling back into the river in the vicinity of cross section 7 (MIKE11 chainage 30425). A visualisation of the model results for the 1998 calibration run, overlaid with vectors showing the direction of flow is presented in Figure 7-19.

Figure 7-20 - 1998 Calibration results showing water depths

- The model shows significant spilling on the true left bank in the reach downstream from the railway bridge at MIKE11 chainage 29550. This results in significant inundation of the Mawley Holiday Park and surrounding houses. The model shows a significant gap in the stopbank in this location, however inspection of the 2013 LiDAR and visit to site has confirmed that there is a continuous bank in this location which is covered with fairly dense vegetation. It is recommended that this bank is cleared of vegetation so that the crest level can be accurately surveyed and included in the model. It is likely that the section of model in this reach will need to be recalibrated once this bank is included.

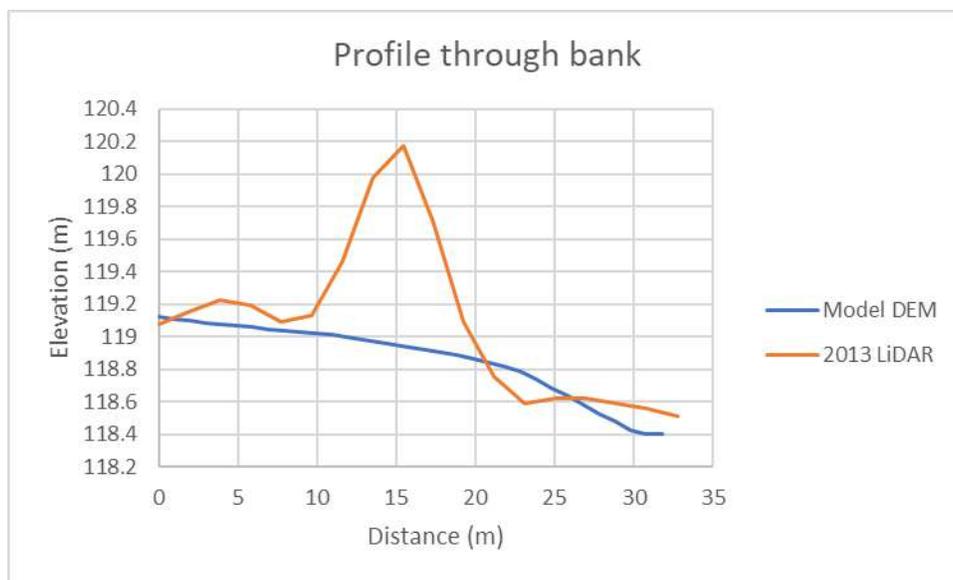
Figure 7-22 – Comparison of modelled terrain levels (2008 LiDAR) with 2013 LiDAR

An inspection of the underlying LiDAR (2008) used in the model shows that there is a gap in the stopbank in this location, however when compared with the 2013 LiDAR dataset in the same location, it appears that there is actually a continuous bank in this location. Topographic survey data which was commissioned by GWRC in this area has not picked up a bank however, which explains why the modeller would have believed the gap in the bank seems realistic. The reason why the surveyors did not survey the bank should be further investigated.
