Te Kauru FMP Audit Report

Client: Greater Wellington Regional Council

Report by: Matthew Gardner & Vicki Henderson

TE KAURU FLOOD PLAIN MANAGEMENT PLAN

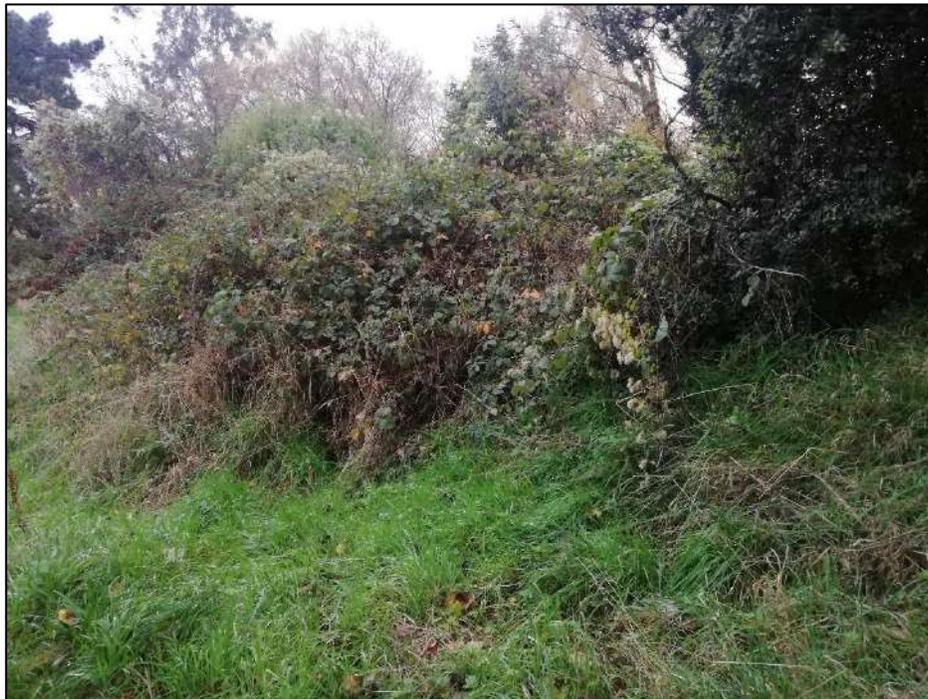
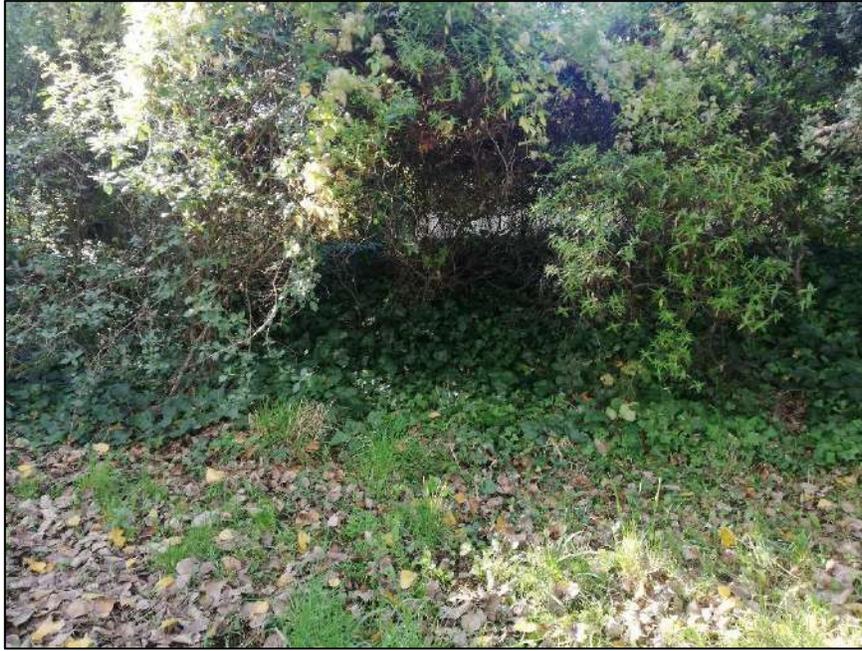
Figure 7-23 – View of continuous stopbank on site

I went to site on the 9th of May to inspect the area and can confirm that there appears to be a solid continuous embankment in this location. The embankment is covered in thick ivy and blackberry in locations, however would appear to act as a significant barrier to flow. The following figures show the bank as observed on site.

Figure 7-24 - View of continuous stopbank on site (2)

- The model shows significant spilling on the true left bank in the reach downstream from the railway bridge at MIKE11 chainage 29550. This results in significant inundation of the Mawley Holiday Park and surrounding houses. The model shows a significant gap in the stopbank in this location, however inspection of the 2013 LiDAR and visit to site has confirmed that there is a continuous bank in this location which is covered with fairly dense vegetation. It is recommended that this bank is cleared of vegetation so that the crest level can be accurately surveyed and included in the model. It is likely that the section of model in this reach will need to be recalibrated once this bank is included.

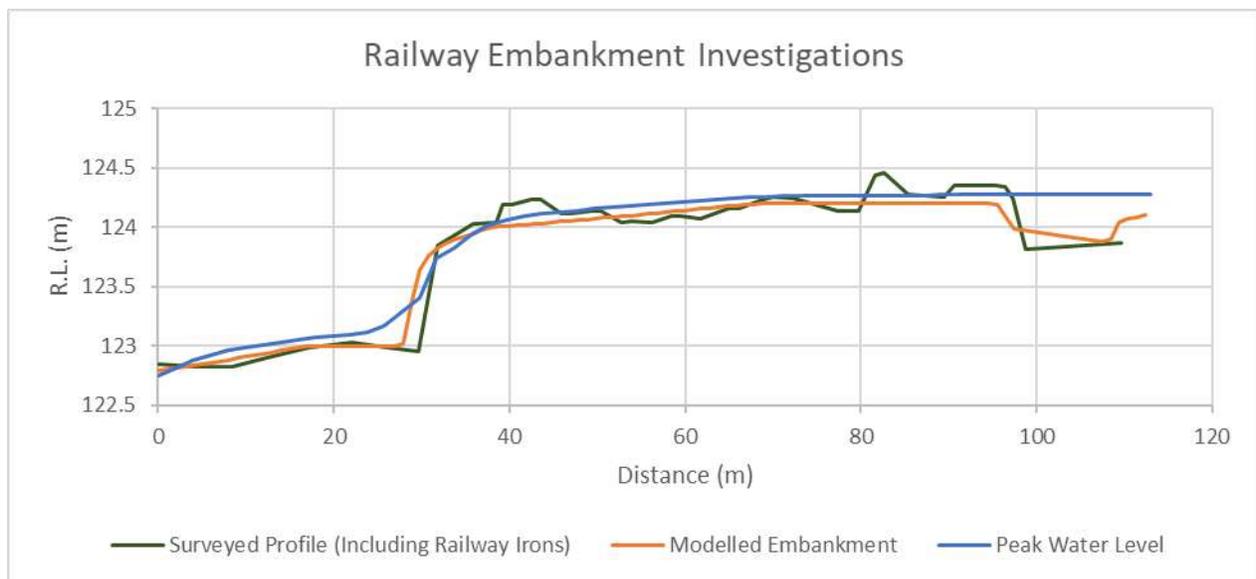
Figure 7-25 – Comparison of modelled embankment levels with survey

Peak water level results for the sensitivity run were also extracted in this location and found to be overtopping the embankment by only 0.1m. Whilst the railway irons may not prevent the entirety of the flow overtopping the bank in this location, it is likely they would act as a significant barrier to the flow, and would ideally be included in the model.

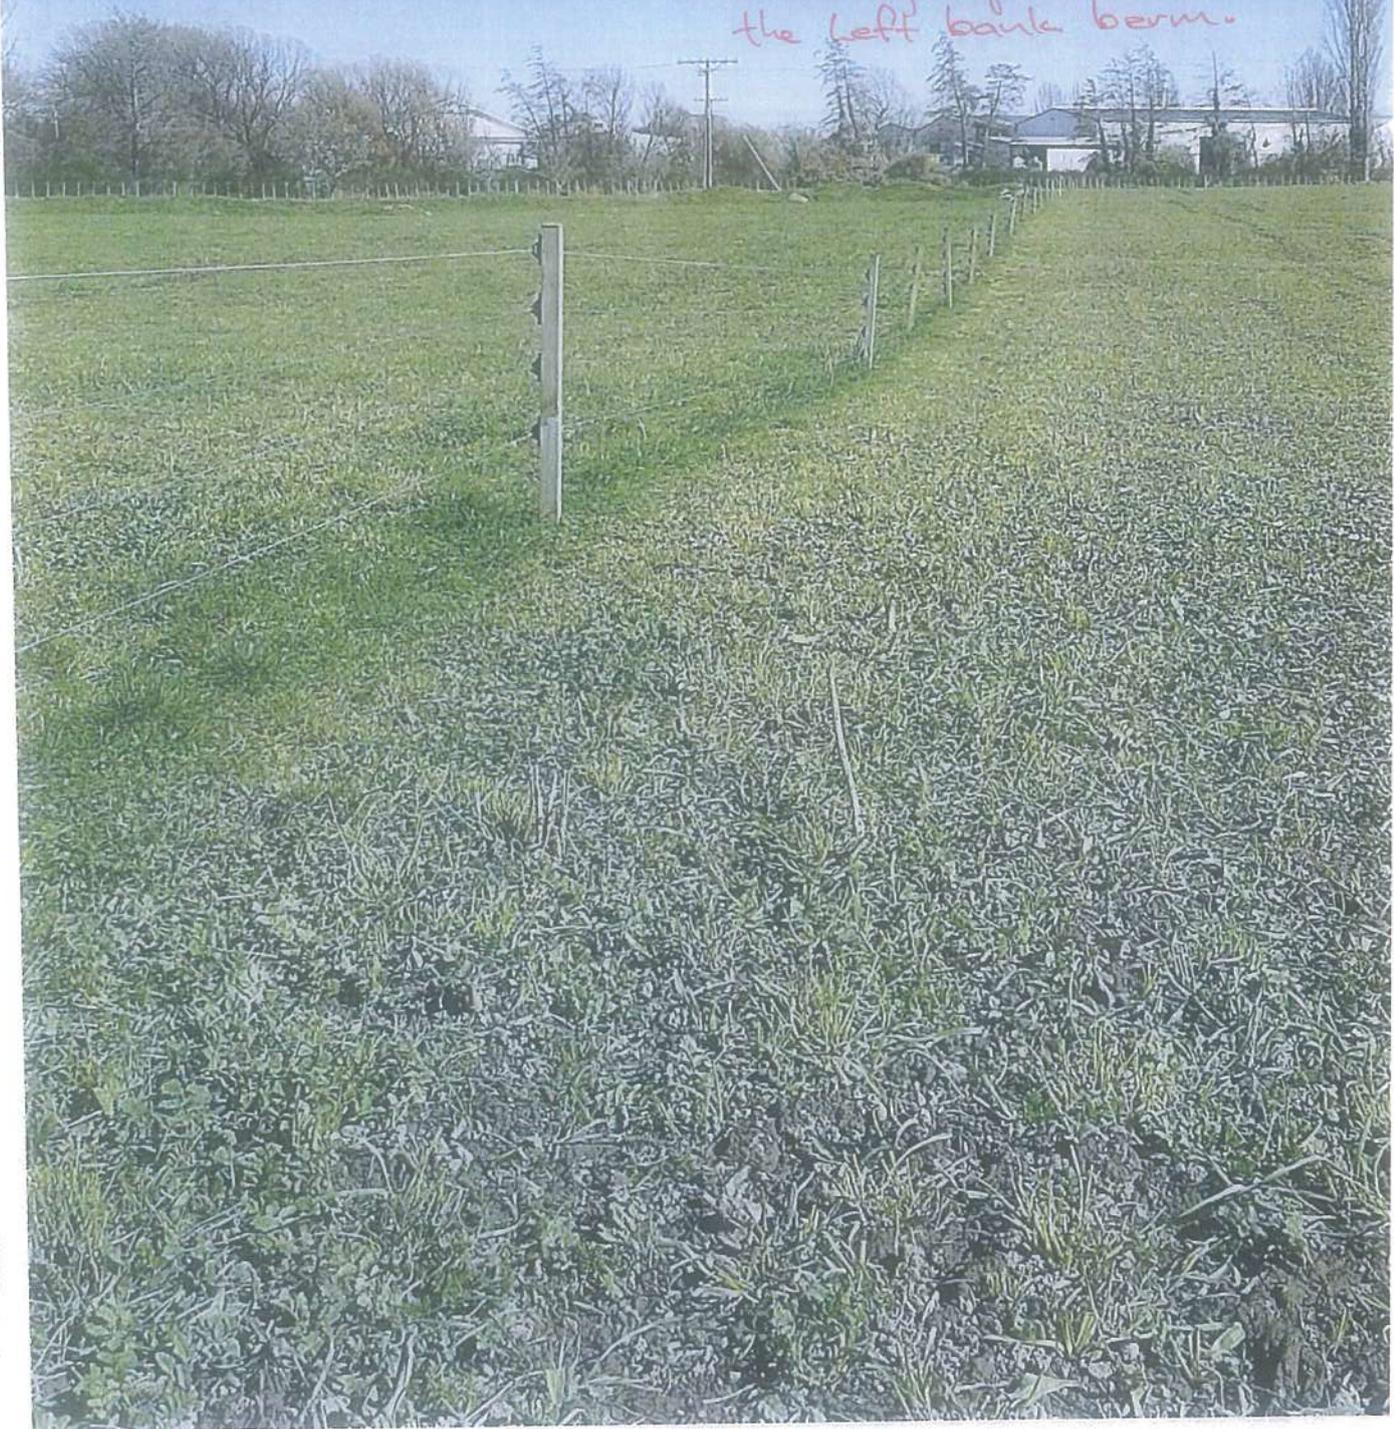
Andrew Donalds Land
just upstream of rail bridge
showing depression back from
the left bank berm.

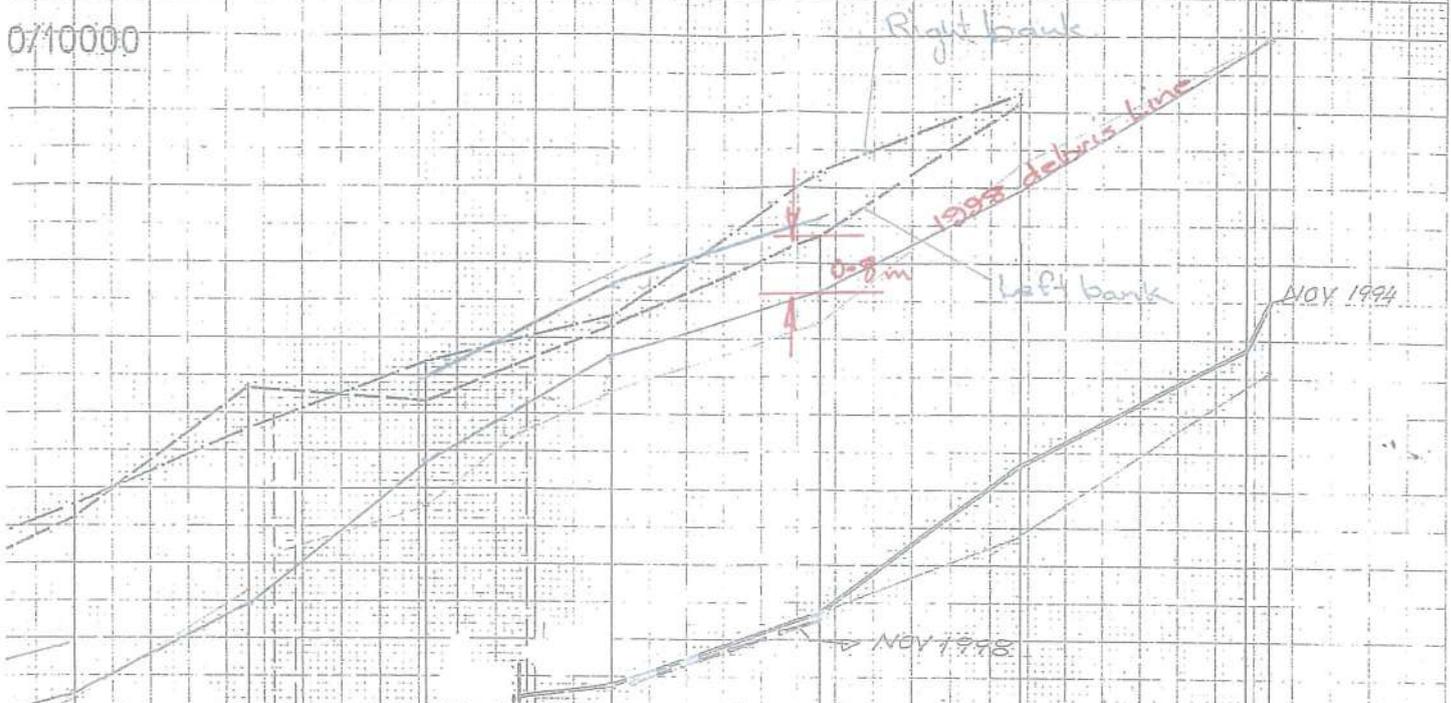
This level surveyed by GW backs up what Mark Hall stated 3 years ago

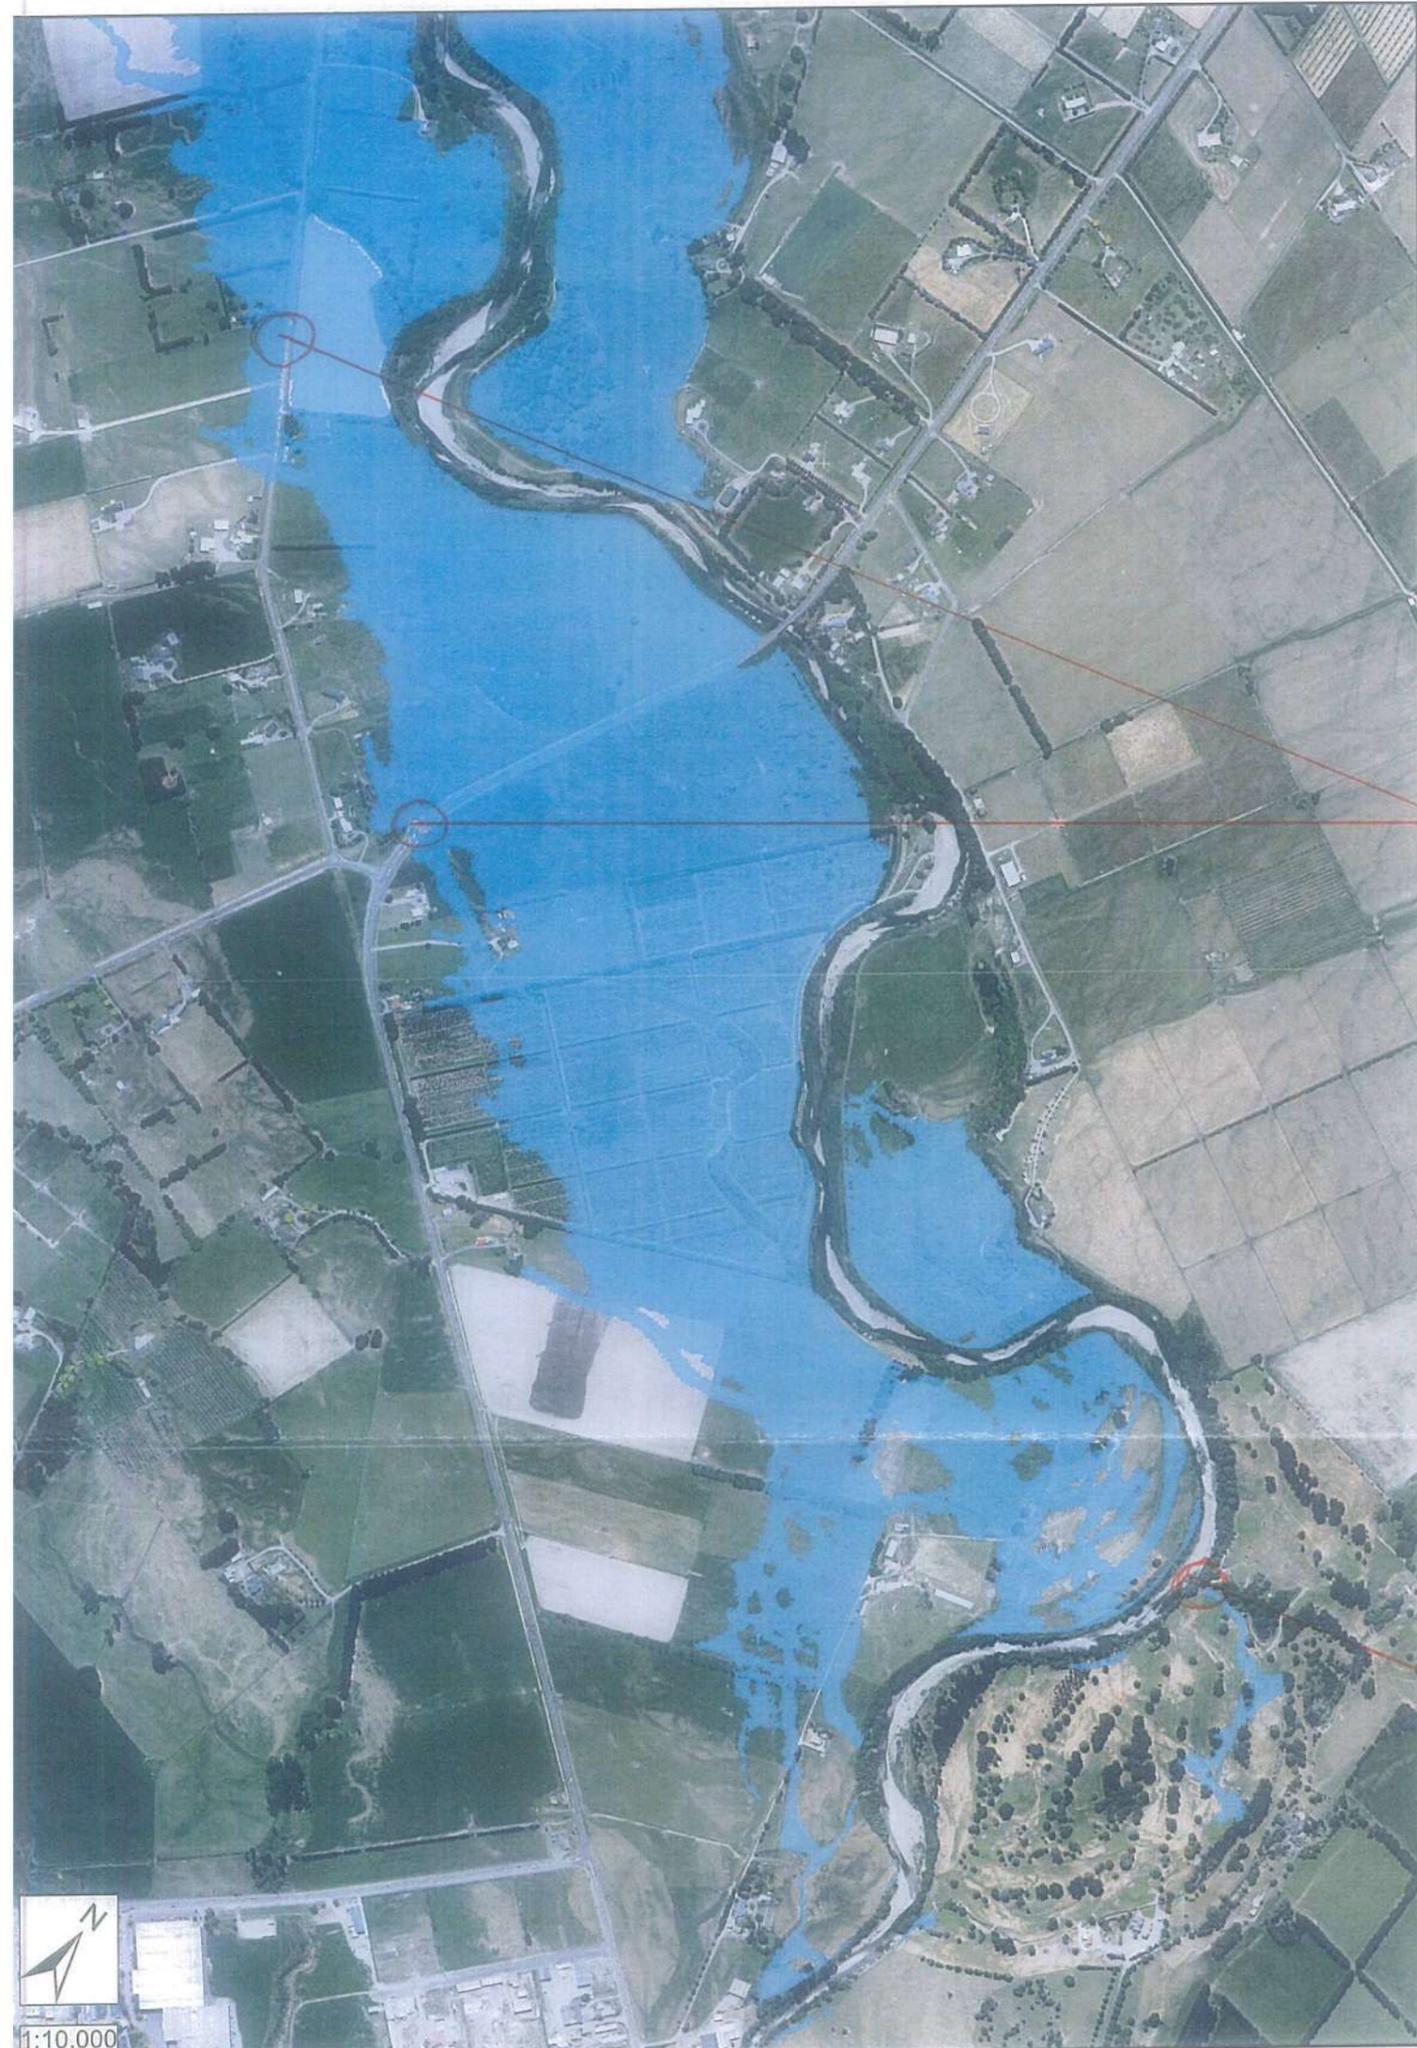
Alec Birch verified this extent of flooding while inspection roads at the time.

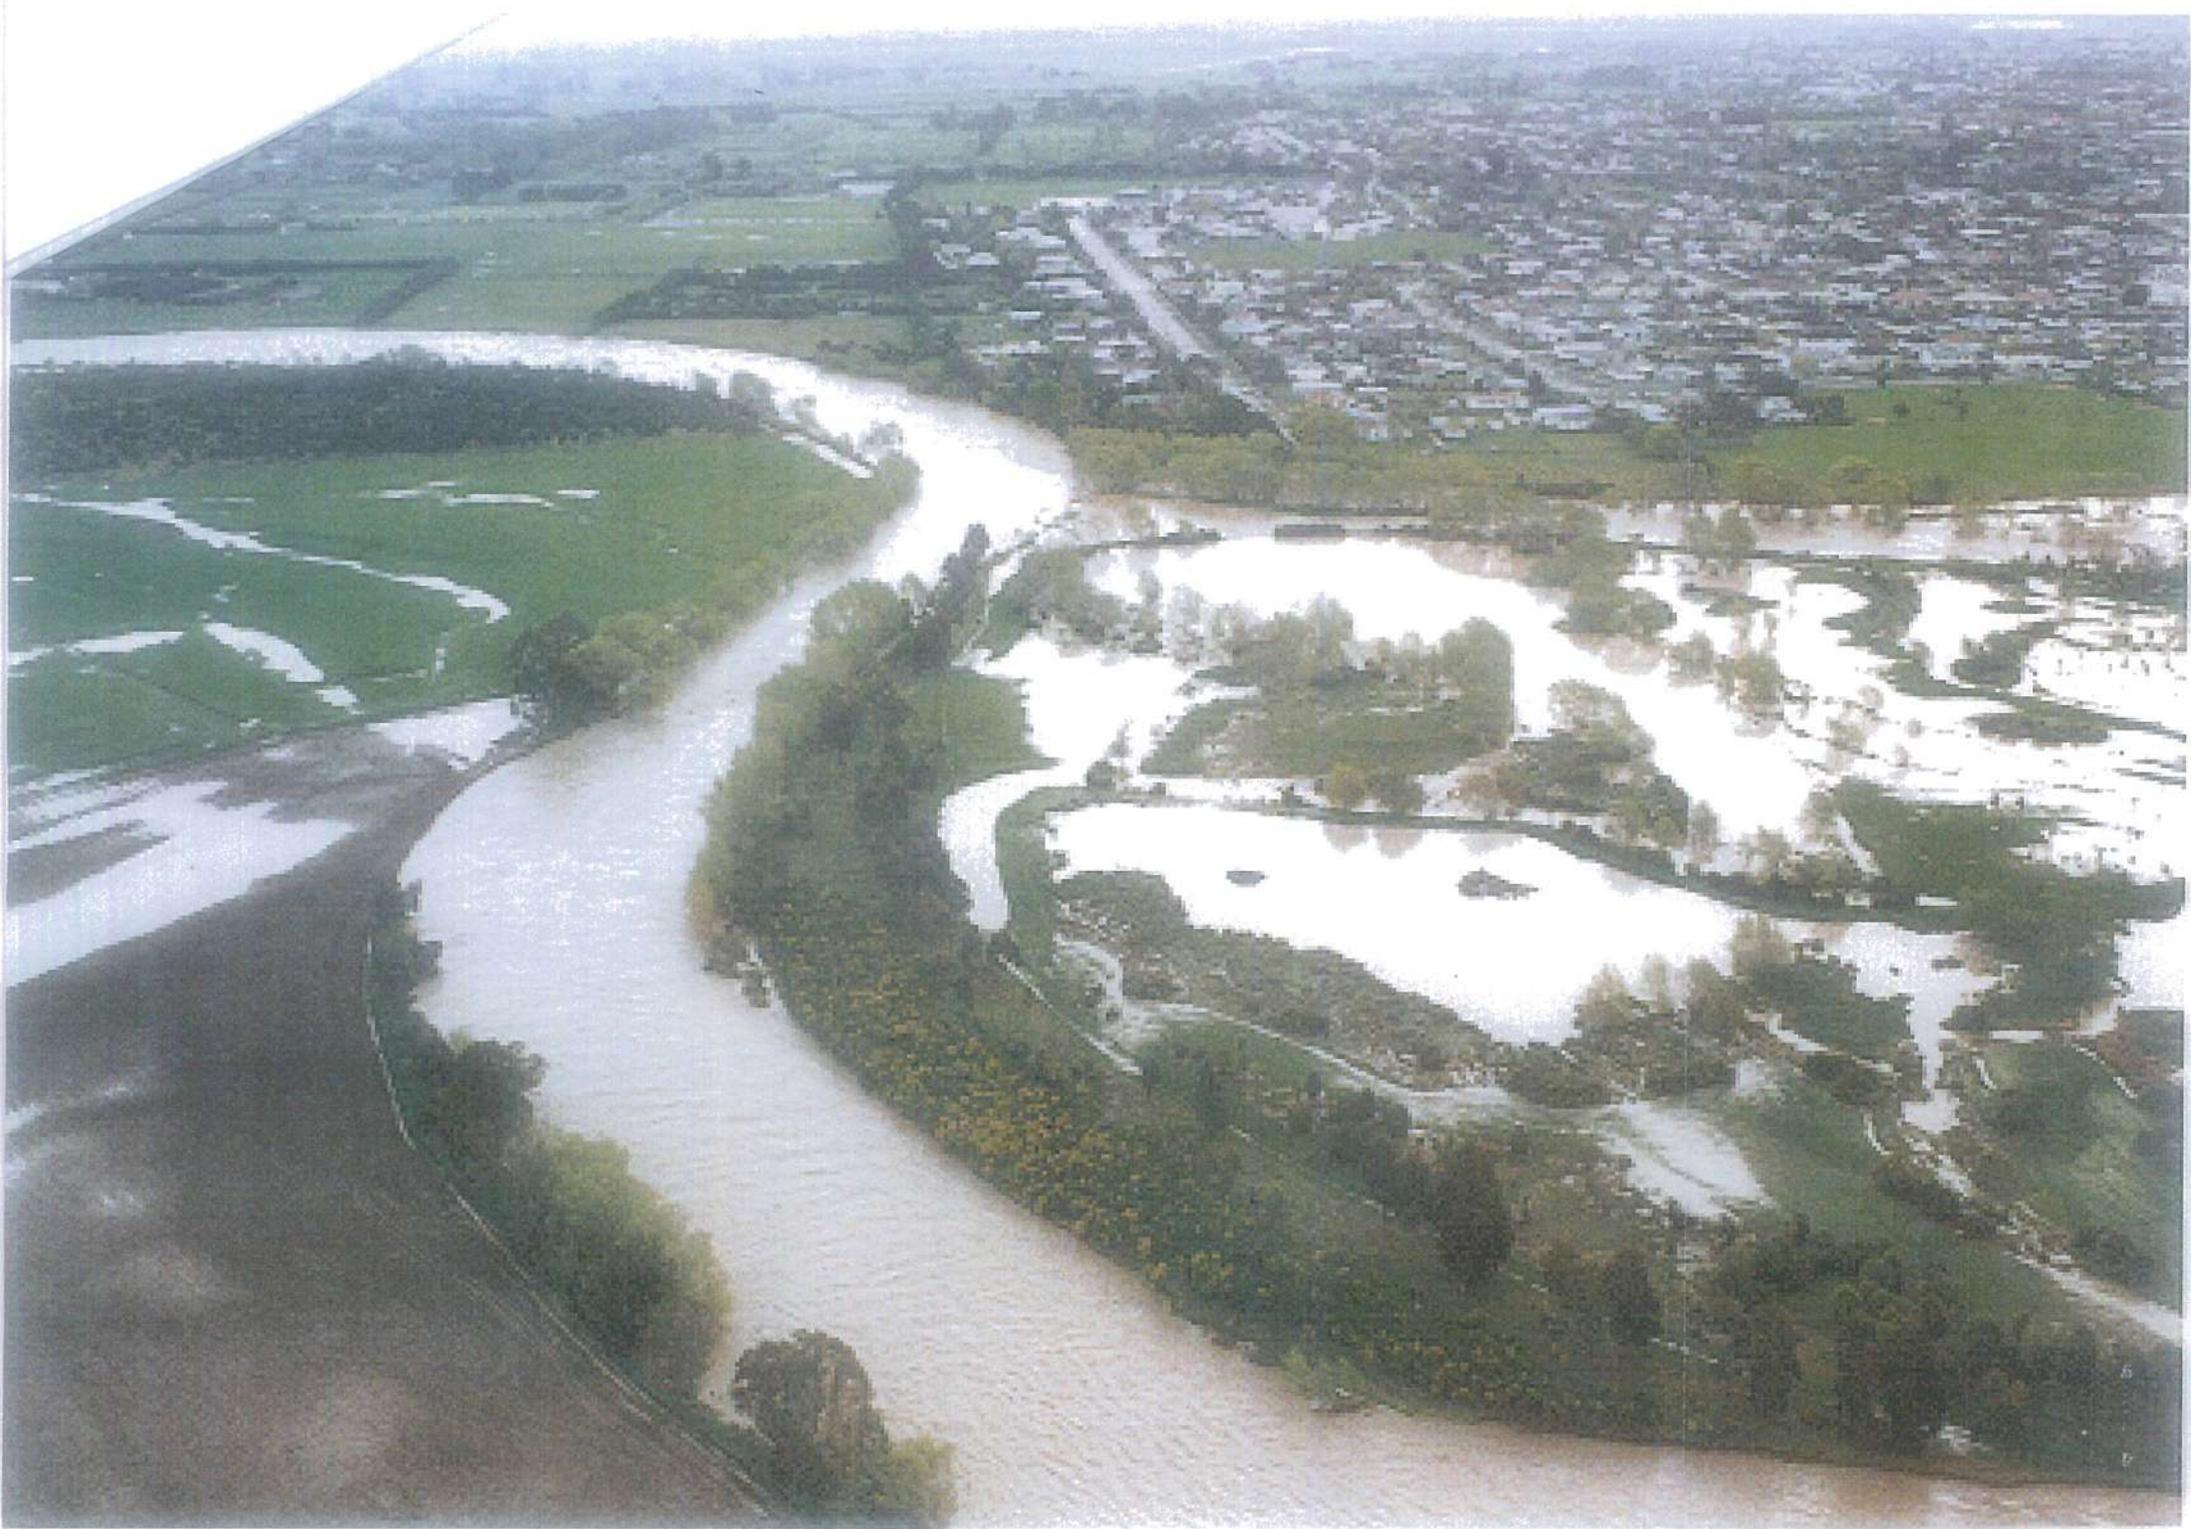
Yes. See attached photo
from Oct. 2000 aerial.
GW flew the 98 flood too late to
record what happened in Masterton.
They managed to record the lower
valley peak.

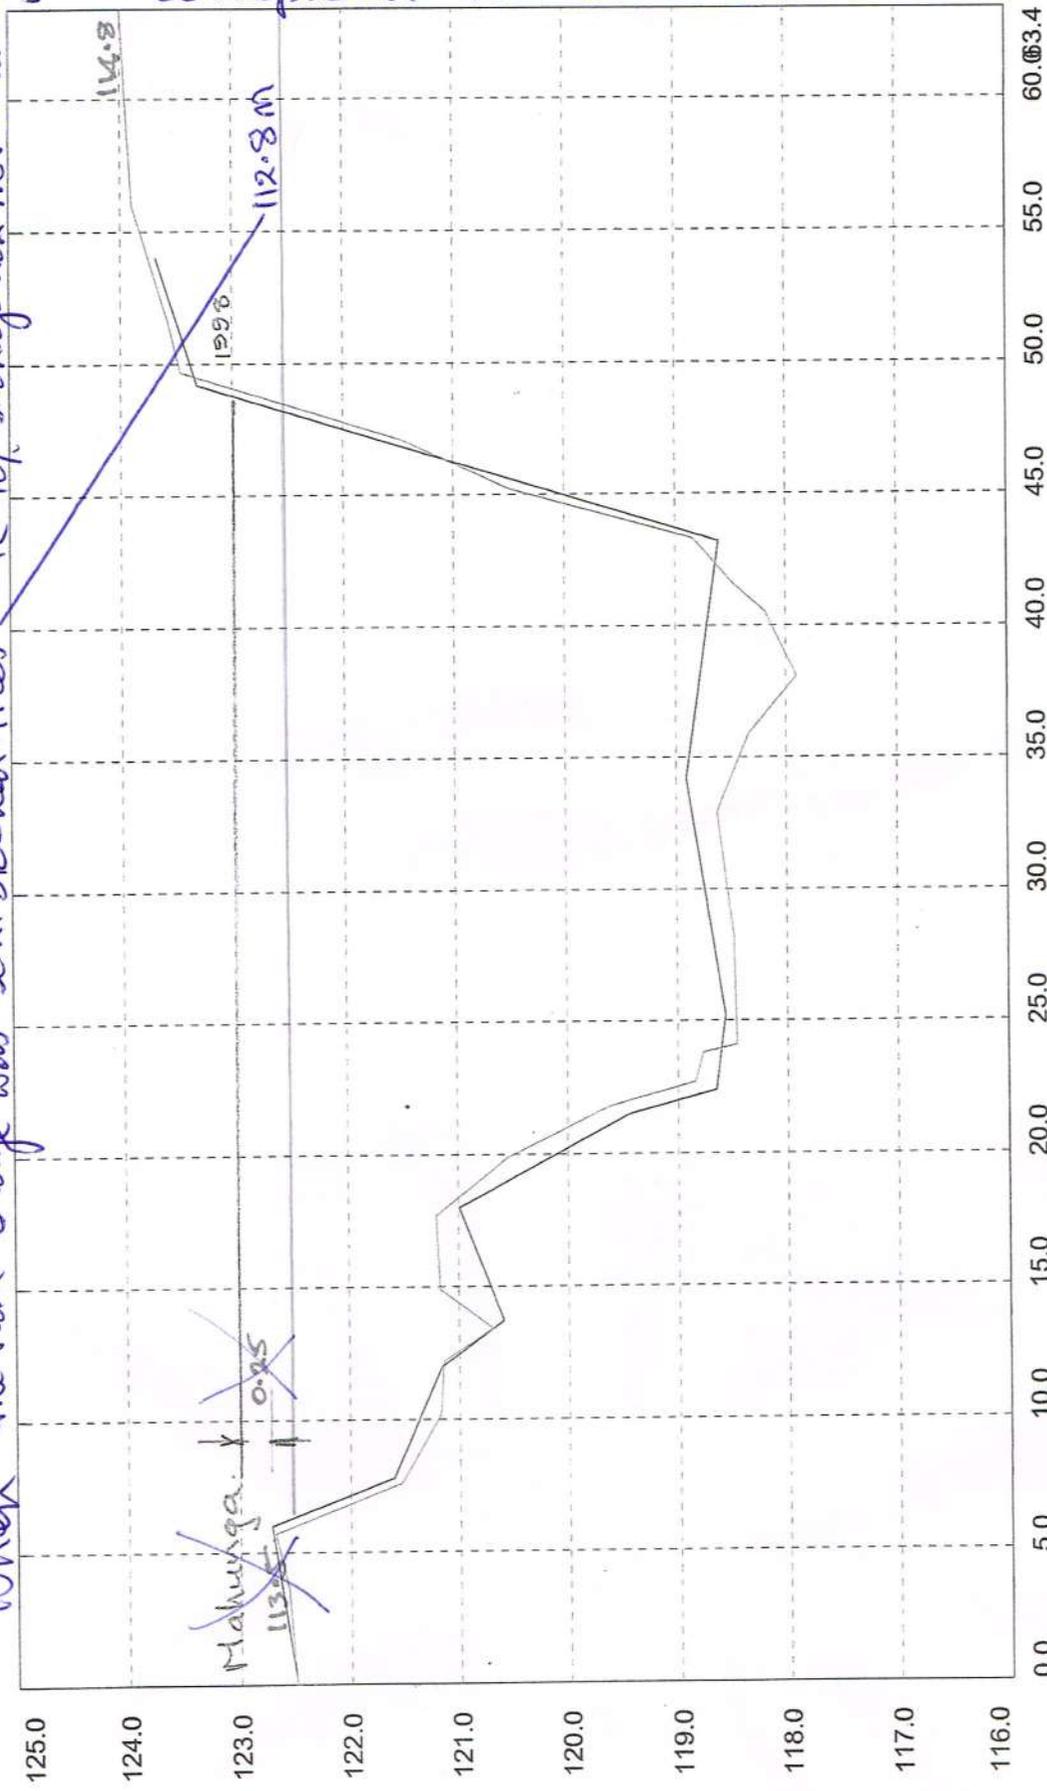
— RL Section at Site 11 on 16-Jan-1995 12:00:00
 - - - RL Section at Site 11 on 24-Aug-2010 12:00:00
