Appendix E Natural Character Index assessment

Natural Character Index (NCI) for Waipoua and Mangatarere Rivers

Report for Greater Wellington

March 2024

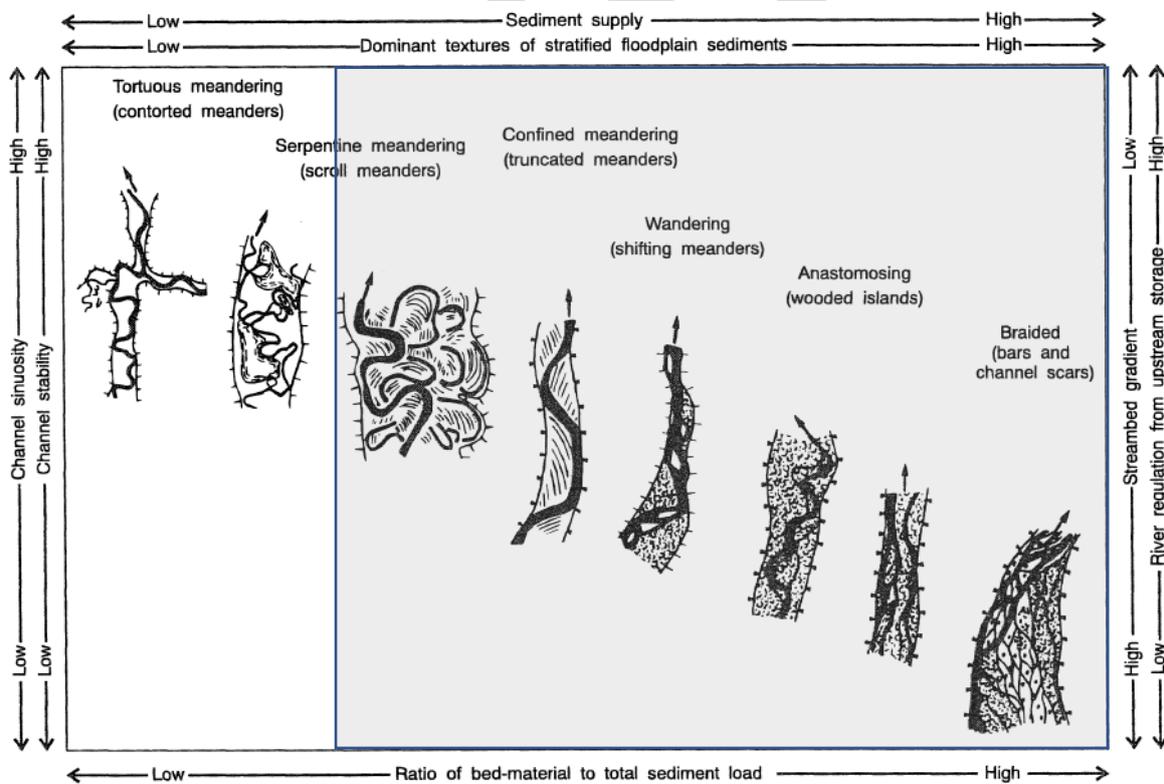
Figure 1. Continuum of river channel types and controlling variables, highlighting the spectrum of gravel-bed river types (shaded), after Mosley (1992).

In undertaking any assessment of river geomorphology, it is important to recognise the range and diversity of river types, which reflect the prevailing controls on channel form at any given reach or segment of any given river. Figure 1 outlines a broad spectrum of New Zealand’s River types and summarises their controls and characteristics. It is important to note that any single river could display the range of these characteristics along its full length, from source to sea/lake. As such, it is also important to take into account catchment characteristics to understand what type of river might be expected at a given location within that catchment (section 1.3).

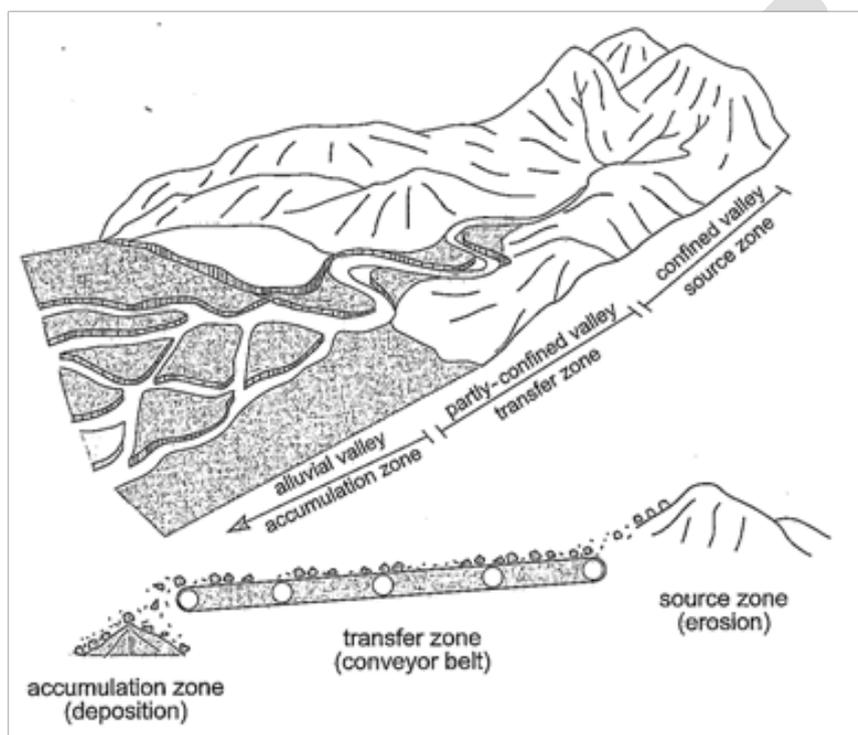
Figure 2. The catchment sediment conveyor (from Brierley & Fryirs, 2005).

Catchment context must be taken into account when assessing river geomorphology. Figure 2 conceptualises the catchment 'sediment conveyor'. The availability of sediment, its supply and transportability in a river (particularly bedload) shapes the channel form (Figure 1). The geomorphology of gravel bed rivers, which describe both the Waipoua and Mangatarere Rivers, reflects the supply, movement, and storage of the river's bedload (sand, gravel, cobbles, boulders), which is sourced from two key areas in the catchment:

- i. Original generation from the source, or production zone, i.e. the catchment headwaters.
- ii. Reworked alluvial deposits that have been originally sourced from the production zone, but temporarily stored in river terrace and floodplain deposits in the transfer zone (Figure 2).

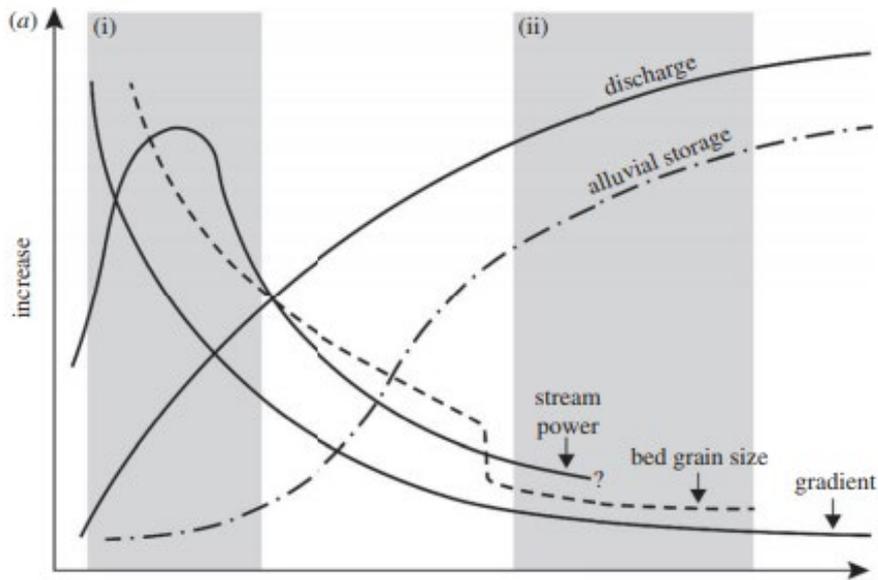
Figure 3. River system attributes in relation to drainage area, the gravel-sand transition is defined as the abrupt change in bed grain size, reflecting critical reduction in gradient and stream power at this point in the catchment (from Macklin et al., 2012).

the catchment sediment cascade is also described as the gravel-sand transition, because downstream from this point, the river is only competent to transport sand size material (Figure 3). This point is not attained in the Waipoua and the Mangatarere Rivers, which transport gravel to their respective end points (Ruamahunga confluence and Waiohine confluence, respectively). As such, the form and behaviour of the Waipoua and the Mangatarere Rivers is best understood in the context of higher-energy transfer zones in their respective catchments.

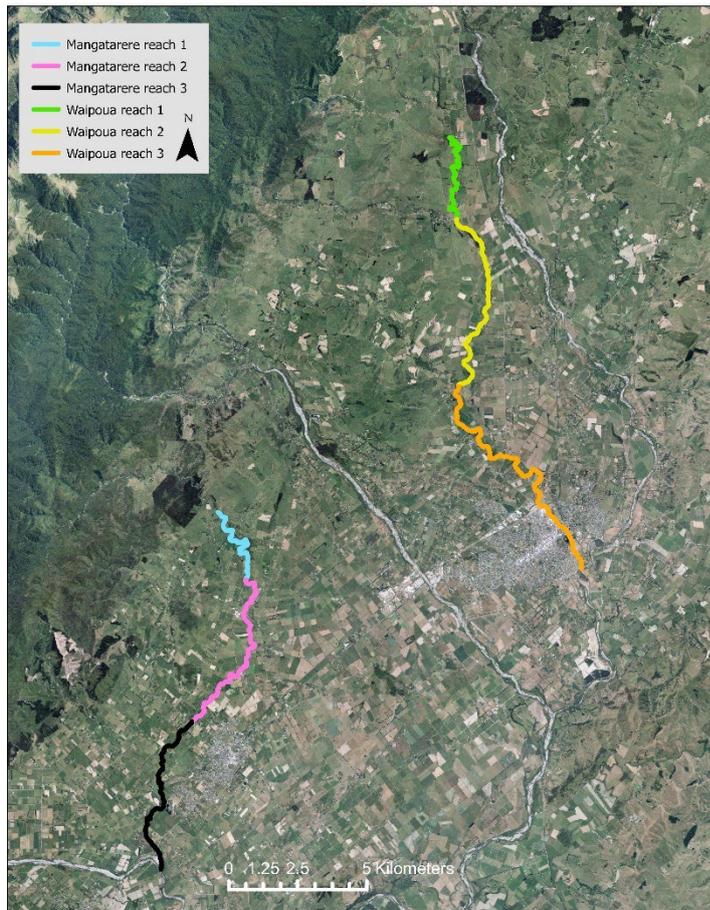
Figure 4. Extents of mapping in the Waipoua and Mangatarere Rivers.

Channel morphology was mapped for the lengths of the Waipoua and Mangatarere Rivers shown in Figure 4. The extent of mapping was intended to cover the length of each river managed under their respective River Control Schemes.

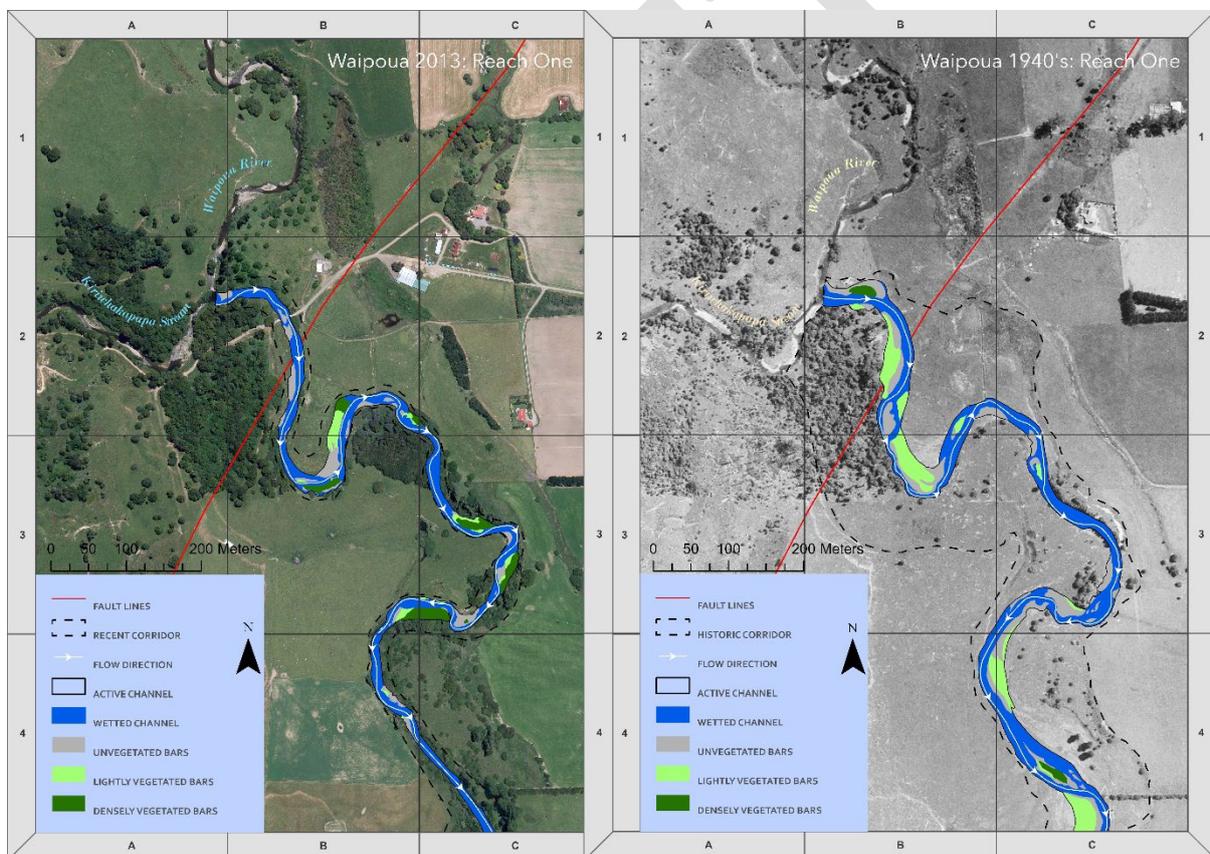
Figure 5: Upper Waipoua geomorphology (Reach 1.0).

The upper Waipoua River (Reach 1, Figures 5-8) has the characteristics of a laterally active, sinuous gravel-bed river, with an insufficient number of medial bars in the 1940s to be classified as partially braided. Bends are evident and well developed and therefore the morphology is consistent with a meandering channel planform. Incision appears to be dominant which is indicated by the various flights of terraces on both sides of the main channel. This makes sense given its relative position upstream from the Wairarapa fault where a change in base level takes place. The overall channel morphology is retained in 2013, but the active channel corridor is narrower, with results showing a 23% reduction in active channel area (Table 1, Figure 38). Some movement has occurred over the 70-year period.

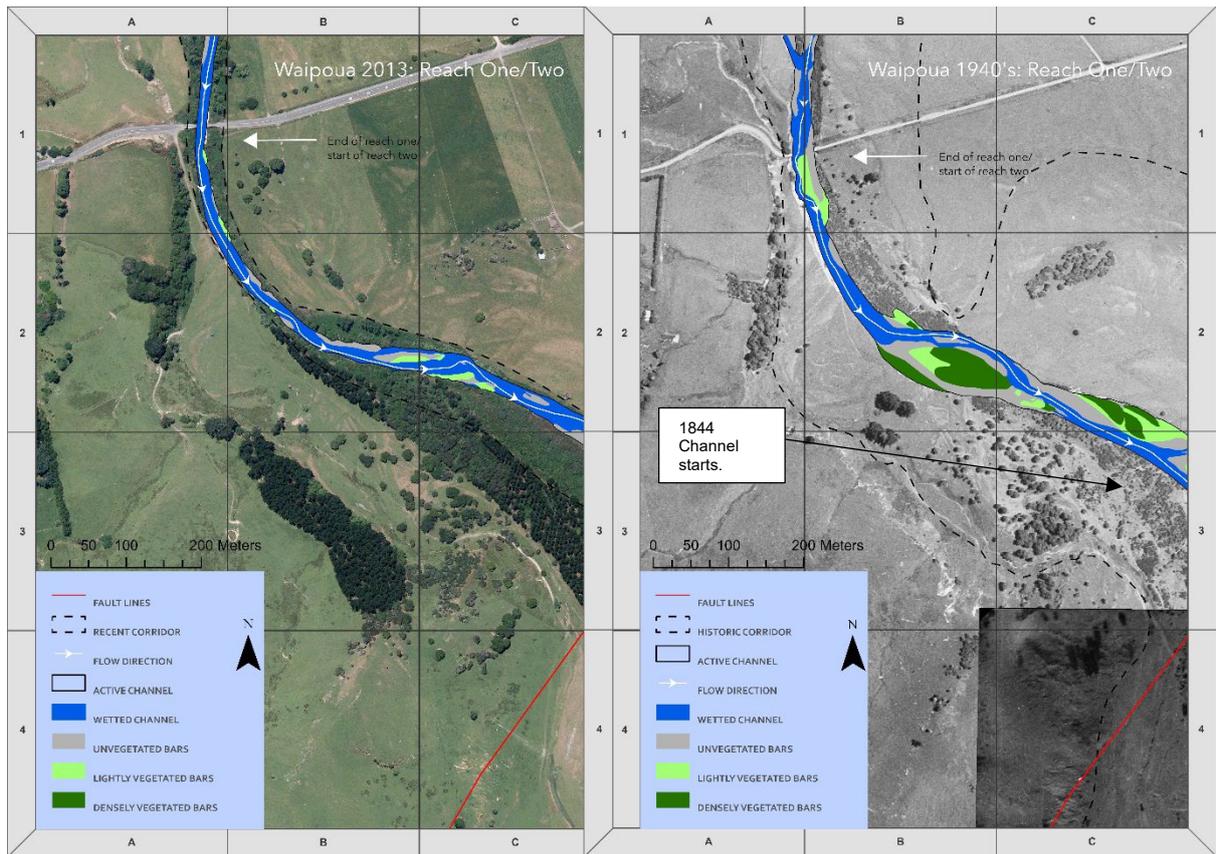
Figure 8: Upper Waipoua geomorphology (Reach 2.0).

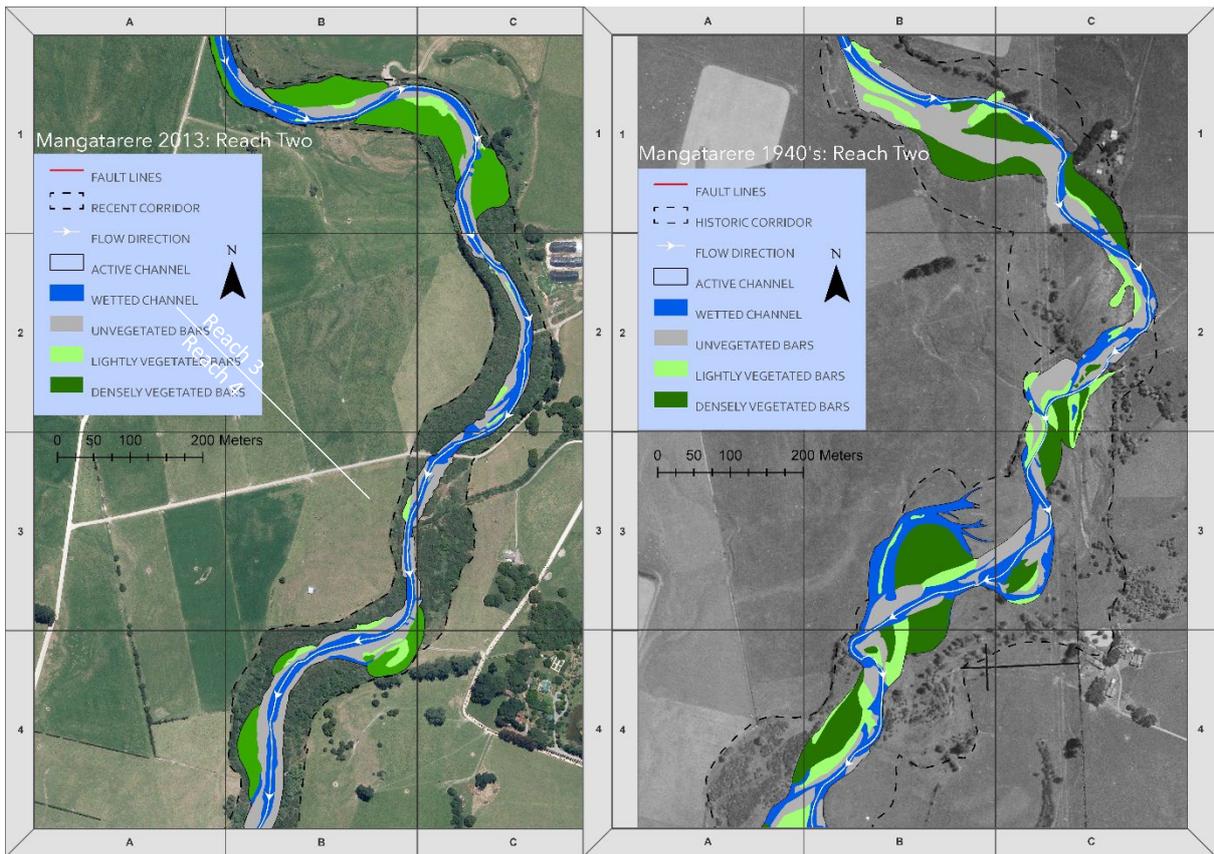
Figure 26. Middle Mangatarere geomorphology (Reach 2.0).

Lightly vegetated bars see a 65% drop while unvegetated bars remain similar - Note that in reach 2, the 2013 imagery shows evidence for recent cross blading (Figures 26, 27, 28). Densely vegetated bars

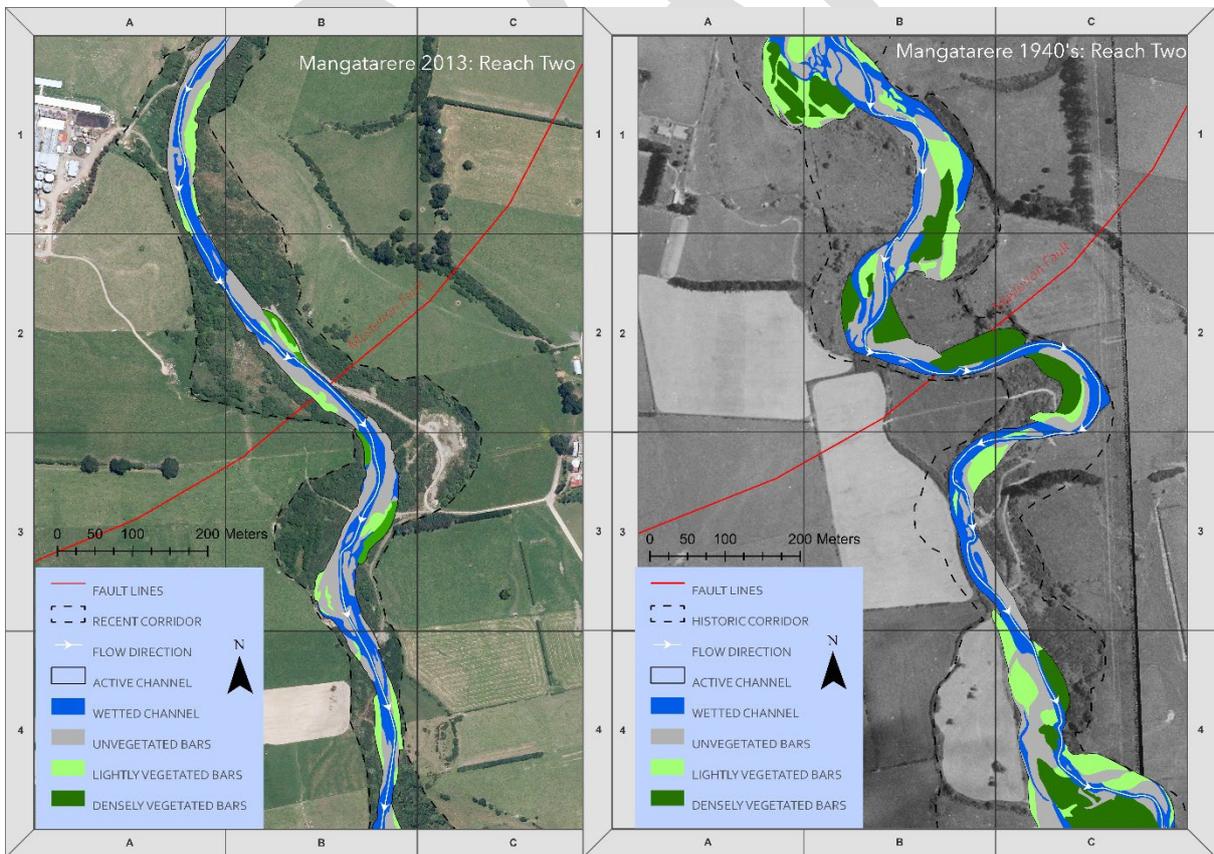
Figure 27. Upper Mangatarere geomorphology (Reach 2.1).

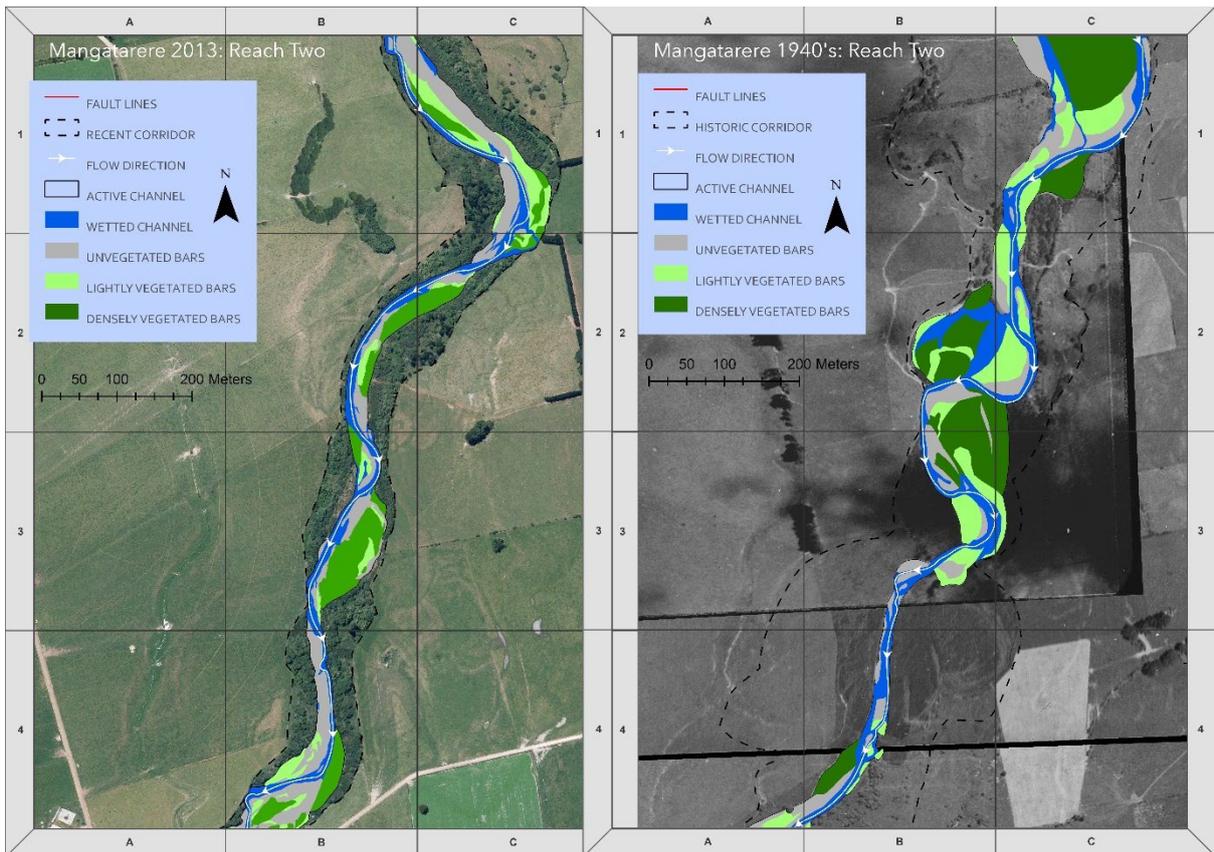
Figure 28. Upper Mangatarere geomorphology (Reach 2.2).

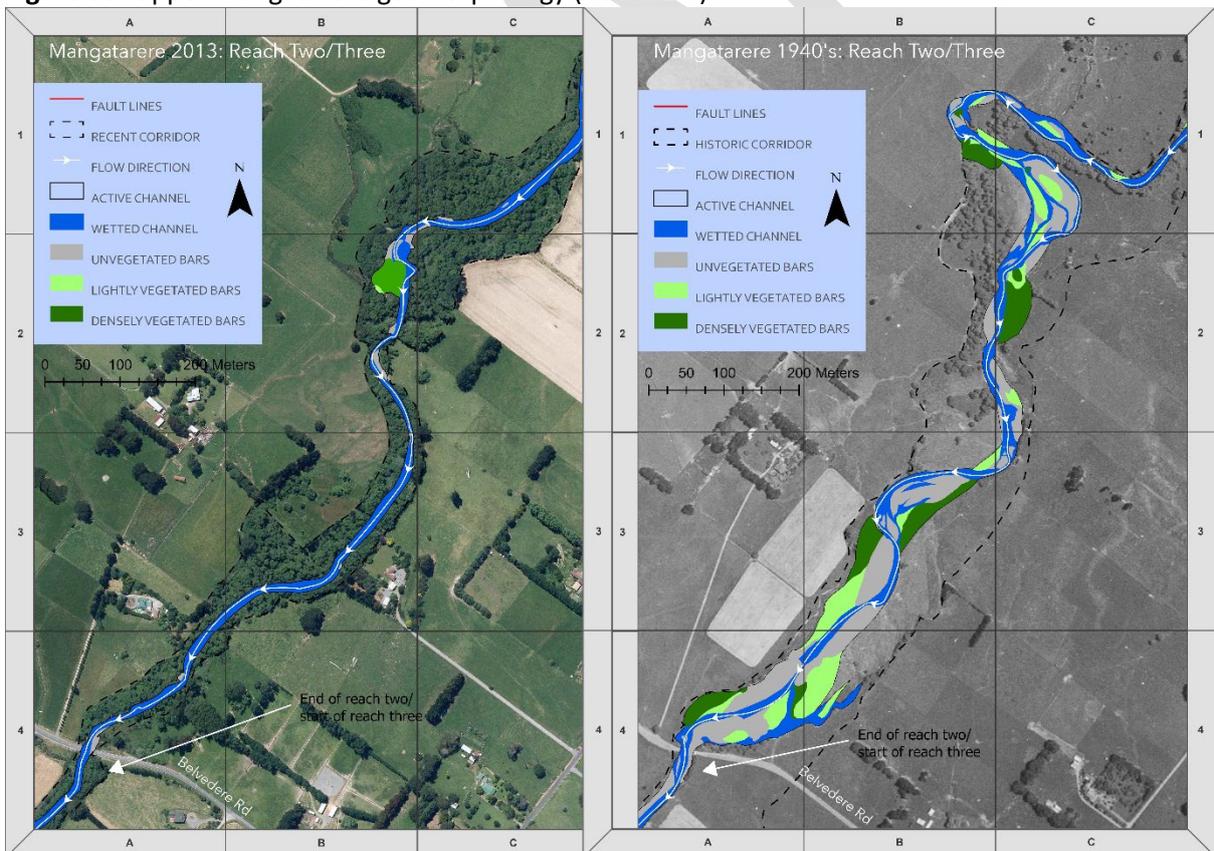
Figure 31. Upper Mangatarere geomorphology (Reach 2.5).

in between small avulsions or channel cutoffs. Reach 2.5 is heavily locked up by vegetation in 2013 while in the 1940's the river was open and somewhat bare towards belvedere bridge (Figure 31). Back waters here suggest that the river had recently occupied the true left. All parameters have dropped by 2013, with a 65% drop in lightly vegetated bars being the most significant. Unvegetated bars remain similar, but it should be noted that the 2013 imagery shows evidence for recent cross blading which likely exposed more gravel. Densely vegetated bars have dropped by 36%, but this does not mean that there is necessarily more vegetation in the 1940's as the active channel area has dropped by 24% (Table 6, Figure 46).

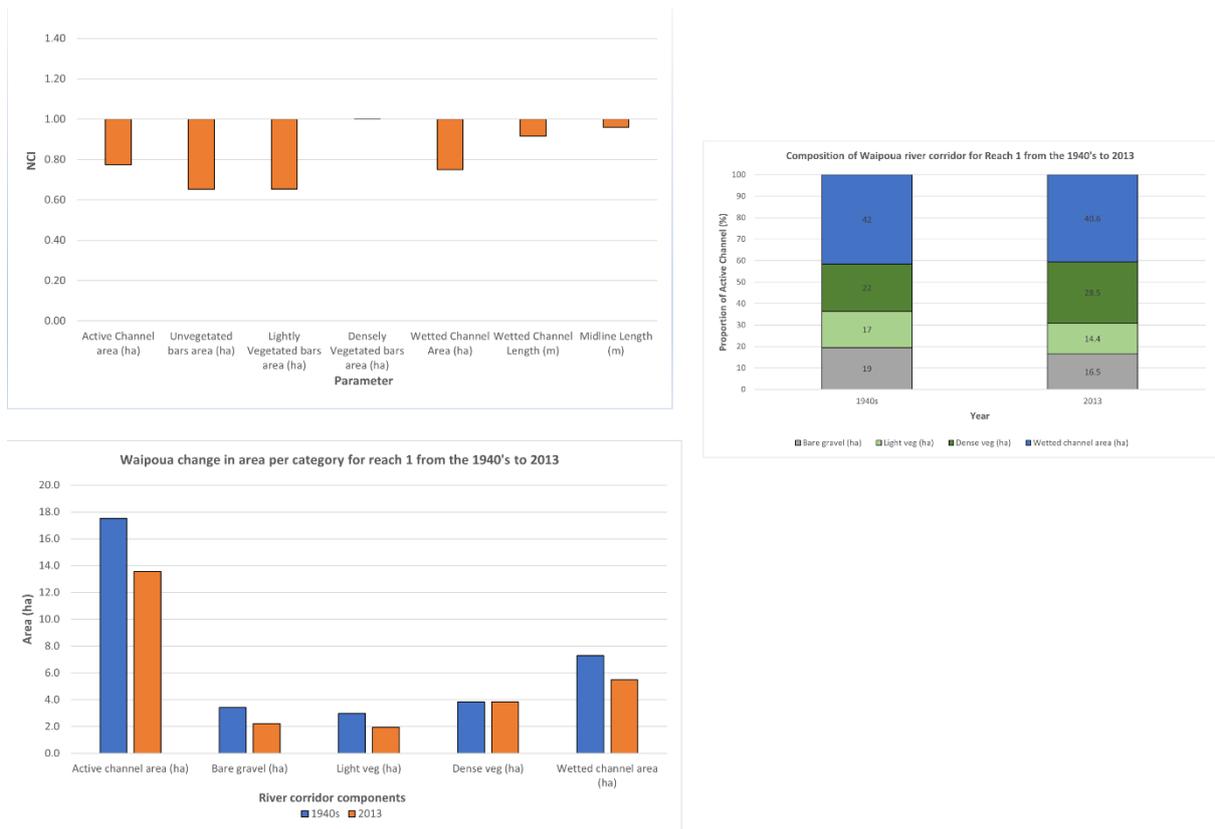
Figure 38. Summary of changes in channel characteristics (NCI, areas and composition) in the Waipoua river in reach one 1940s – 2013.

Reach one indicates a 23% reduction in the active channel, a 35% reduction in unvegetated bars, and a 35% reduction in lightly vegetated bars. Wetted channel area has dropped by 25% and wetted channel length by 8%. Densely vegetated bars remain the same (**Table 1, figure 38**).

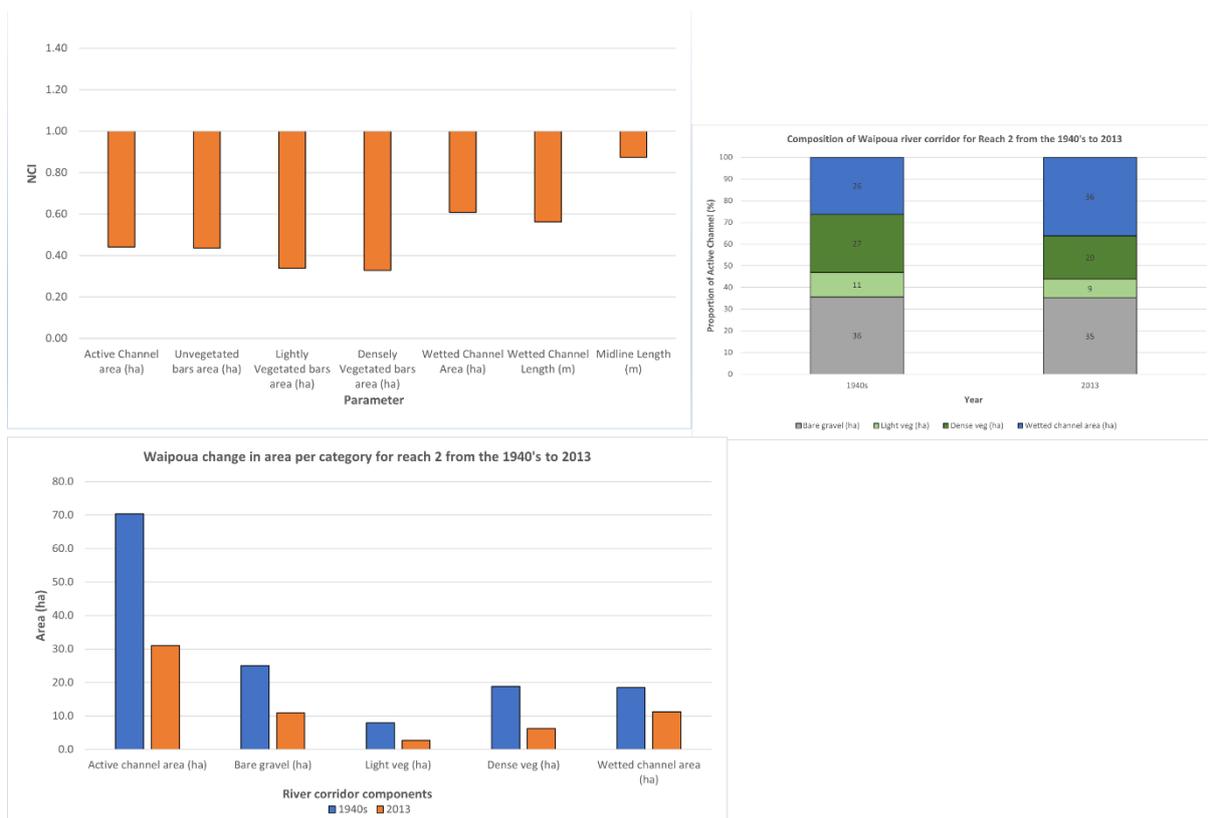
Figure 39. Summary of changes in channel characteristics (NCI, areas and composition) in the Waipoua river in reach two 1940s – 2013.

In reach two, there is a 56% reduction in the active channel area, a 56% reduction in unvegetated bars (bare gravel), a 66% reduction in lightly vegetated bars, a 67% reduction in densely vegetated bars, a 39% reduction in wetted channel area, and a 13% reduction in midline length (Table 2, Figure 39).

Reach 2 in 2013 is entirely different from that of the 1940s, where the 1940s channel displays characteristics of a laterally active wandering planform. Channel bifurcation is dominant in the 1940's, excluding the transition between reach one and two (Figure 8) where the Waipoua crosses the Wairarapa Fault scarp. There is an abundance of backwaters, medial bars, cutoffs, and local flow division. Of note, it appears that the 1884 channel at the start of reach 2 was positioned further to the true right (Figure 8), before re-entering into its original channel (Figure 11). The morphology of the 1884 channel is consistent with a meandering planform with a diverse array of backwaters and paleo channels which is evident by the preservation of geomorphic units. There is no evidence in the DEM to suggest that migration into the 1940s channel was gradual, rather, it appears to have avulsed. It has not been established when this occurred. This reach is classified as partially braided which is consistent with the transition across the Wairarapa fault, enhanced sediment supply following the 1855 earthquake, and a flood rich phase. Reach 2 displays characteristics of a nearly straight river in 2013, with little to no bends nor braiding in reach 2.1-2.2 (Figures 9-10). The overall river in 2013 shows a 56% reduction in both active channel area, unvegetated bars and a 66% reduction in lightly vegetated bars including a very significant drop in all other parameters (Table 2, Figure 39).

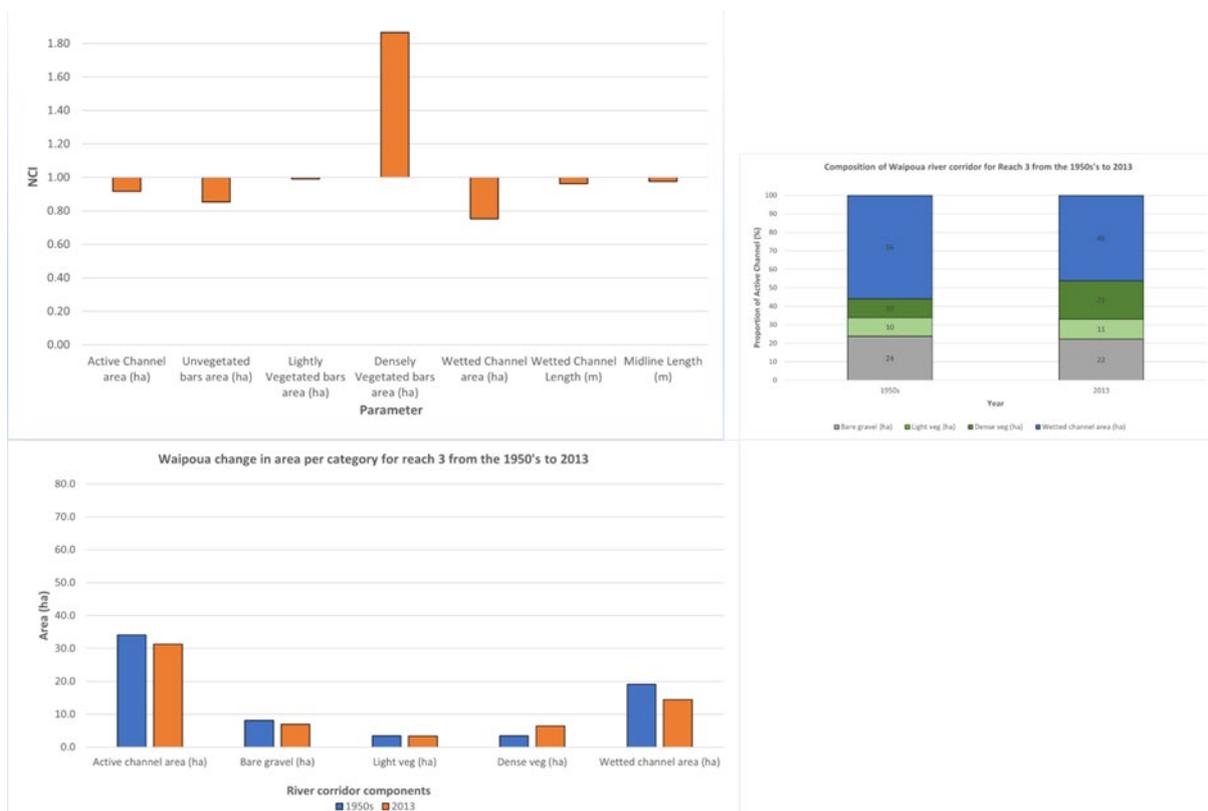
Figure 40. Summary of changes in channel characteristics (NCI, areas and composition) in the Waipoua river in reach three 1950s – 2013.

Densley vegetated bars show a significant increase in 2013 vs 1950, with an 87 % gain in dense vegetation. Wetted channel length has decreased by 25%, and unvegetated bars (bare gravel) has decreased by 15% (Table 3, Figure 40).

Reach 3 displays little change between the 1950's and 2013. While reach 3 is not classified as braided not meandering, it falls closest to meandering. The first three quarters of reach 3 from Wakamoekau Creek is laterally active and contains some well-developed bends. Paleo channels adjacent to the main channel suggest that this reach has actively meandered and wandered over recent centuries. The reach from the Masterton railway bridge the Ruamahunga confluence is nearly straight in both sets of imagery, although some bend development is evident ~250 metres upstream of the confluence in the 1950's. Nevertheless, densely vegetated bars have increased by 87% and unvegetated bars have dropped by 15% (Table 3, Figure 40).

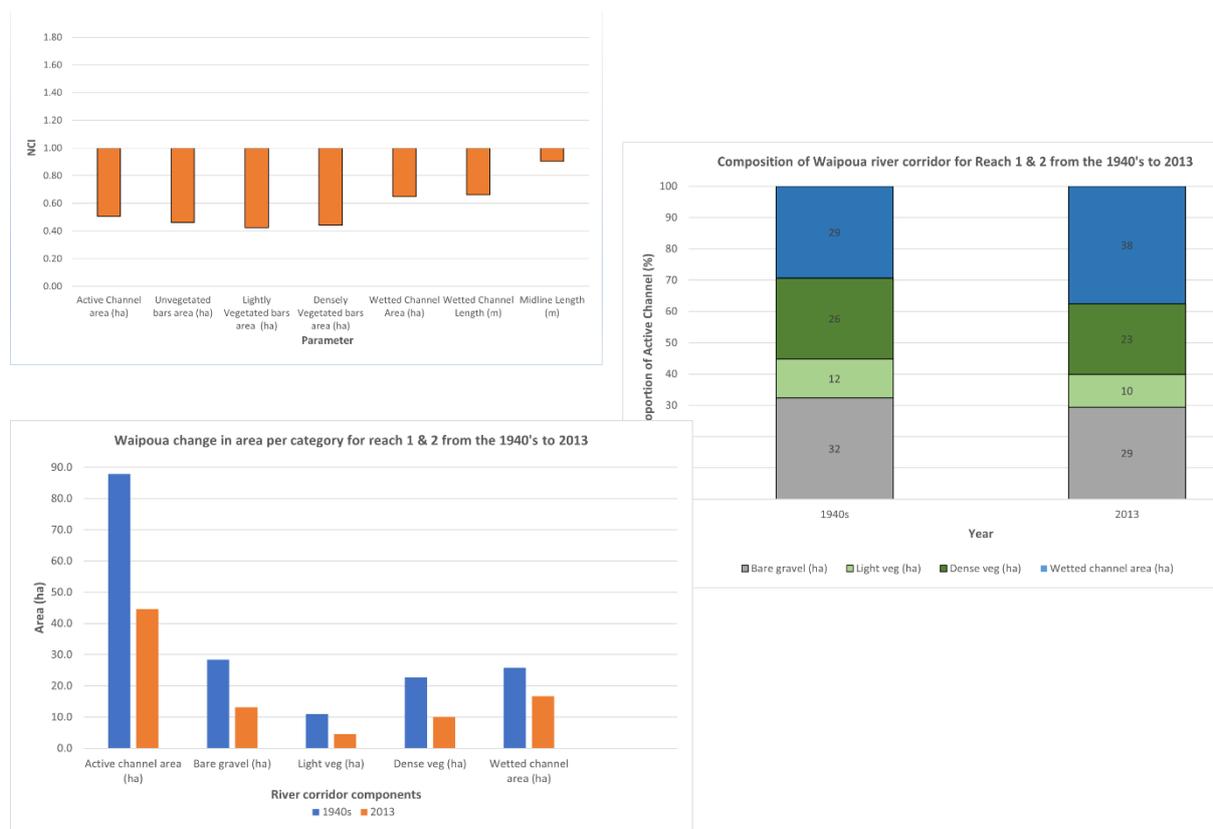
Figure 41. Summary of changes in channel characteristics (NCI, areas and composition) in the Waipoua river in reach one and two 1940s – 2013.

The most significant changes in the Waipoua river corridor in reach one and two combined are a 49% reduction in active channel area, a 58% reduction in unvegetated bars bar (bare gravel), and a 56% reduction in densely vegetated bars. Wetted channel area has reduced by 35% and midline length by 34% (Table 4, Figure 41).

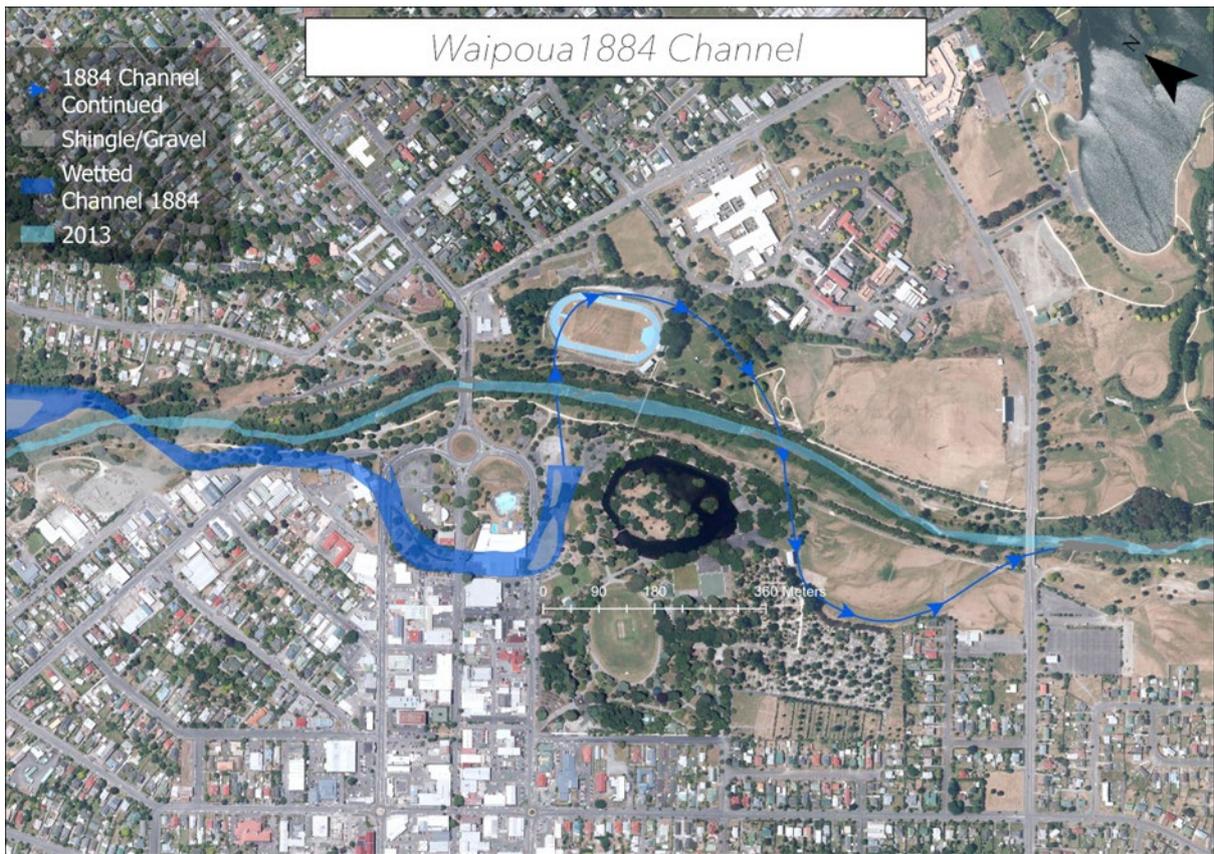
Figure 42. The 1884 river channel with the 2013 channel overlaying.

We were able to establish a sinuosity value for the stretch of river from Bentley Street to the Colombo Road bridge just above the Ruamahunga confluence (Figure 42). Sinuosity values align with what is observed according to interpretation of the 1880s maps which show the morphology of a meandering river in the 19th century where extracted sinuosity values = 1.5 (meandering), while in 2013 sinuosity = 1.0 (straight). Meandering morphology is observed in the 1883 channel where the settlers have attempted to push the river back towards the train bridge to stop it out flanking the train bridge run up on the true right (Figure 43), therefore the river type may have been stable. Following the 1884 flood, the river shows a completely different wandering morphology conjunctive with aggradation and channel expansion. Very large fluvial deposits are present, as is channel bifurcation and avulsions on both the true left and right of the prior channel. Given the 1884 and 1886 map are in the same scale, overlap, and are only two years apart, it is not unreasonable to conclude that channel adjustment and expansion continued for quite some time following the 1884 flood (Figure 44). It is likely that the 1884 flood in combination with enhanced sediment supply from the 1855 earthquake led to a breach in threshold conditions to allow for a different river type to form quite rapidly. This may have been through the single 1884 flood event and/or for the following years until 1886 and onwards given the 19th century is known to have been a flood rich phase in the Manawatu/Wairarapa (Fuller et al., 2018).

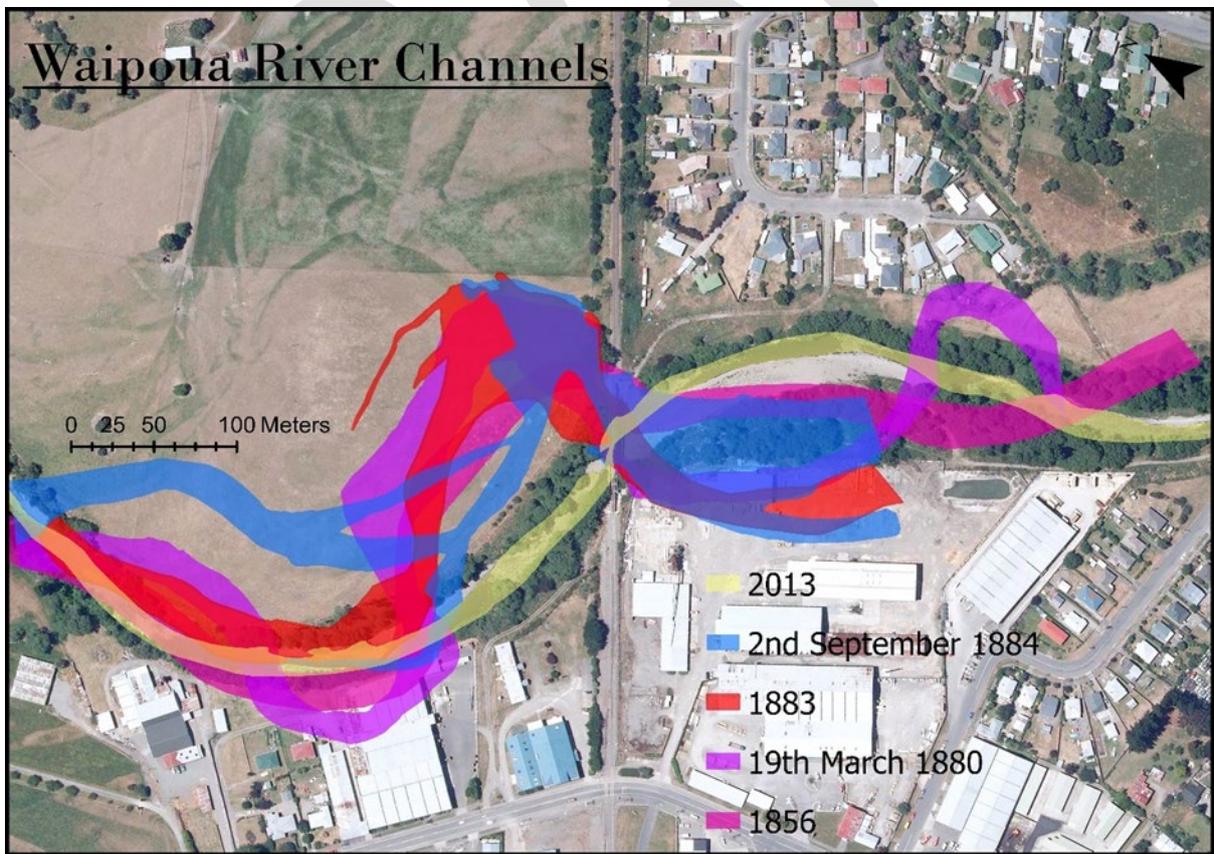
Figure 43. Multiple dates showing the location of the Waipoua's channels at the Masterton railway bridge.

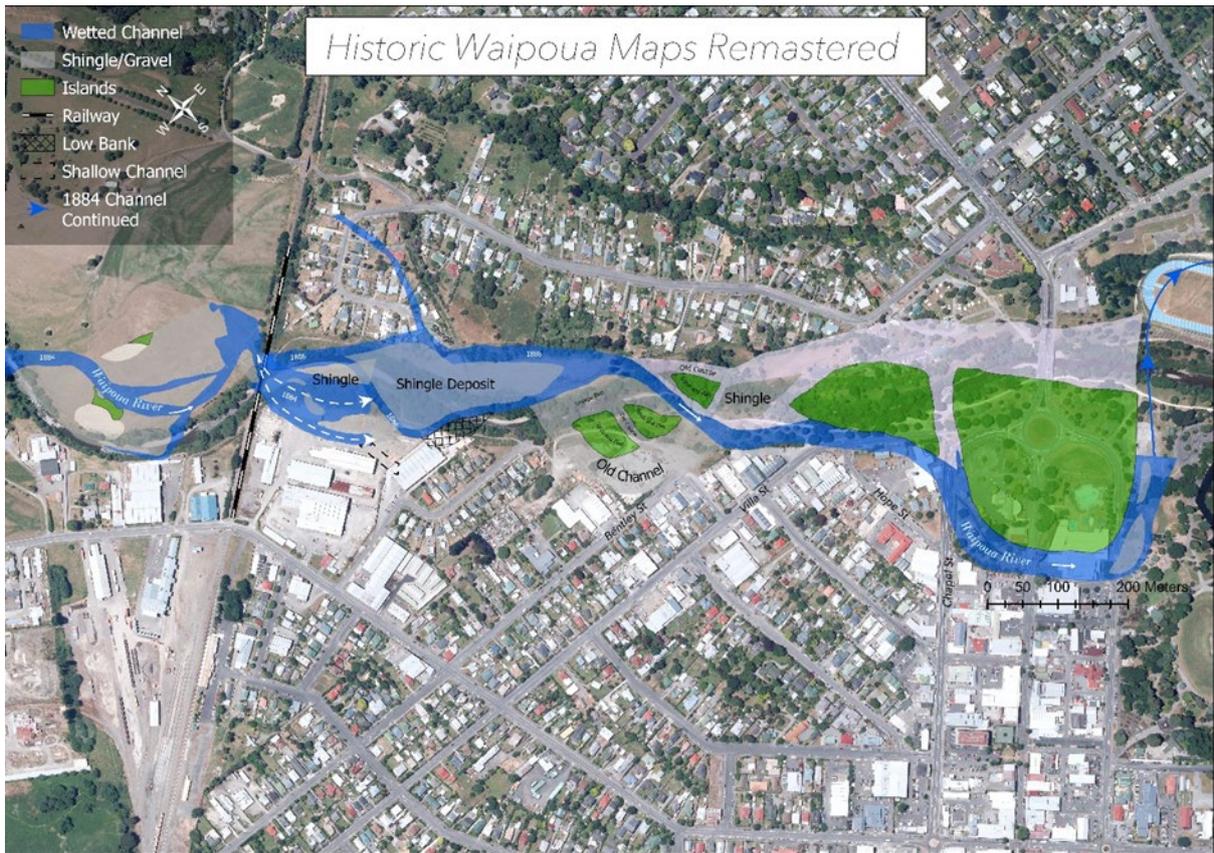
Figure 44. The 1884 channel fitted with the 1886 channel.

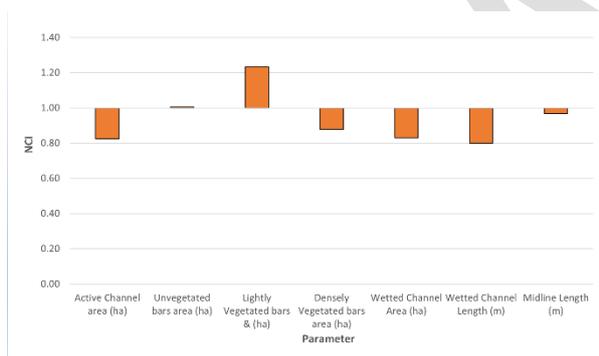
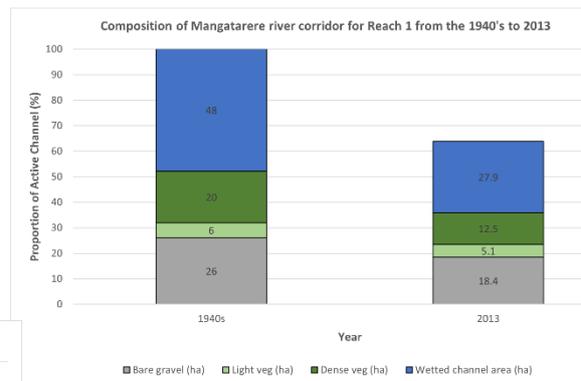
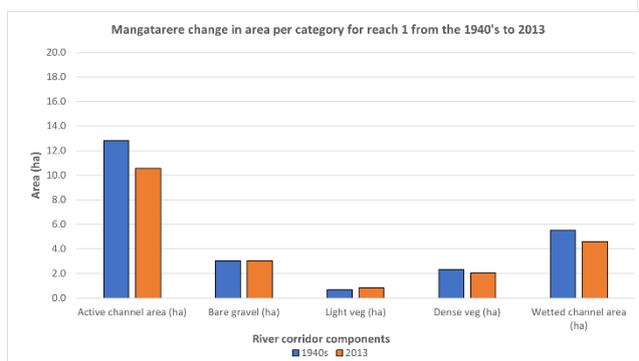
Figure 45. Summary of changes in channel characteristics (NCI, areas and composition) in the Mangatarere for reach 1, 1940s – 2013.

Overall, there is a drop in most parameters, notably a 17% drop in both active channel area and wetted channel area. Channel length is 20% shorter, and densely vegetated bars by 12%. Midline length and unvegetated bars remain the same. There is a 23% increase in lightly vegetated bars.

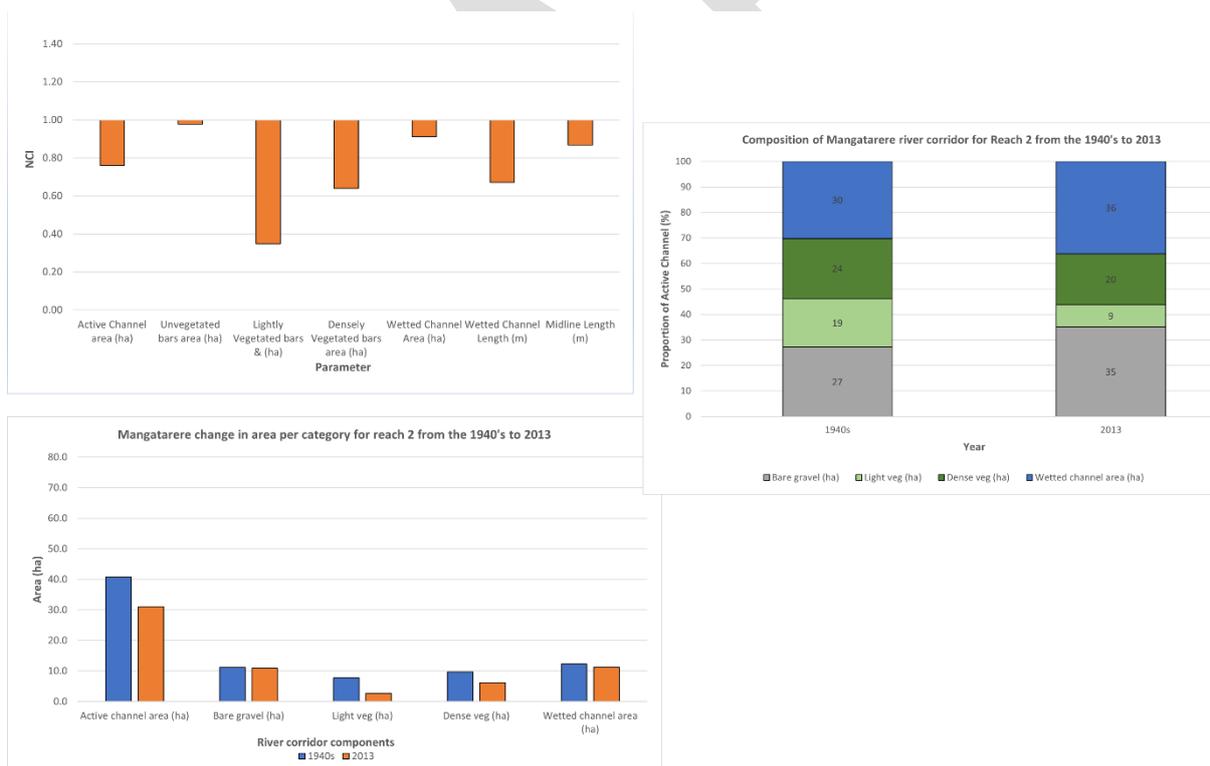
Figure 46. Summary of changes in channel characteristics (NCI, areas and composition) in the Mangatarere for reach 2, 1940's – 2013.

have dropped by 36%, wetted channel area by 33%, active channel area by 24%, midline length by 13%, and wetted channel area the least, by 9% (Table 6, Figure 46).

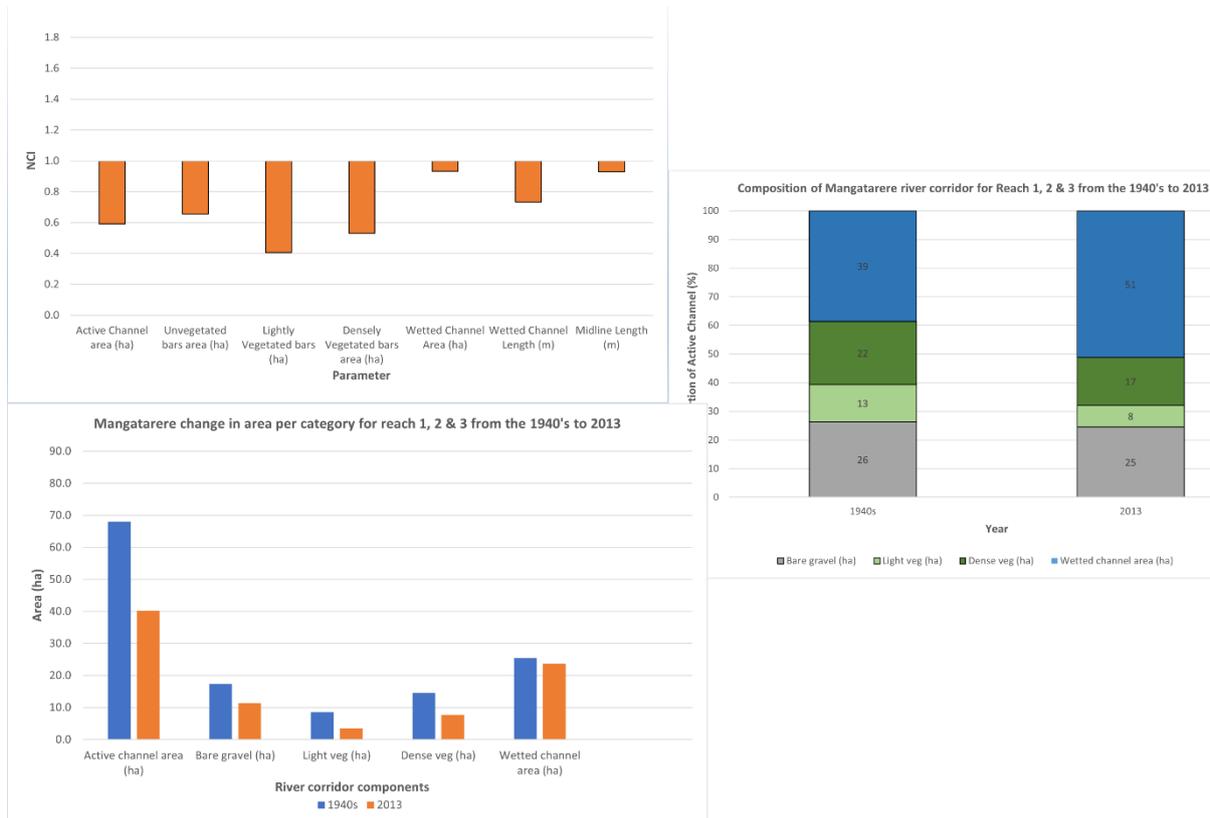
Figure 49. Summary of changes in channel characteristics (NCI, areas and composition) in the Mangatarere for reach 1, 2, 3 , 1940s – 2013.

Overall, there is a 40% reduction in the active channel, a 59% reduction in lightly vegetated bars, a 47% decrease in densely vegetated bars, a 34% drop in unvegetated bars, and a 27% decrease in wetted channel length, a 7% drop in both midline length and wetted channel area.
