Shelly Bay Development

Preliminary Geotechnical Assessment Report

Client: The Wellington Company

19-Jan-2016

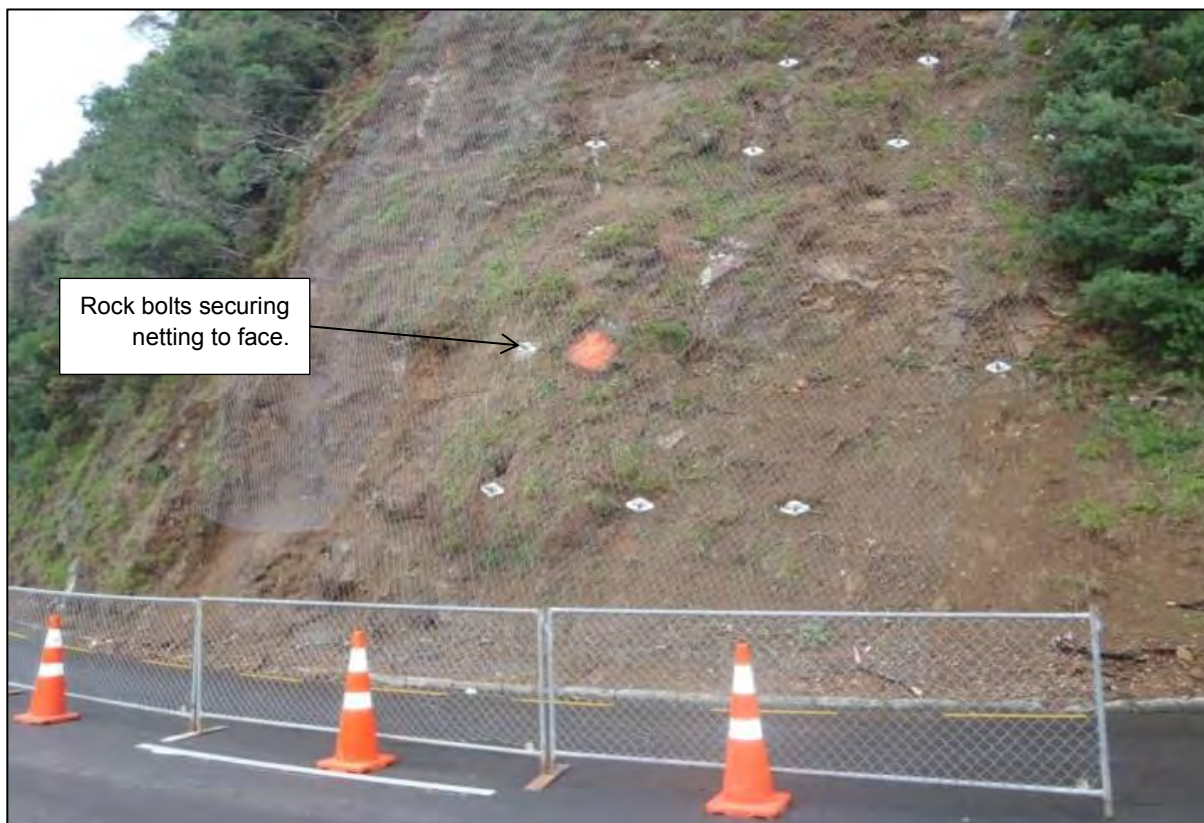
Figure 9 Rock netting designed by AECOM and installed on Birdwood Street, Wellington, 2013.

Where rock slope failures continue to be predicted with respect to the proposed geometry of each slope, the most economical form of remediation is likely to be high strength netting secured to the slope with a grid of rock bolts at approximately 2m centres; additional discrete bolts may also be deployed. Similar remedial works have been employed in the greywacke bedrock present across the greater Wellington region with apparent success; an image of a rock bolt netting on Birdwood Street, Karori, is shown below in Figure 9.

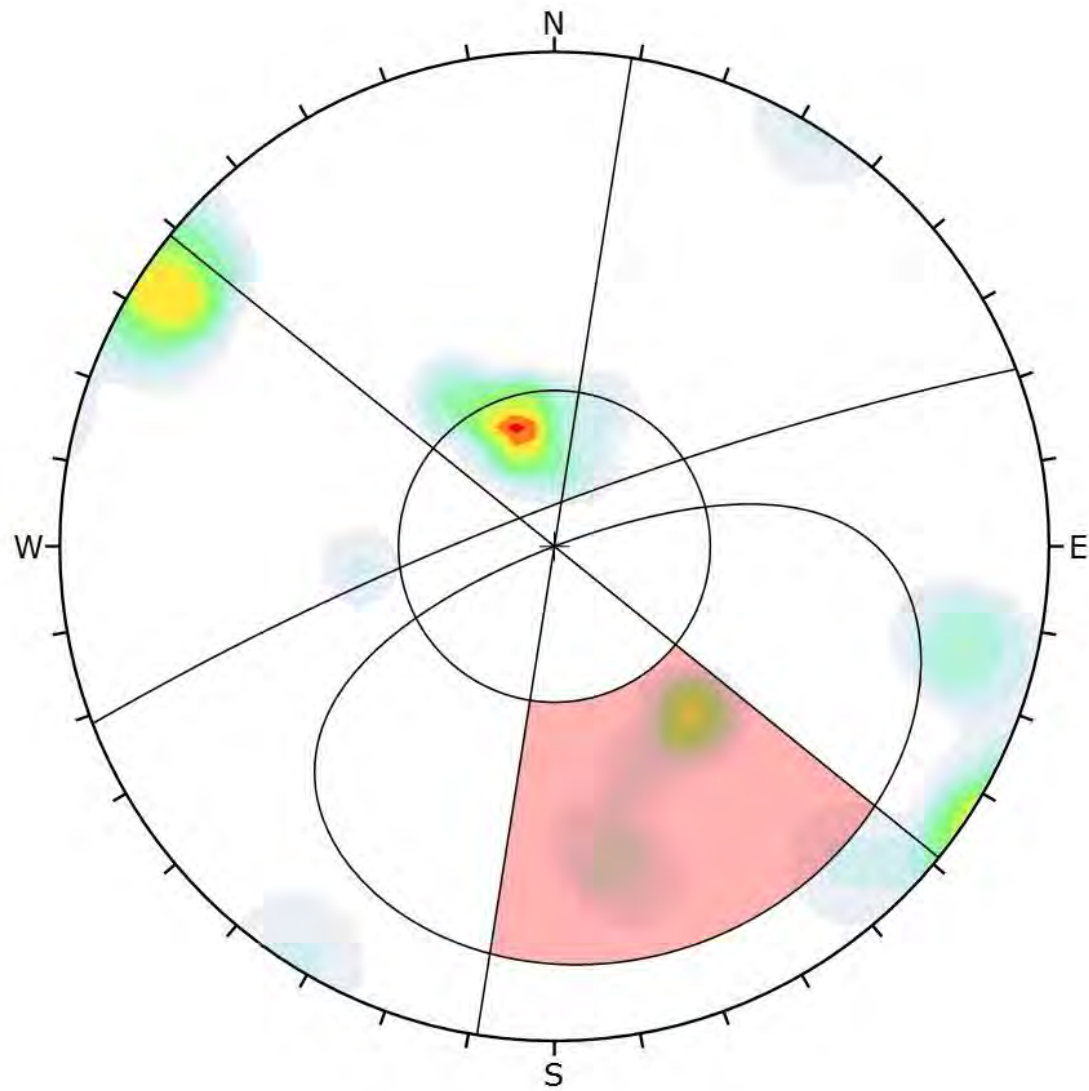
**Slope 1
Planar Sliding**

Color	Density Concentrations
	0.00 - 1.90
	1.90 - 3.80
	3.80 - 5.70
	5.70 - 7.60
	7.60 - 9.50
	9.50 - 11.40
	11.40 - 13.30
	13.30 - 15.20
	15.20 - 17.10
	17.10 - 19.00
Maximum Density	18.00%
Contour Data	Pole Vectors
Contour Distribution	Fisher
Counting Circle Size	1.0%
Kinematic Analysis	Planar Sliding
Slope Dip	81
Slope Dip Direction	339
Friction Angle	35°
Lateral Limits	30°
	Critical Total %
Planar Sliding (All)	6 25 24.00%
Plot Mode	Pole Vectors
Vector Count	25 (25 Entries)
Hemisphere	Lower
Projection	Equal Angle

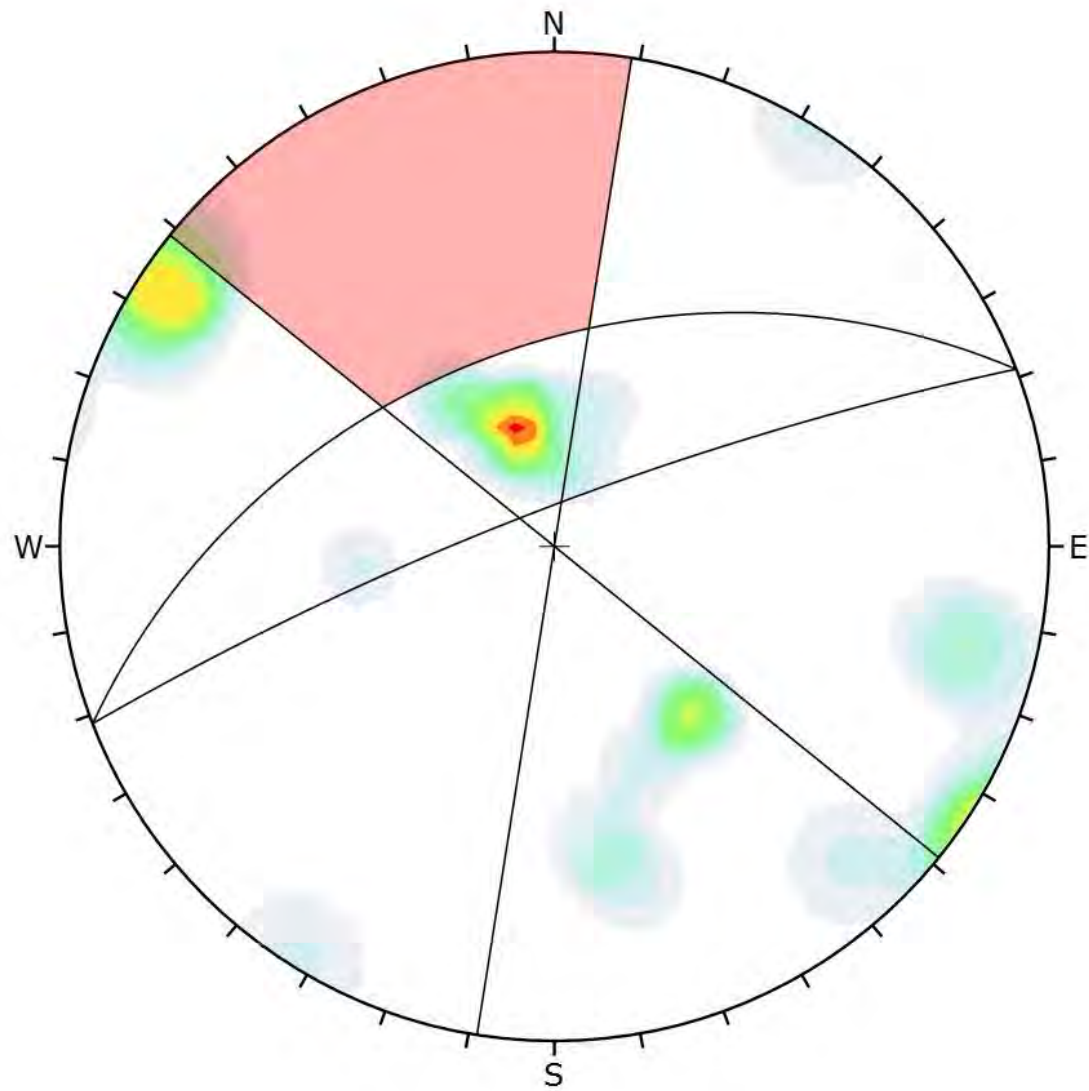
**Slope 1
Flexural Toppling**

Color	Density Concentrations		
	0.00	-	1.90
	1.90	-	3.80
	3.80	-	5.70
	5.70	-	7.60
	7.60	-	9.50
	9.50	-	11.40
	11.40	-	13.30
	13.30	-	15.20
	15.20	-	17.10
	17.10	-	19.00
Maximum Density	18.00%		
Contour Data	Pole Vectors		
Contour Distribution	Fisher		
Counting Circle Size	1.0%		
Kinematic Analysis	Flexural Toppling		
Slope Dip	81		
Slope Dip Direction	339		
Friction Angle	35°		
Lateral Limits	30°		
	Critical	Total	%
Flexural Toppling (All)	0	25	0.00%
Plot Mode	Pole Vectors		
Vector Count	25 (25 Entries)		
Hemisphere	Lower		
Projection	Equal Angle

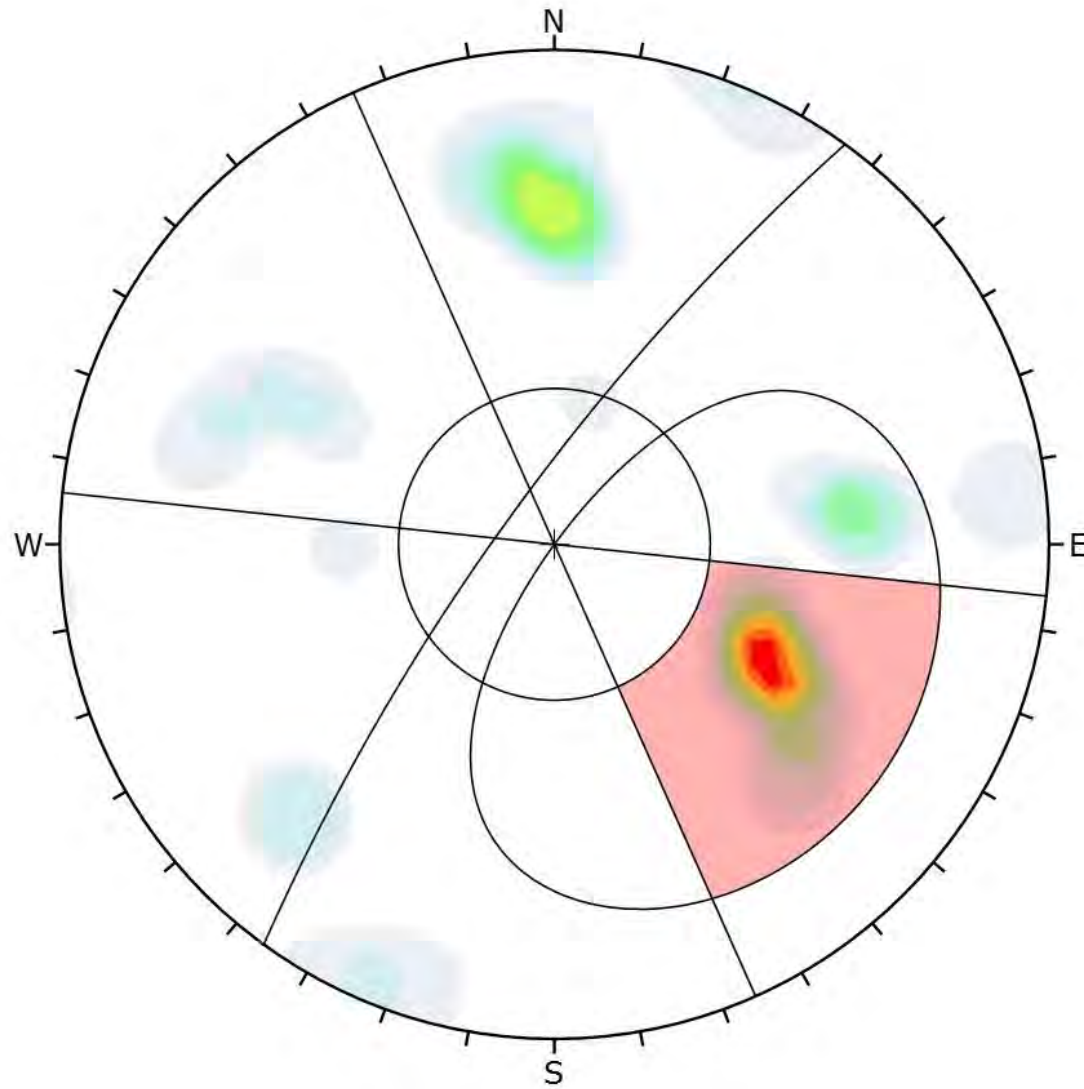
**Slope 5, Face 1
Planar Sliding**

Color	Density Concentrations		
	0.00	-	1.90
	1.90	-	3.80
	3.80	-	5.70
	5.70	-	7.60
	7.60	-	9.50
	9.50	-	11.40
	11.40	-	13.30
	13.30	-	15.20
	15.20	-	17.10
	17.10	-	19.00
Maximum Density	18.41%		
Contour Data	Pole Vectors		
Contour Distribution	Fisher		
Counting Circle Size	1.0%		
Kinematic Analysis	Planar Sliding		
Slope Dip	78		
Slope Dip Direction	306		
Friction Angle	35°		
Lateral Limits	30°		
	Critical	Total	%
Planar Sliding (All)	14	37	37.84%
Plot Mode	Pole Vectors		
Vector Count	37 (37 Entries)		
Hemisphere	Lower		
Projection	Equal Angle

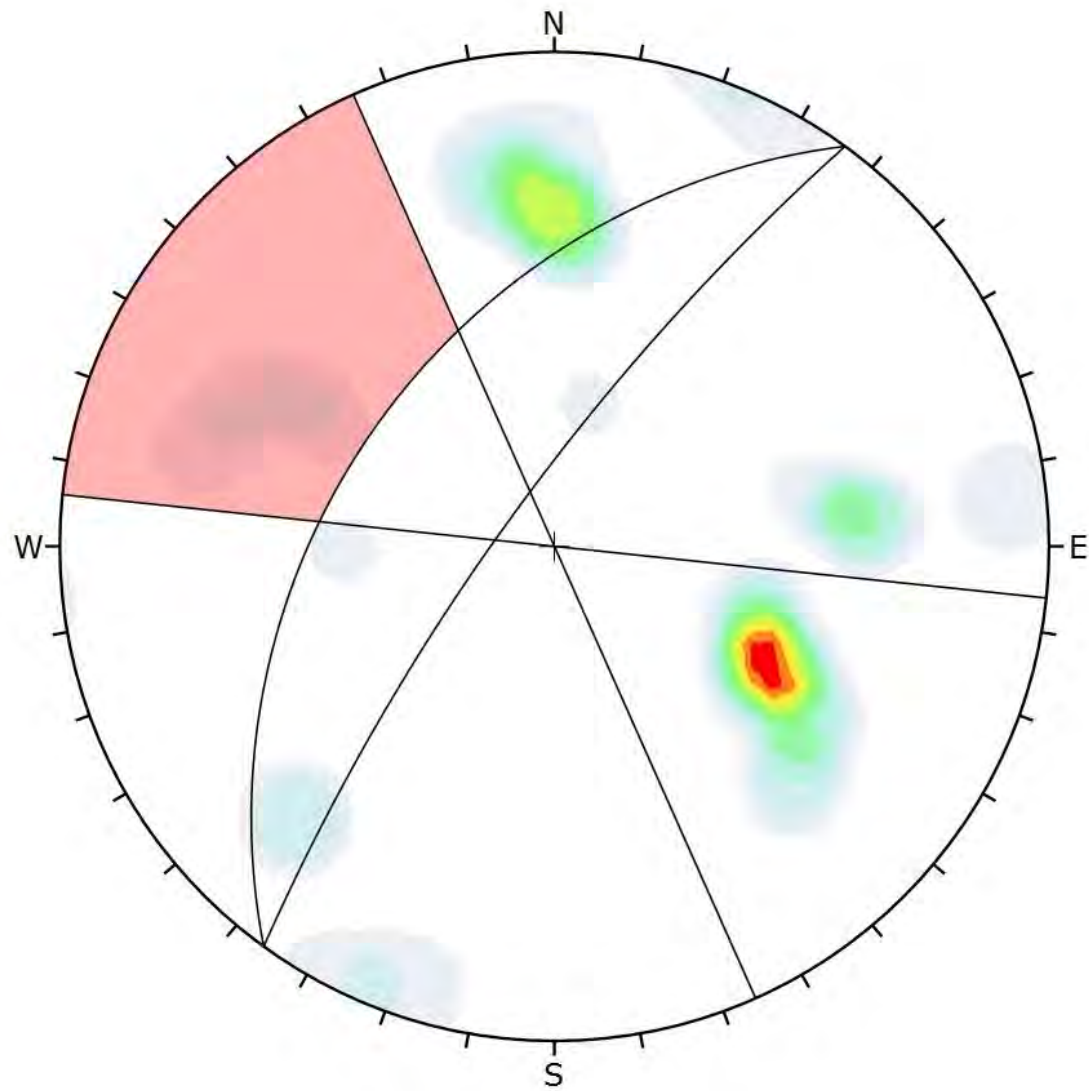
**Slope 5, Face 1
Flexural Toppling**

Color	Density Concentrations		
	0.00	-	1.90
	1.90	-	3.80
	3.80	-	5.70
	5.70	-	7.60
	7.60	-	9.50
	9.50	-	11.40
	11.40	-	13.30
	13.30	-	15.20
	15.20	-	17.10
	17.10	-	19.00
Maximum Density	18.41%		
Contour Data	Pole Vectors		
Contour Distribution	Fisher		
Counting Circle Size	1.0%		
Kinematic Analysis	Flexural Toppling		
Slope Dip	78		
Slope Dip Direction	306		
Friction Angle	35°		
Lateral Limits	30°		
	Critical	Total	%
Flexural Toppling (All)	4	37	10.81%
Plot Mode	Pole Vectors		
Vector Count	37 (37 Entries)		
Hemisphere	Lower		
Projection	Equal Angle

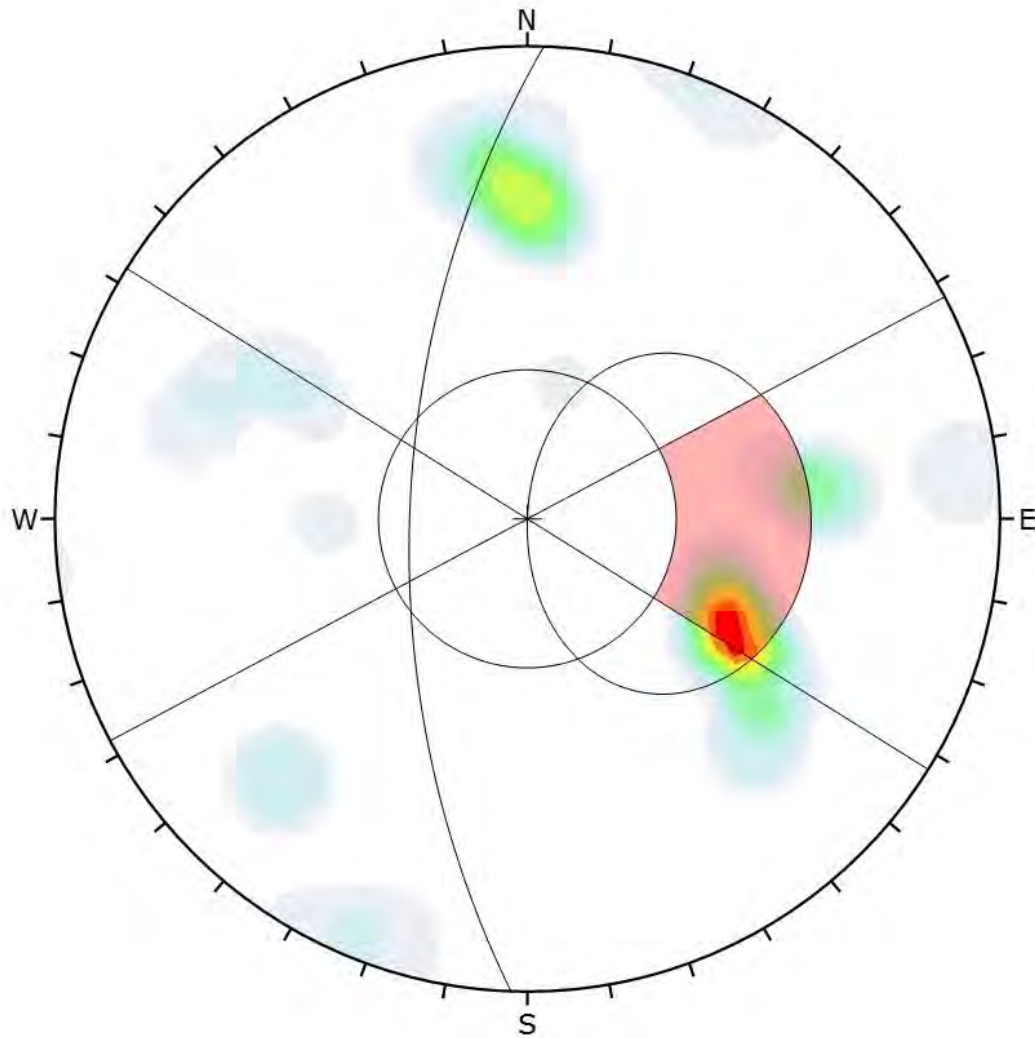
**Slope 5, Face 2
Planar Sliding**

Color	Density Concentrations		
	0.00 - 1.90		
	1.90 - 3.80		
	3.80 - 5.70		
	5.70 - 7.60		
	7.60 - 9.50		
	9.50 - 11.40		
	11.40 - 13.30		
	13.30 - 15.20		
	15.20 - 17.10		
	17.10 - 19.00		
Maximum Density	18.41%		
Contour Data	Pole Vectors		
Contour Distribution	Fisher		
Counting Circle Size	1.0%		
Kinematic Analysis	Planar Sliding		
Slope Dip	62		
Slope Dip Direction	272		
Friction Angle	35°		
Lateral Limits	30°		
	Critical	Total	%
Planar Sliding (All)	9	37	24.32%
Plot Mode	Pole Vectors		
Vector Count	37 (37 Entries)		
Hemisphere	Lower		
Projection	Equal Angle

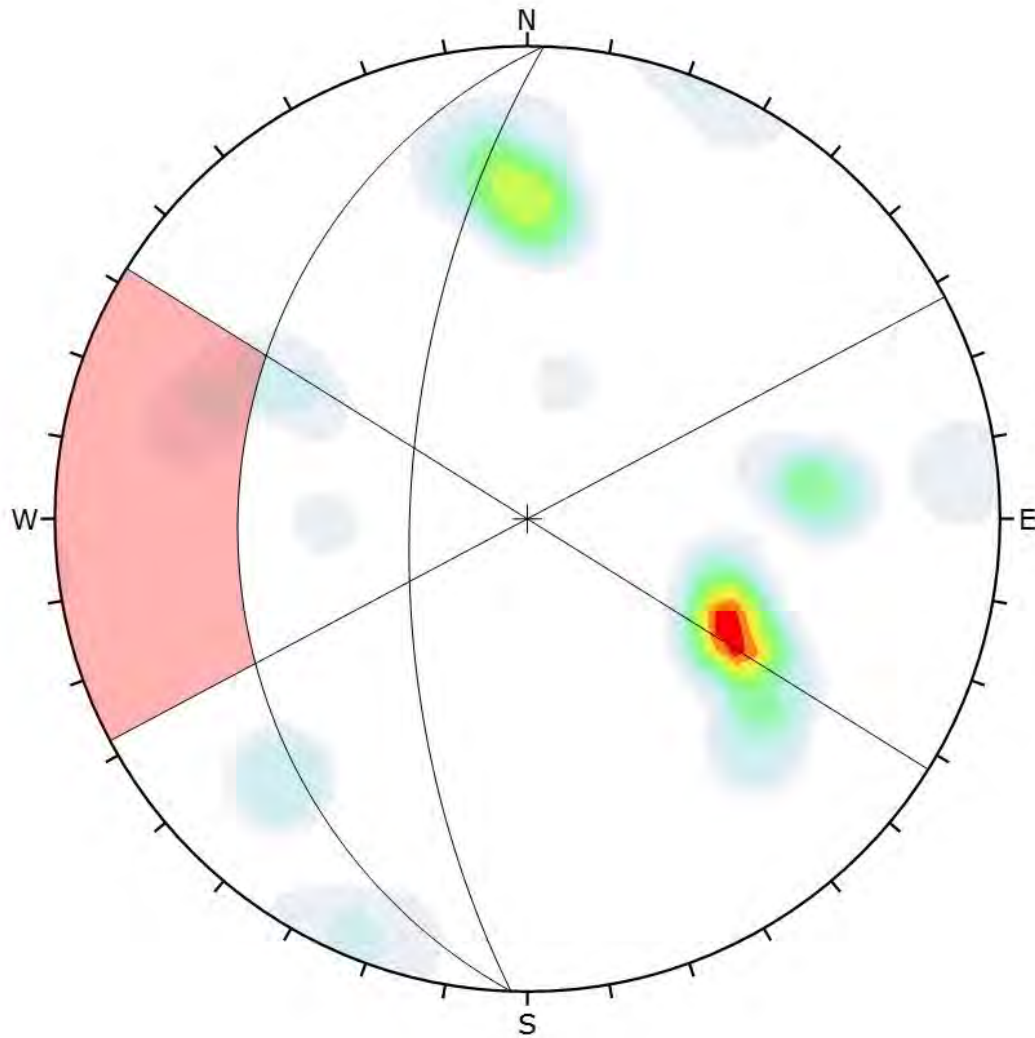
**Slope 5, Face 2
Flexural Toppling**

Color	Density Concentrations		
	0.00 - 1.90		
	1.90 - 3.80		
	3.80 - 5.70		
	5.70 - 7.60		
	7.60 - 9.50		
	9.50 - 11.40		
	11.40 - 13.30		
	13.30 - 15.20		
	15.20 - 17.10		
	17.10 - 19.00		
Maximum Density 18.41%			
Contour Data Pole Vectors			
Contour Distribution Fisher			
Counting Circle Size 1.0%			
Kinematic Analysis	Flexural Toppling		
Slope Dip	62		
Slope Dip Direction	272		
Friction Angle	35°		
Lateral Limits	30°		
	Critical Total %		
Flexural Toppling (All)	2	37	5.41%
Plot Mode	Pole Vectors		
Vector Count	37 (37 Entries)		
Hemisphere	Lower		
Projection	Equal Angle

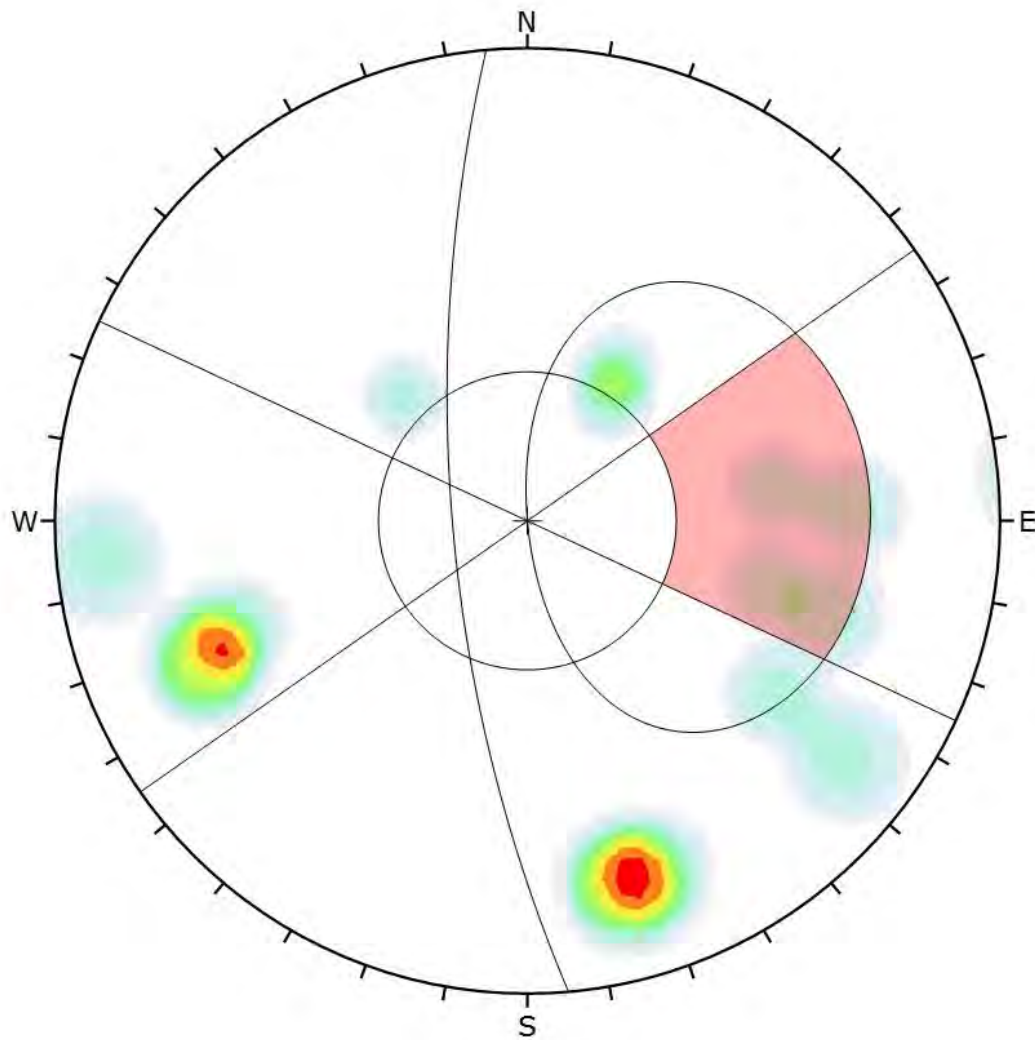
**Slope 7
Planar Sliding**

Color	Density Concentrations		
	0.00 - 1.90		
	1.90 - 3.80		
	3.80 - 5.70		
	5.70 - 7.60		
	7.60 - 9.50		
	9.50 - 11.40		
	11.40 - 13.30		
	13.30 - 15.20		
	15.20 - 17.10		
	17.10 - 19.00		
Maximum Density 18.01%			
Contour Data Pole Vectors			
Contour Distribution Fisher			
Counting Circle Size 1.0%			
Kinematic Analysis Planar Sliding			
Slope Dip 72			
Slope Dip Direction 265			
Friction Angle 35°			
Lateral Limits 30°			
	Critical	Total	%
Planar Sliding (All)	4	16	25.00%
Plot Mode Pole Vectors			
Vector Count 16 (16 Entries)			
Hemisphere Lower			
Projection Equal Angle

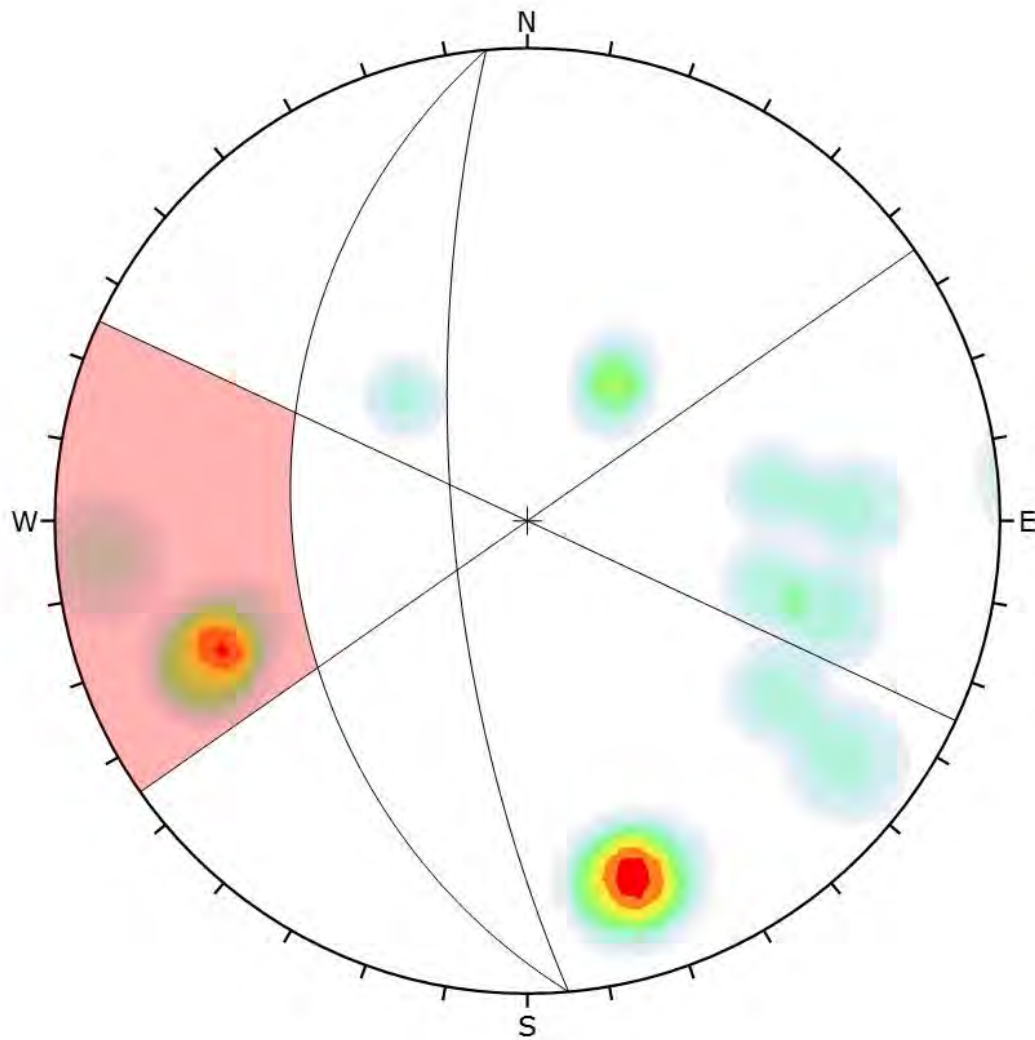
**Slope 7
Flexural Toppling**

Color	Density Concentrations		
	0.00 - 1.90		
	1.90 - 3.80		
	3.80 - 5.70		
	5.70 - 7.60		
	7.60 - 9.50		
	9.50 - 11.40		
	11.40 - 13.30		
	13.30 - 15.20		
	15.20 - 17.10		
	17.10 - 19.00		
Maximum Density	18.01%		
Contour Data	Pole Vectors		
Contour Distribution	Fisher		
Counting Circle Size	1.0%		
Kinematic Analysis	Flexural Toppling		
Slope Dip	72		
Slope Dip Direction	265		
Friction Angle	35°		
Lateral Limits	30°		
	Critical	Total	%
Flexural Toppling (All)	4	16	25.00%
Plot Mode	Pole Vectors		
Vector Count	16 (16 Entries)		
Hemisphere	Lower		
Projection	Equal Angle
