TO                   Whaitua Te Whanganui-a-Tara Committee

TOPIC              Wastewater Network Condition and Overflows by Subcatchment

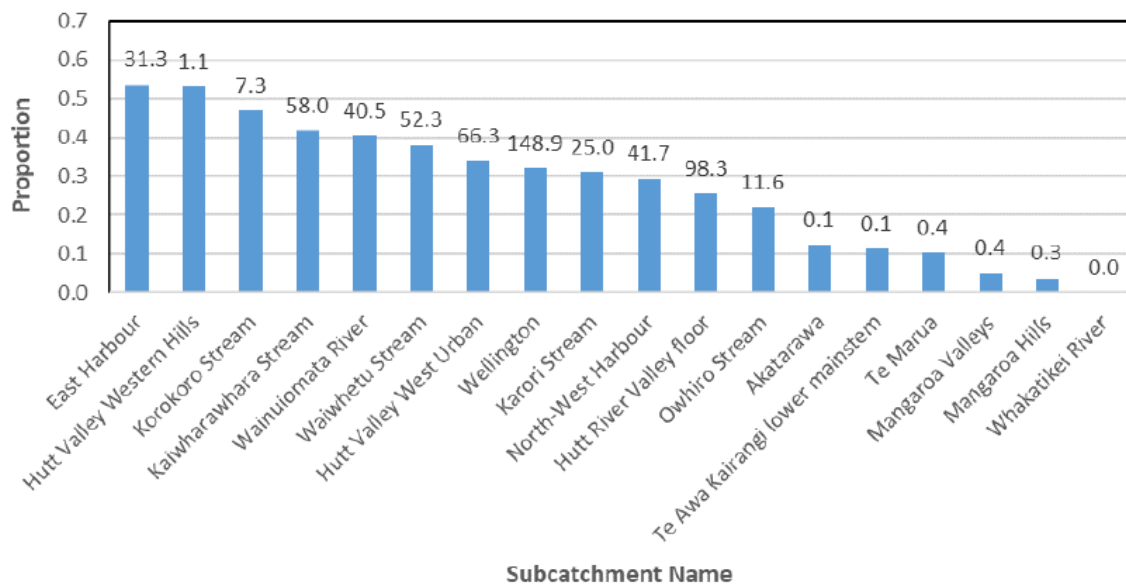
**Figure 1. Proportion (and length in km presented above the bars) of poor/very poor wastewater pipes per subcatchment. For example, Wellington (city) has 148.9 km of poor/very poor condition pipes, representing ~32% (0.32 as a proportion) of its total wastewater pipe network.**

This section highlights the length/extent of only the poor and very poor condition wastewater pipes based on both visual observations then hypothetical extrapolations (for areas not inspected, but of similar age and material). The information is presented in **Figure 1**. Note- Te Awa Kairangi lower mainstem subcatchment is defined in GIS as the river channel.
